Pembrokeshire County Council

Flood Investigation Report

Lower Town, Fishguard, Pembrokeshire
Friday 3rd January 2014.

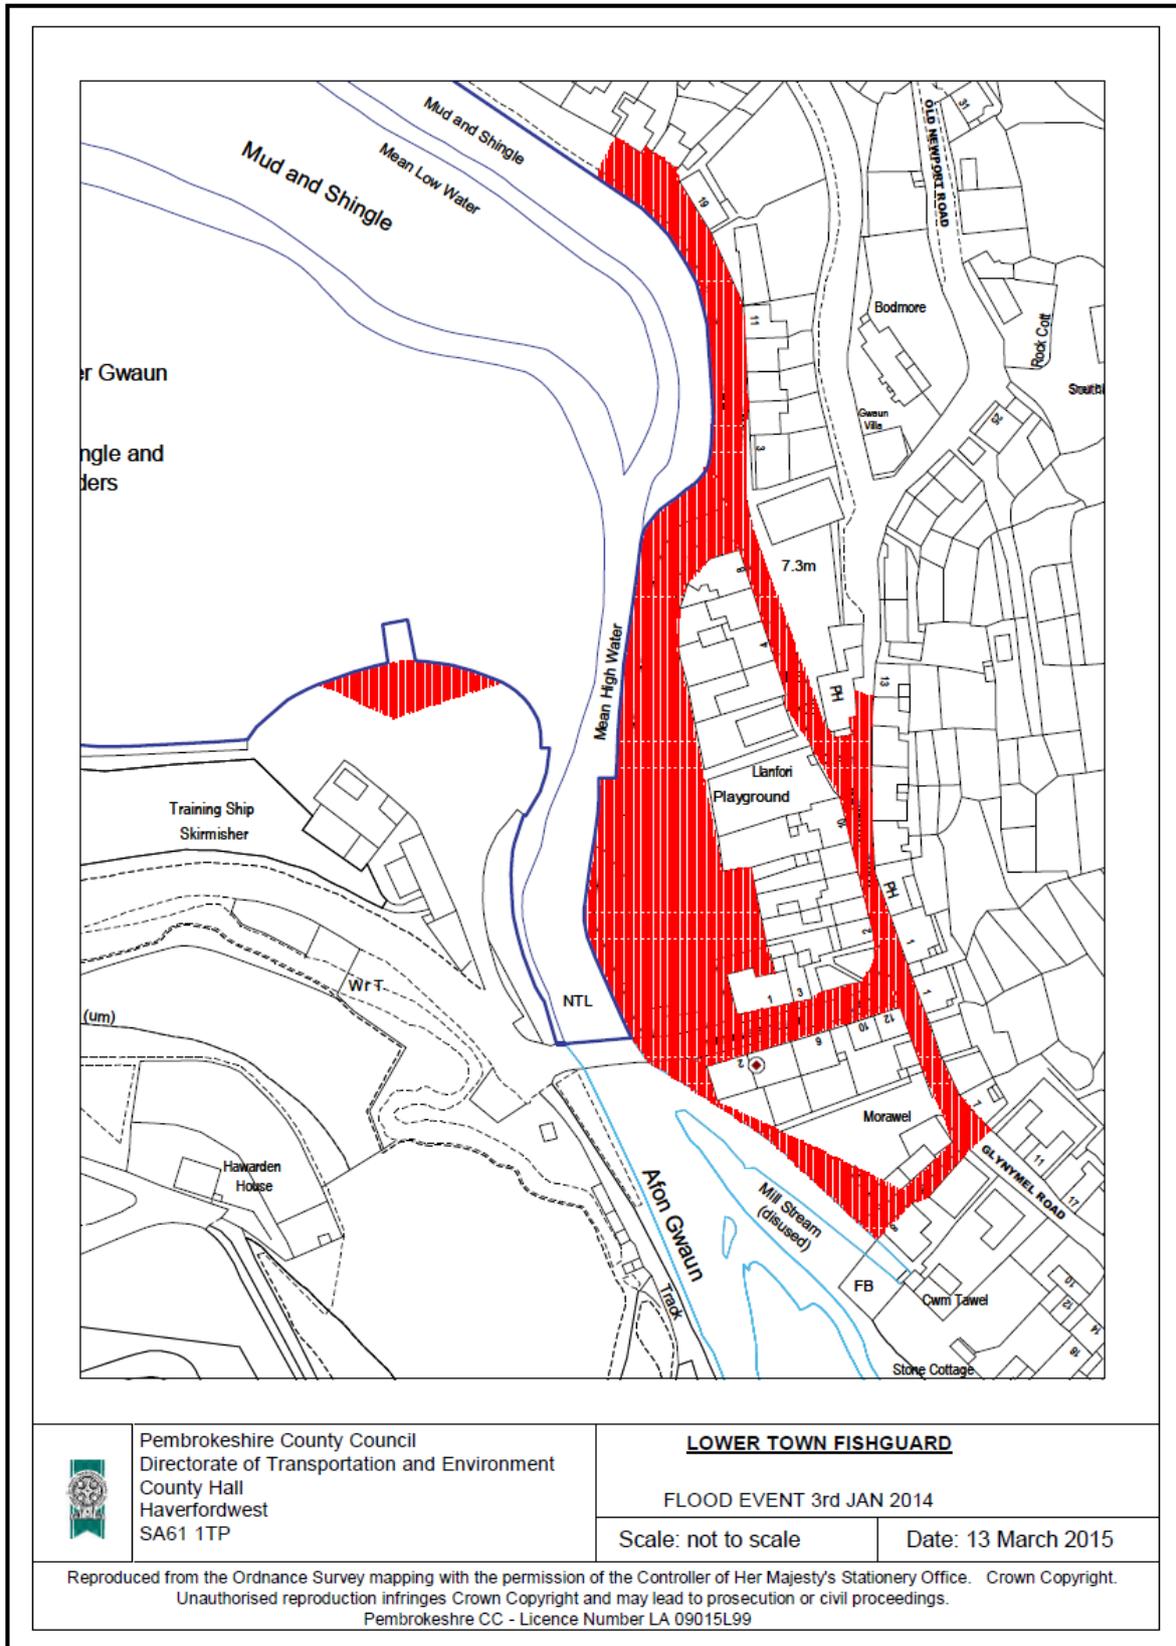
Appendix 4 Approximate area of flooding

Discussions with Officers of Pembrokeshire County Councils Maintenance team, Emergency Planning Staff and local residents confirmed that the tidal water overtopped the quayside and river bank at Lower Town, affecting an area of approximately 6000 msq. **(Appendix 4)**

The areas affected by the flooding incident include, Newport Road, Bridge Street, Quay Street, Car Park and Glynymel Road. The approximate area being affected being 6000 sq m.
