Penally Training Camp Phase 1 Land Quality Assessment

PROJECT NO. 62302982

OUR REF. NO. 62302982-20-1005-WSP-REP-001

DATE: FEBRUARY 2024

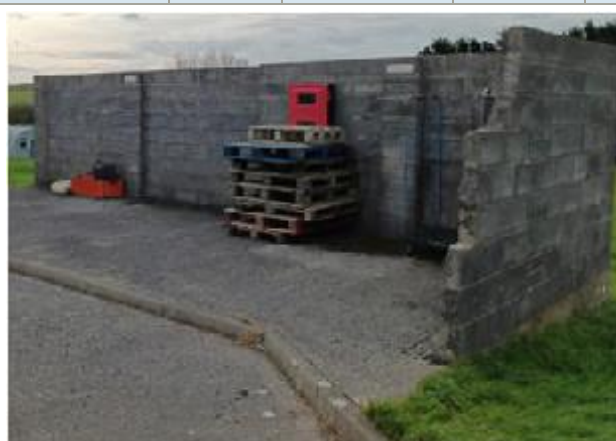
Source Type	Hazard	Contents and capacity	Current Status	Description
B01 Underground Storage Tanks	B01-1	DERV (diesel oil for road vehicles) 2000 gallons 9092 litres	Unknown	A POL point was located at the edge of the parade square, installed in 1976 [5] and comprising two USTs. The associated office is now used to store minor quantities of fuel (F01-1). The remains of the kerbside POL point pumps were present in 2013 but were not observed by WSP. Areas of replaced concrete indicate where these features were originally.
	B01-2	Leaded gasoline 5000 gallons 22730 litres	Unknown	<p>A sign on the wall states the tanks contained leaded gasoline, with the wording implying that the tanks are still present but have been emptied; this has not been confirmed and the current condition of the tanks is unknown.</p> <p>Anecdotal evidence collected by SKM Enviro indicates there were no spill prevention systems in place and spillages would have run straight to ground [1]. Drainage grates were observed in the concrete, as well as a linear drain following the kerb. The Landmarc utilities plan [6] describes these drains as 'soak away gullies' indicating drainage flowed straight to ground.</p> <p>The installation plan [5] shows the two drainage grates flowing to a three chambered interceptor to the east of the POL point prior to flowing to a soakaway to the south. The linear drain discharged straight to the soakaway.</p>

Photo 3 Fuel storage tank location

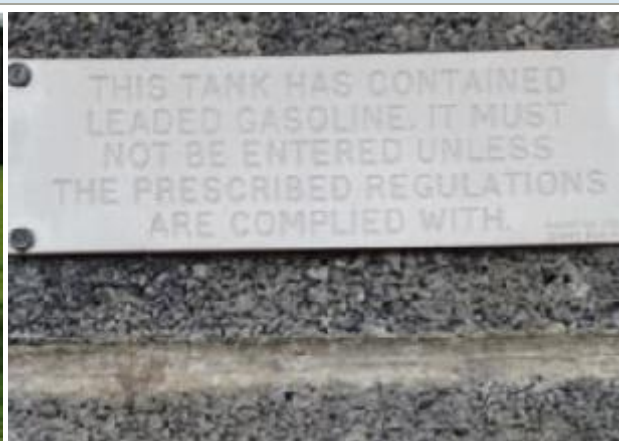
Photo 4 Fuel tank label

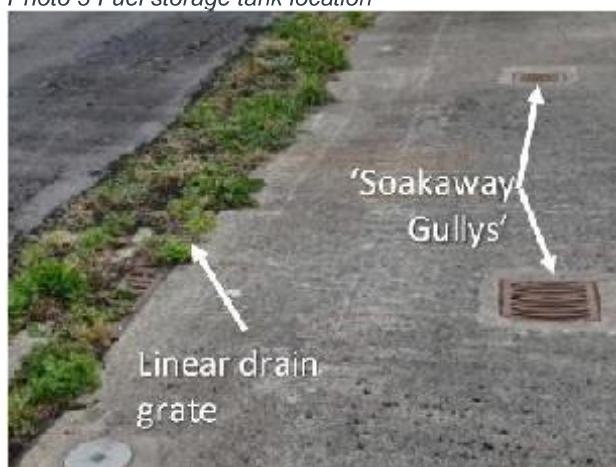
Photo 5 Drainage grates

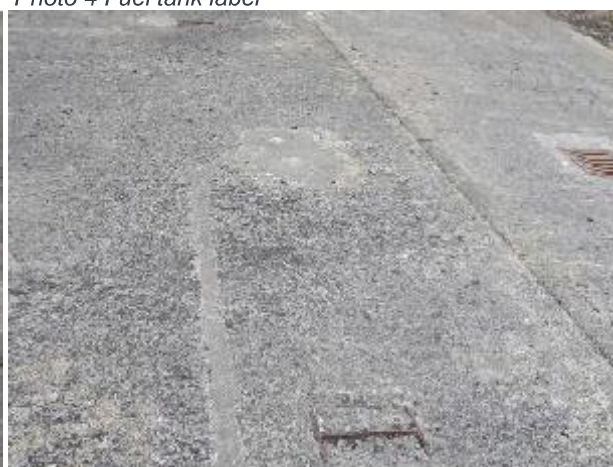
Photo 6 Removed POL point

Source Type	Hazard	Contents and capacity	Current Status	Description
B04 Refuelling Area (no tanks)	B04-1	Troop-provided fuel	Disused	The parade square was historically used for vehicle parking and anecdotally for refuelling vehicles by visiting troops. Bulk POL was located off-site at Castlemartin [1], but troops bringing fuel onto site would store it within the POL store (F01-1). Any modern-day refuelling would have been undertaken subject to spill prevention measures. The parade square is on hardstanding and areas of drainage were observed at the edges, notably in the southern edge by the POL store (F01-1).

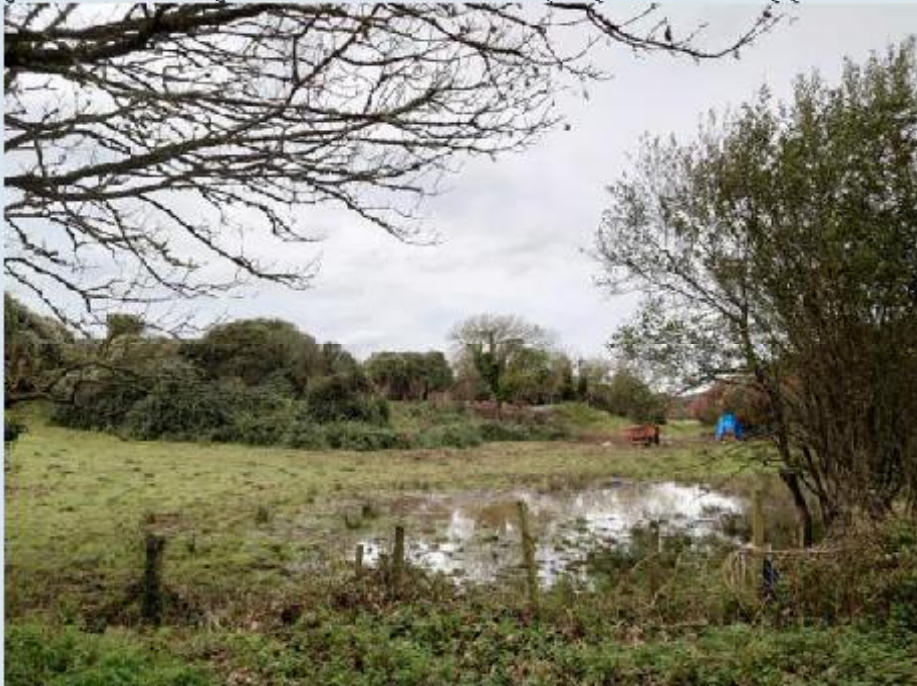
Source Type	Hazard	Description
C02 Infilled ground including pits / ponds	C02-1	<p>Former quarry to the west of the sewage treatment works (R02-1) lies 30m off site to the west of the sewage works. The Envirocheck [7] lists this area as a BGS Recorded Mineral Site, described as an opencast limestone quarry which is no longer active. The site name is 'Penally Barracks', indicating it was operated by the site.</p> <p>The area has been infilled, although materials are unknown. Likely historically used for disposal of material from camp and ranges [1]. Currently occupied by a farm and satellite imagery indicates the area is used for waste storage or movement. Unable to access during the walkover, although the area was observed to be raised above ground level and vegetated. Stated to be a landfill quarry in HER record [8].</p>

<p><i>Photo 7 Possible infilled quarry. View from sewage works (R02-1) to the east</i></p>

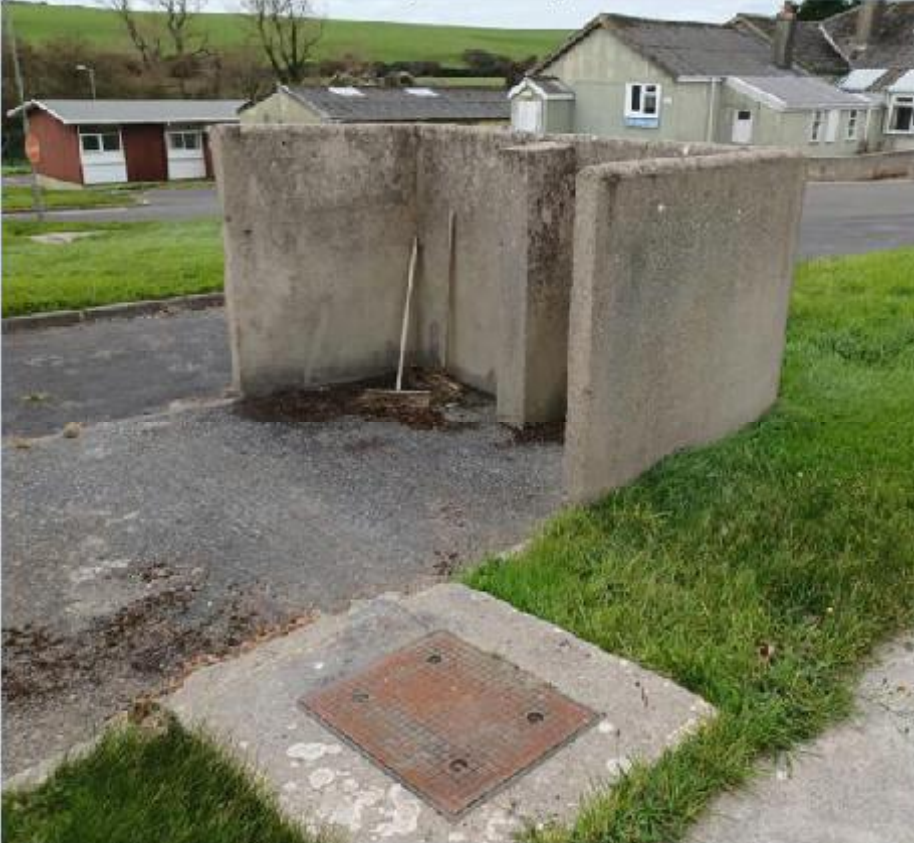
Source Type	Hazard	Description
		won. Potential for made ground and building rubble in soil due to multiple on-site demolished buildings.
	C03-4 C03-5	Two areas of 'cut and fill' identified in the previous LQA, likely resulting from clearing ground for building construction. Due to the proximity to historical buildings these likely contain building rubble, although this is not confirmed. The mounds were all observed to be grassed during the walkover, with no evidence of soil composition observed.
C05 Waste Compound / Scrapyard	C05-1 C05-2	<p>Waste compounds used for temporary storage of waste from site are located adjacent to kitchens and previously stored bins. Waste was removed from site under a third-party contract. Areas were underlain by hardstanding.</p>

<p><i>Photo 8 Waste storage compound by kitchen</i></p>

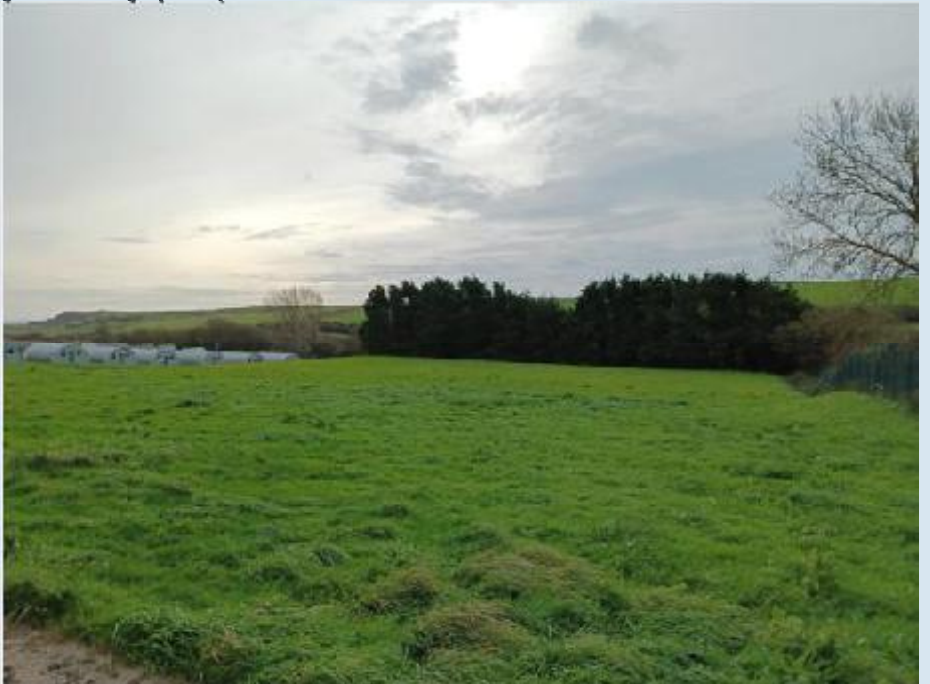
Source Type	Hazard	Description
D01 Burning Ground	D01-1	The Enviro LQA [1] identifies an historical burning ground in the west of the site, beyond the parade ground and close to the MT workshop (E01-1), although the exact location is uncertain. It is possible that burning occurred on the parade square itself. No information on this burning ground is available and no evidence was observed during the walkover.
D03 Incinerators	D03-1	An incinerator was noted by Enviro [1] to have been present in the west of the site and was marked on a 1943 site plan [10]. It was absent in the site plan from 1978 [11] and the walkover did not identify any evidence of this feature.
D04 Tip and Burning Area	D04-1	The sports field in the west of the site is a flat piece of ground with a steep bank sloping down in the south (C03-1) and another sloping up in the north (C03-2) towards the parade square. The previous LQA [1] states that this area was historically used as

Source Type	Hazard	Description
		<p>both a burning ground and dumping area, indicating that the presence of made ground is highly likely.</p>

<p><i>Photo 9 Sports field</i></p>

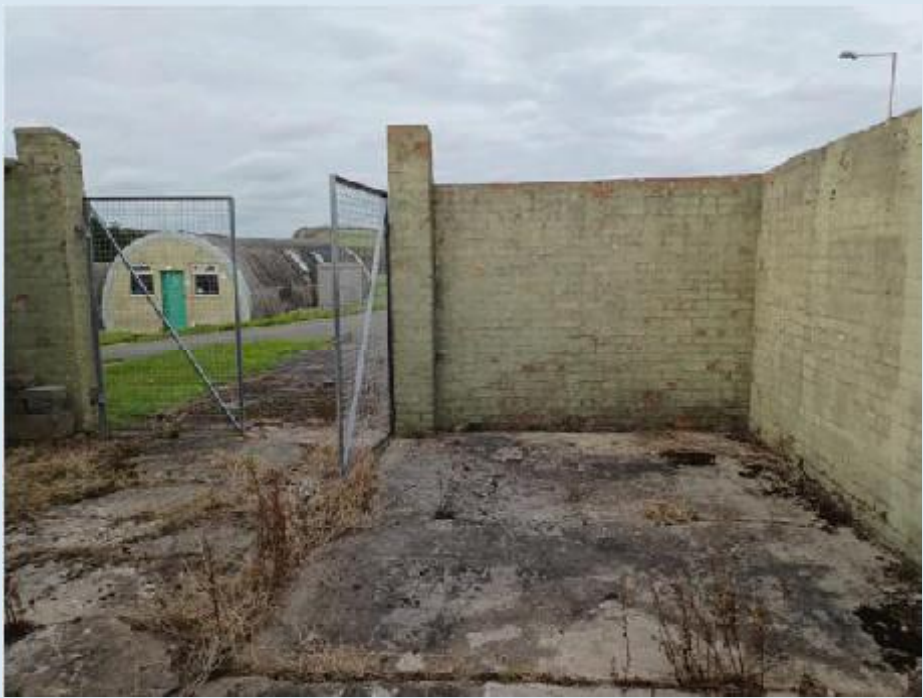
Source Type	Hazard	Description
E01 Vehicle Workshops	E01-1	A former MT garage, Building 48, lies to the west of the parade square. It was not possible to access the building during the walkover, although site staff confirmed in recent history it was used for just storage of vehicles and there were no maintenance bays.
	E01-2	A vehicle repair shop was present in the south of the site, between the magazine (Q01-1) and armoury/guard room (Q02-1), as shown on the 1943 site map [10]. This is no longer present and is in an area of landscaping adjacent to the shooting-in box (A14-1). A hand-annotated map from 1958 [12] shows this building to have been crossed out in pencil, indicating it was demolished around this time.
E02 Range workshops	E02-1	<p>Main camp workshop used for maintenance of equipment and storage. It would have included a COSHH locker and been used for the storage of small quantities of paints and possibly oils. Like the rest of the camp, the building was mostly empty during the walkover. Two barbeques and a metal drum which possibly contained oil were stored in an attached shed, although site staff did not know what the drum contained or where it came from.</p> <p>This was historically the RE (possibly stands for Royal Engineers, although not defined in drawing) workshop (Building 479/80) as shown on the site plan from 1943 [10].</p>

<p><i>Photo 10 Courtyard of disused maintenance workshop (E02-1)</i></p>
	E02-2	<p>An historical repair shop in the southeast of the site shown on a site plan from 1943 [10] as Building 48. The building numbers on this plan do not align with current-day building numbers. It is assumed this was used for camp repair work. It is now demolished and is covered by hardstanding used for parking.</p>

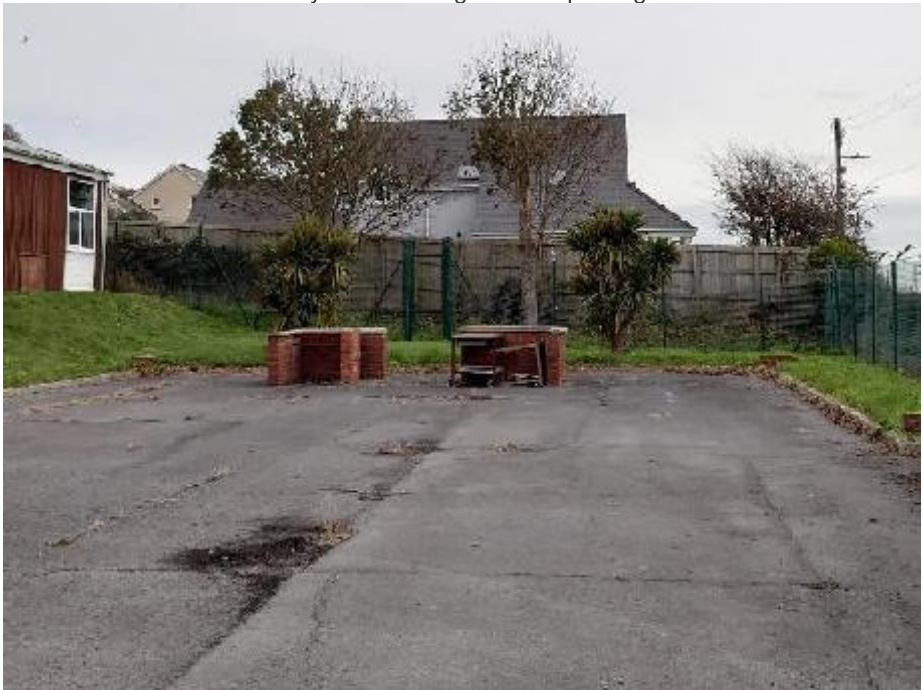
<p><i>Photo 11 Demolished repair shop now a car park (E02-2)</i></p>

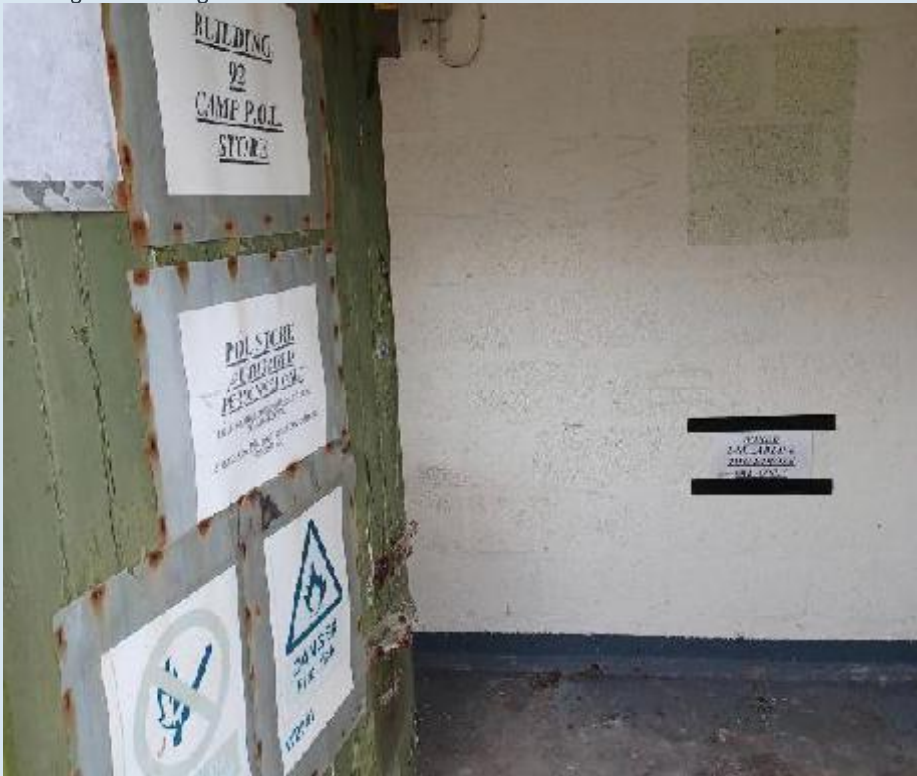
Source Type	Hazard	Description
F01 Hazardous materials including fuel storage	F01-1	<p>A small brick building adjacent to the parade square used for storing small quantities of fuel whilst the camp was active. Jerry cans were used by facilities management for equipment refuelling. The building was self-contained, and no gaps were visible around the floor, with a raised lip at the doorway likely preventing spills from escaping the building. The building was empty during the walkover. No staining was visible although the storage conditions whilst in use are unknown.</p>

<p><i>Photo 12 Interior of small scale fuel storage building</i></p>
	F01-2	<p>A building in the north of the site, which has been present since the 1890s, was used during WW2 (1943 site plan [10]) as a coal and fuel store used for the nearby NAAFI building (G01-1). This is currently out of bounds due to asbestos, although site staff identified it as a stable. It is not known what fuel (other than coal) was stored there and when this storage ceased.</p>

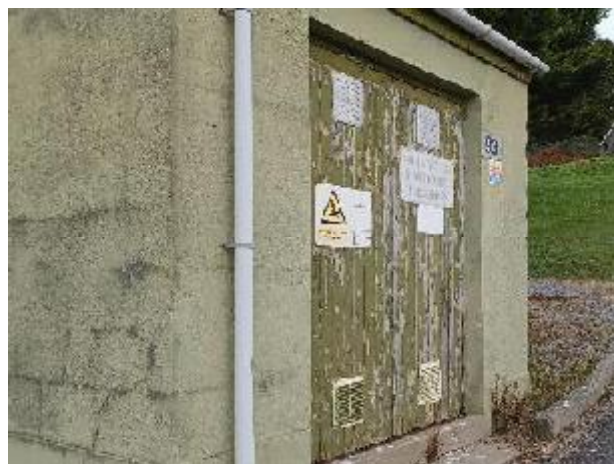
Source Type	Hazard	Description
M01 Substations	M01-1 M01-2	Two substations are located in the centre of the camp, adjacent to one another. A concrete block building housed an older substation (M01-1) with the newer building (M01-2) adjacent to it. These are both understood to have been disconnected from the mains and no longer active. They are adjacent to a brick switchgear room.

Photo 17 Old substation (M01-1)

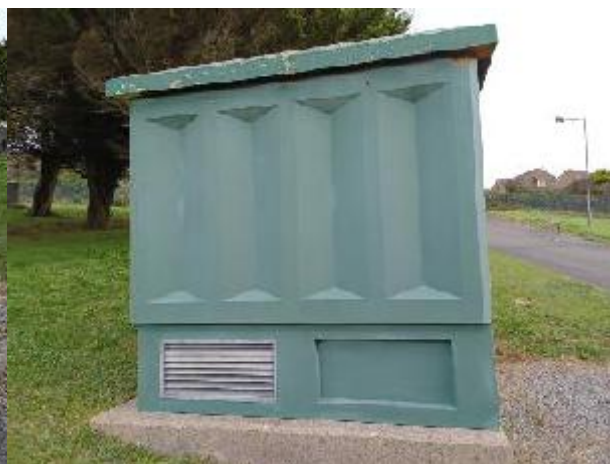
Photo 18 Newer substation (M01-2)

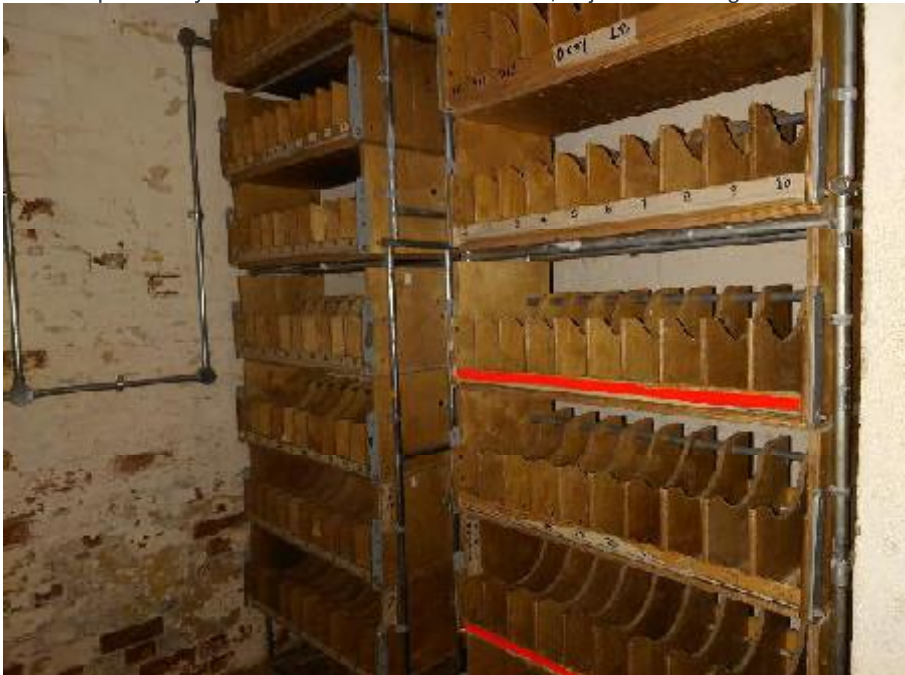
Source Type	Hazard	Description
Q02 Armoury	Q02-1	<p>The camp armoury was located at the site entrance, adjacent to the guardroom.</p>

<p><i>Photo 21 Shelving inside armoury building.</i></p>

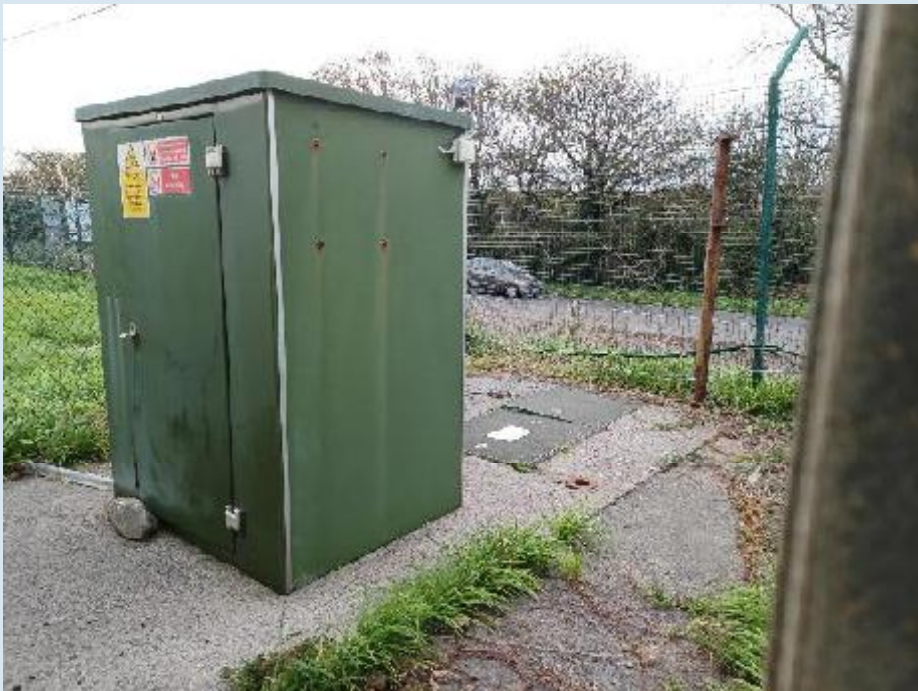
Source Type	Hazard	Description
R01 Cess pit / septic tank	R01-1	<p>Foul water drainage at the site was previously connected to the mains sewerage system. It was disconnected recently, along with other utilities, when the camp was cleared. The connection in the south of the site, behind the magazine (Q01-1) required power to pump into the sewers, which is no longer possible. As such, the foul water discharge chamber has become a holding tank and is manually emptied by a third-party contractor.</p>

<p><i>Photo 22 Drainage outflow point</i></p>
R02 Sewage treatment works	R02-1	<p>Historical sewage treatment works located to the south of the main camp, across the A4139 road. A site plan dated to 1913 [15] shows the layout of the sewage treatment works, featuring two filter beds, a bank of settling tanks and what appears to be a soakaway system. Two foul water drainage routes were shown to connect the camp to the system, one of which was labelled 'stormwater'. The outlet pipe discharged to an off-site drainage channel [16]. It was labelled as a 'sewage farm' in 1978 [11] and was disused by 1991 [17].</p> <p>The area is now heavily overgrown and there is little evidence of prior use. The current utility plan [6] does not show any historical services connecting to this area.</p>

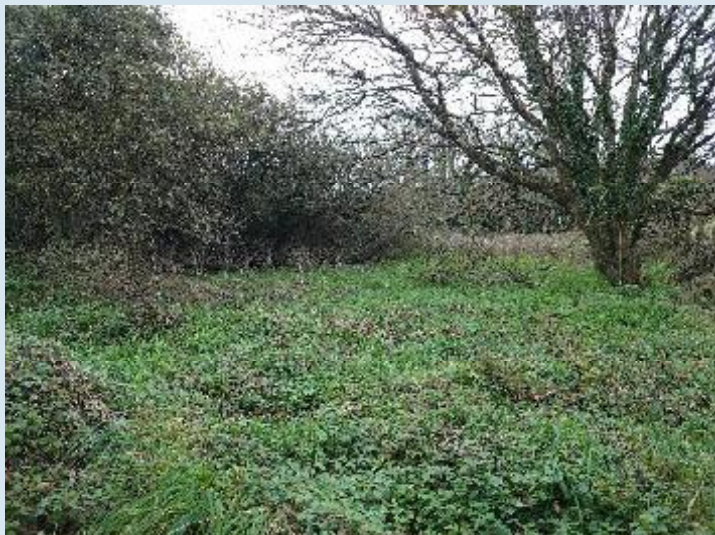
Photo 23 Extract of 1913 plan [15]		Photo 24 Historical sewage treatment works area

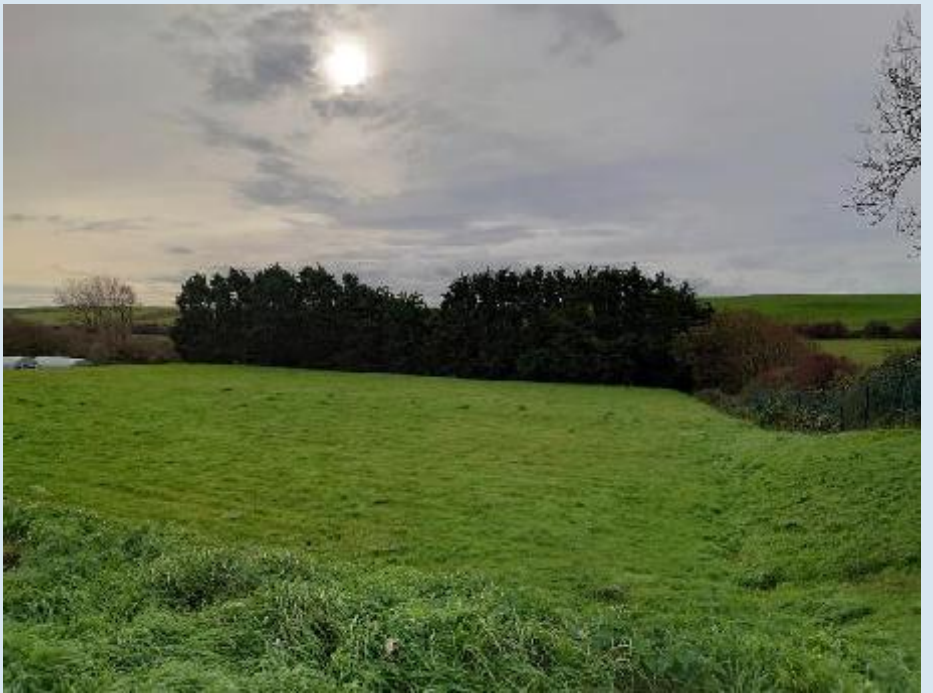
Source Type	Hazard	Description
X06 Helicopter landing sites	X06-1	A helicopter landing area is shown on the site plans produced by Landmarc [6] in the northeast corner of the playing field, which is in the southwest of the site. During the walkover site staff indicated that there was not a formal landing spot, stating that helicopters could use the entire playing field and were likely to have also used the parade ground to the north. There is no evidence that refuelling of helicopters took place at the site.

<p><i>Photo 25 Sports field used as a helicopter landing site.</i></p>
