Newgale Shingle Bank

Vulnerability Assessment

Pembrokeshire County Council

Final Report

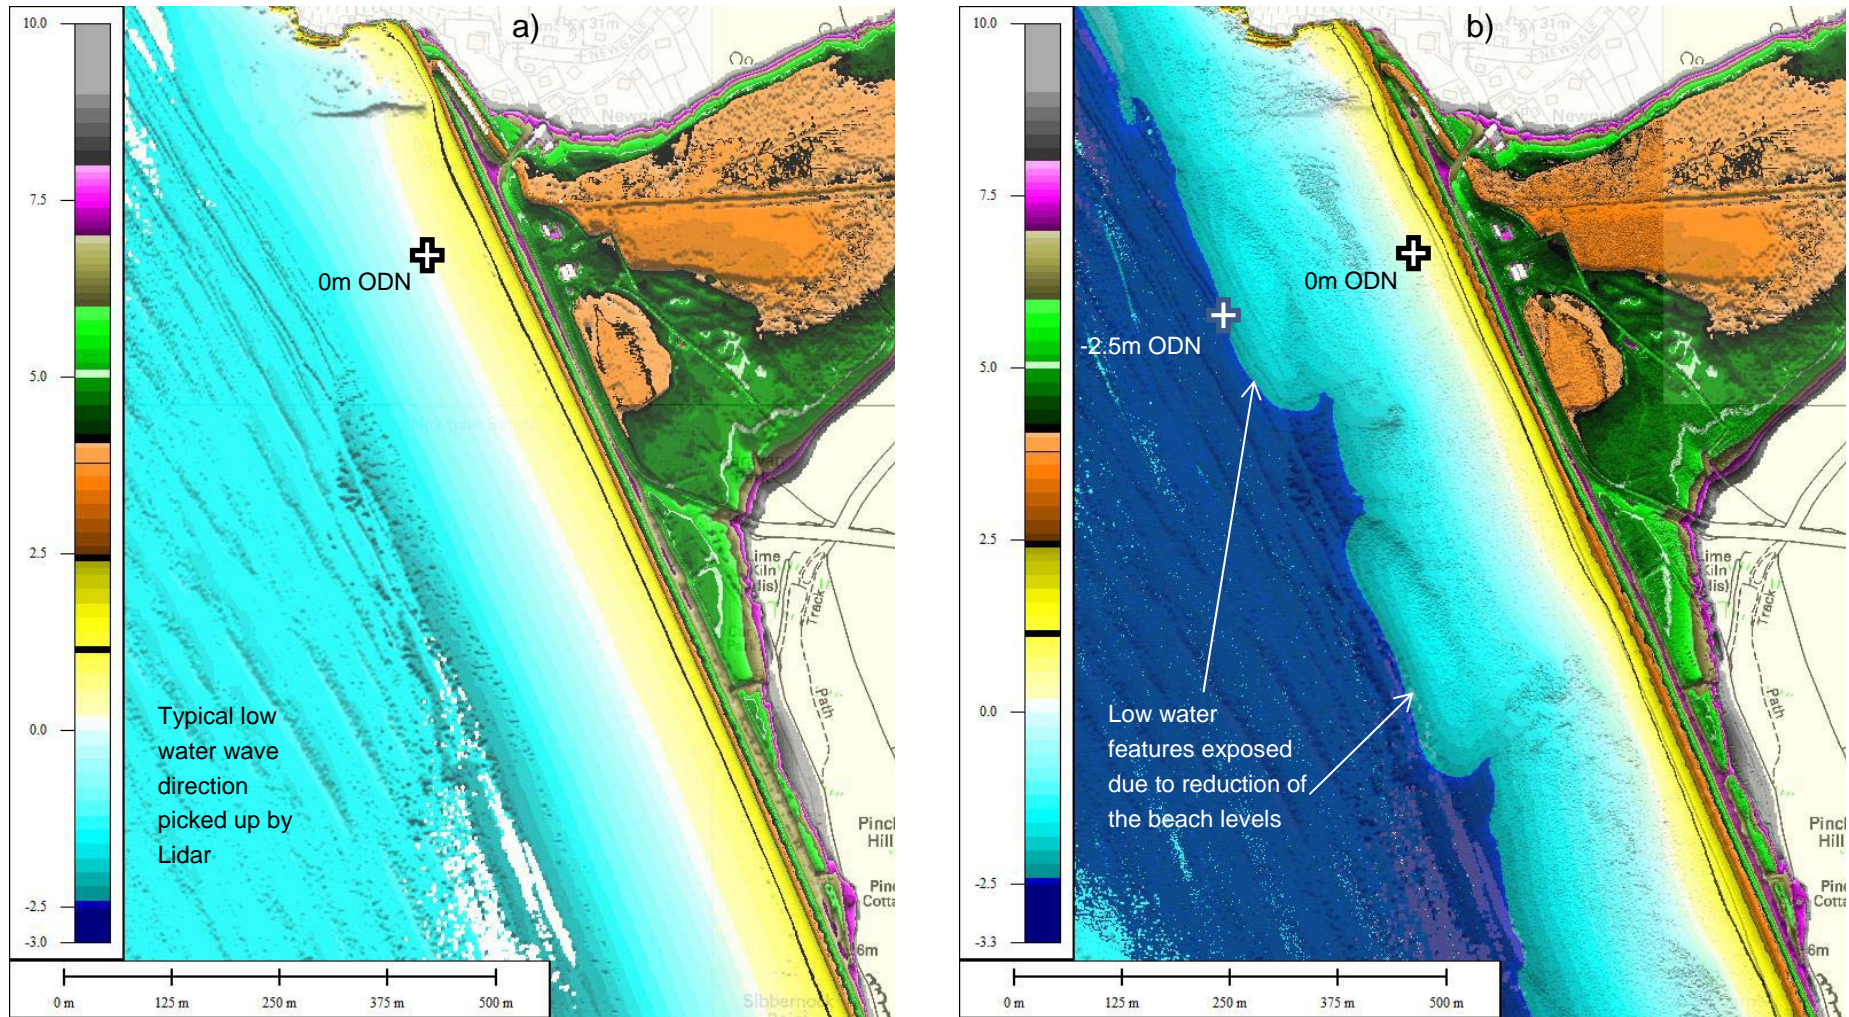
Figure 2.3. Comparison of ground levels between a) 2006 and b) 2014

In the storms of 2014, the lower beach was stripped of sediment in places down to harder material, quite possibly resulting in erosion to the lower foreshore platform. In some areas beach levels dropped by over 1m. The relative position of the 0m ODN contour is shown in the comparison between a) and b) on Figure 2.3.

On the 2014 plot (Figure 2.3 b) two significant low water banks (probably formed of harder material) are seen. With the near normal wave direction, these features may have subtly influenced movement of sediment within the lower and upper beach, resulting in sediment being moved in different directions along the frontage. While there was a general depletion of sediment, this amplified this process in specific areas.

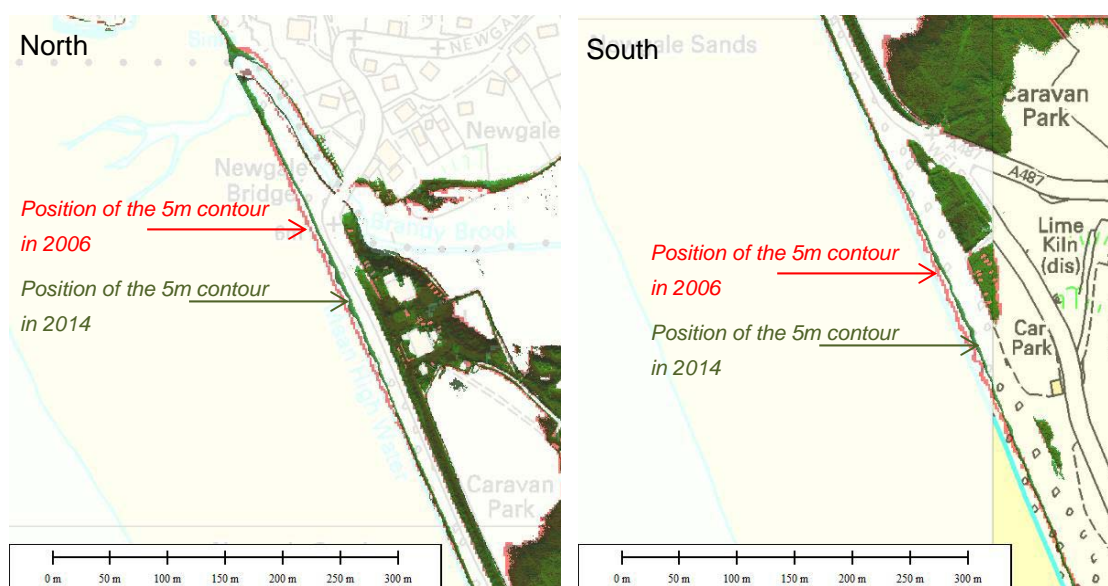
Figure 2.6. Differential change in shingle ridge 2006 compared to 2014.

It may be seen that over the very northern end of the frontage there has been relatively little change in the 5m contour, although in detail the bank was overtopping and shingle was deposited in the stream behind.

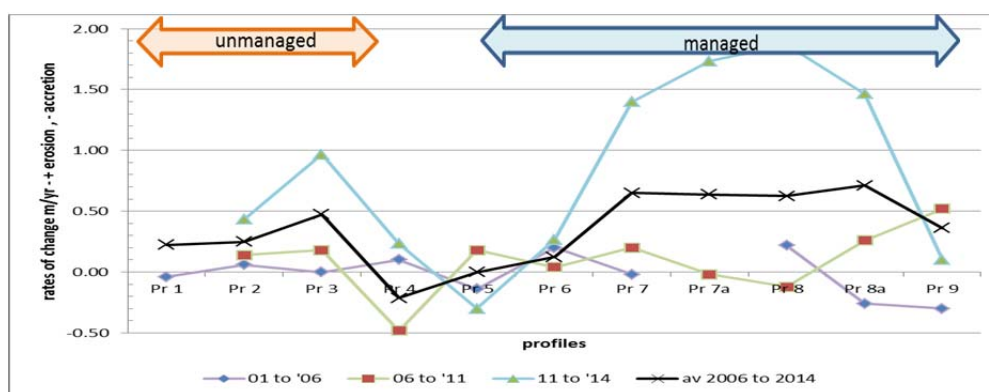
Figure 3.1. Variation in rate of change by profile.

It can be seen that there is quite significant variation along the frontage. Generally over the northern section there has tended to be more retreat, obviously but not exclusively due to the 2014 storms. This process has continued despite re-profiling of the area. In the centre of the frontage there has been less variation, even taking account of the 2014 storms and at profiles 4 and 5, there has been little overall change in position. Over the unmanaged section to the south, there continues to be a general pattern of retreat

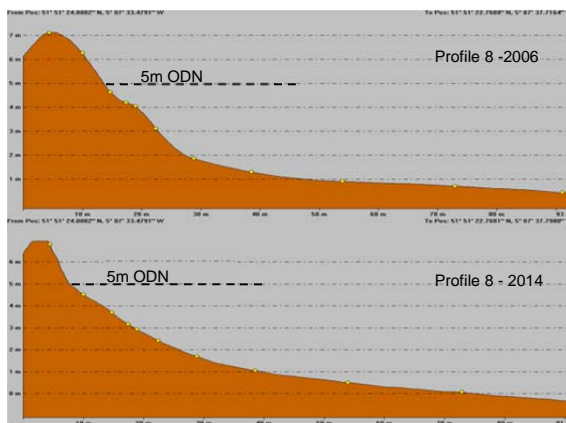
Profile 8 shows a significant cutting back of the main beach face and significant thinning of the upper ridge. (Figure 3.2 a)

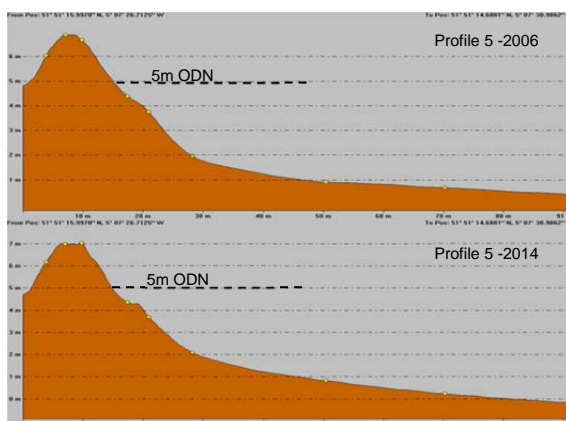
At profile 5, the actual crest of the bank has set back slightly with some overtopping and overwash to the back face. Both the front and back faces are steeper, despite the ridge appearing to retain its integrity. There has been some draw down of sediment at the toe of the ridge. (Figure 3.2 b)

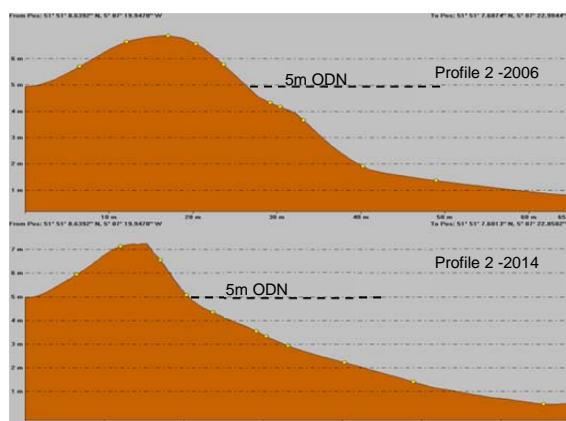
Figure 3.2 comparison between 2006 (upper) cross section and 2014 (lower).

Around profile 2, there has been significant cutting back of the front face of the upper ridge and some overwash of sediment to the back face. There has been some draw down of sediment to form a more gradual transition between the toe of the ridge and the foreshore. (Figure 3.2 c)

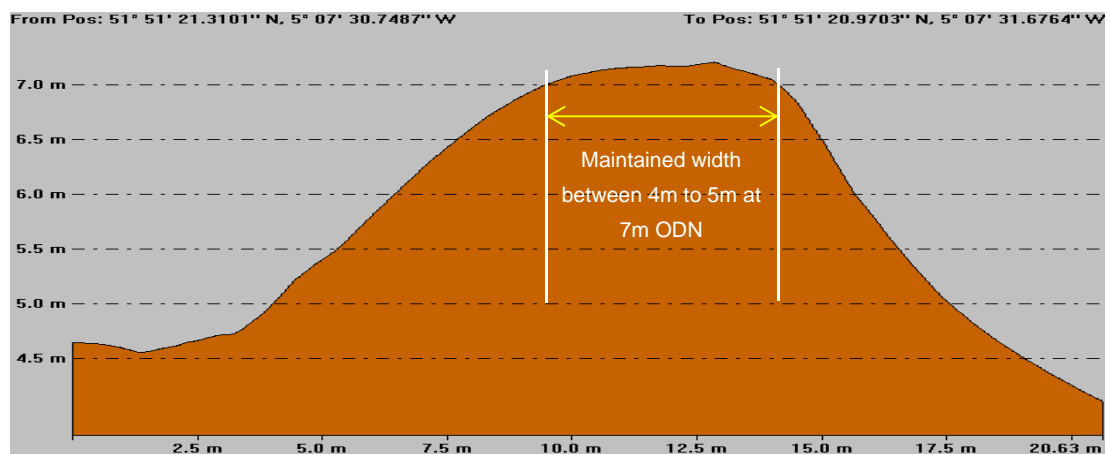
Figure 3.3. Maintained crest shape, based on Profile 7.

With some sections of the ridge this appears not to have been possible, notably at Profile 8 where the crest is shown to be only around 3m wide. In other areas the crest level remains below 7m ODN.

Although reinforcing the crest potentially reduces overtopping during more regular storm conditions, it does not address the fundamental problem of loss of overall bulk of the ridge. The works can result in over steepening both the front and back face of the ridge. Furthermore, as discussed earlier, it is recognised that artificially placed sediment does not respond in the same manner as naturally sorted shingle and is therefore more vulnerable to subsequent movement by wave action.

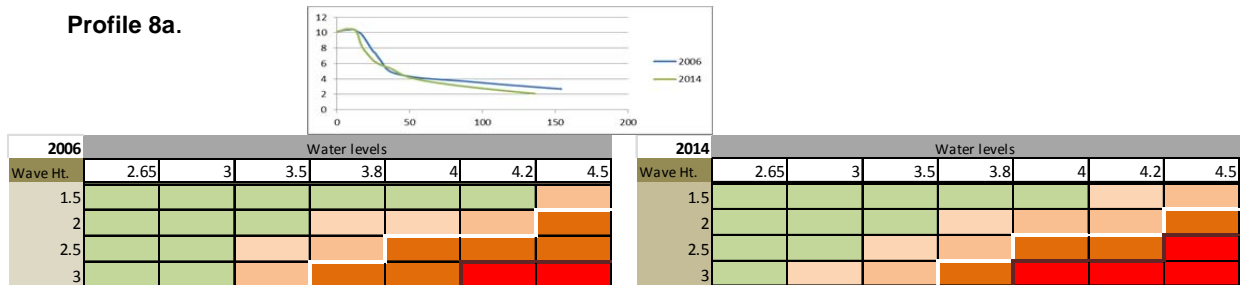
Profile 8a.

At profile 8a (Figure 4.4), it can be seen that there is a wide berm at the crest running back to the stream behind. Here, and as seen during the 2014 storms, the Breakwat model predicts that starting from the 2006 profile, with a water level of 3.8m ODN shingle is likely to be moved away from the front face and moved onto the crest. Analysis of the 2014 profile suggests that while the ridge, under similar storm conditions is slightly more vulnerable, sediment is still likely to remain within the existing ridge. While the profile, therefore becomes more vulnerable, even with increased water levels (i.e. more severe events or with sea level rise) there is still sufficient width (bulk) within the bank to resist full collapse.

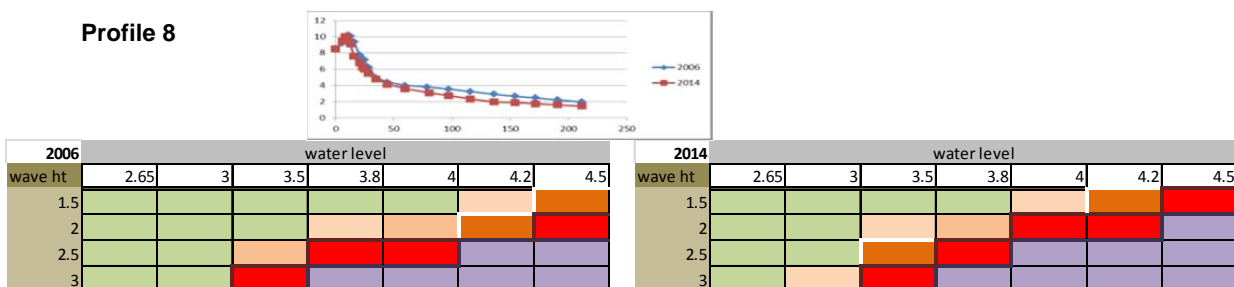
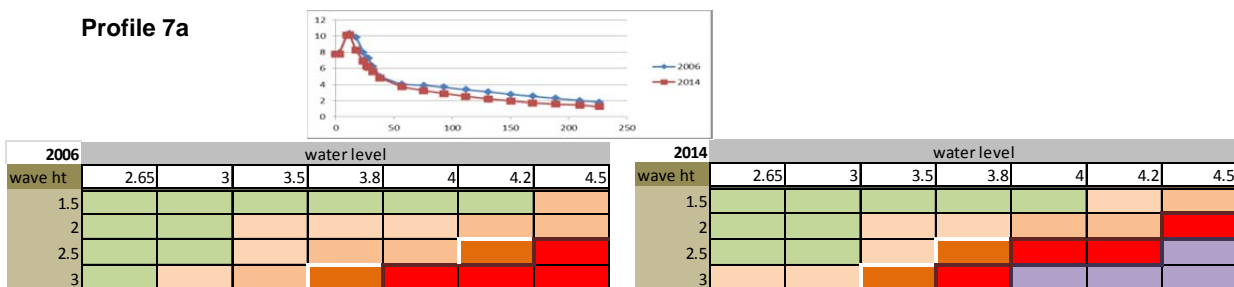
Profiles 7a and 8 (Figure 4.4) cover part of the most vulnerable section of the frontage. While the trigger water level at either section remains the same (comparing 2006 profile and that of 2014) at around a 3.5m ODN level, both sections have become more vulnerable, even with efforts to re-establish the crest. In the case of profile 8, the 2006 cross section could potentially withstand waves up to 2m on a water level of 3.8m ODN but starts to fail on higher water levels. With the narrower ridge, the resilience of the bank remains relatively similar but becomes significantly more vulnerable to even minor increase in water level above 3.8m ODN. Significant failure might be expected with waves of 2m on a 4m ODN water level and, indeed, greater damage may now occur with higher waves on water levels as low as 3.5m ODN.

The increase in vulnerability (comparing 2006 and 2014) is even clearer for profile 7a. With the present profile full failure might now be expected with wave heights greater than 2m on water levels above 3.8m ODN.

Typically these profiles might be considered to have a standard of failure at around a 1:1 year water level (Figure 4.1 – 3.5m ODN) with major failure occurring at around a 1:10 to 1:20 year water level. With sea level rise, the standard of failure might be expected to be exceeded more frequently than once a year, with total failure occurring possibly every year with a sea level rise of 0.25m.

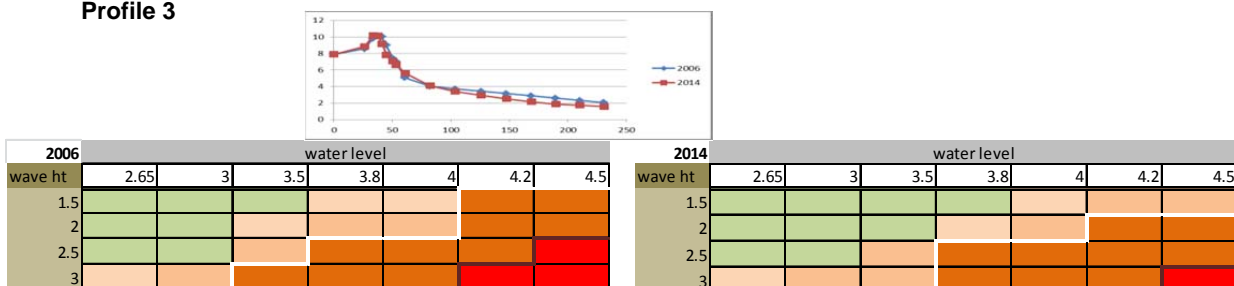
Profile 3

Profile 3, shown on Figure 4.5, represents a more naturally developing section of the frontage. For this profile it may be seen from Figure 4.3 that significant overwash occurs at a water level of 3.5m ODN (with higher wave height) but that complete failure is not indicated to occur even under the most severe conditions tested.

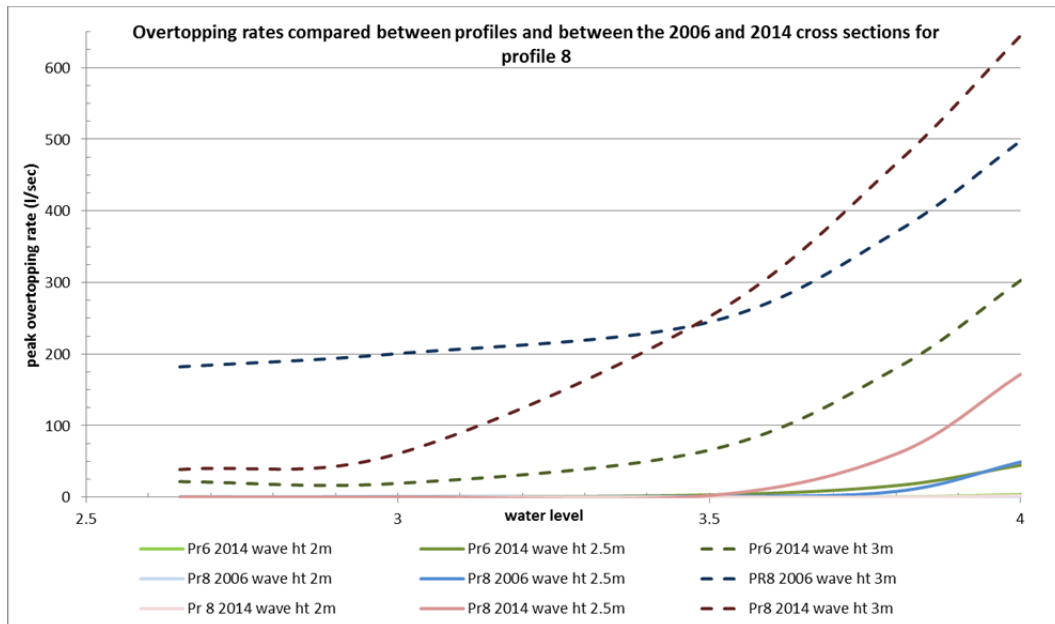
Figure 4.6. Comparison of overtopping rates

increased. This can be seen (Figure 4.6) also in relation to the marked increase in overtopping on the 2014 profile occurring at around the 3.8m ODN water level.

In summary, Profile 6 appears to have a standard of defence against significant overtopping of around a 1:10 year return period of water level, under more moderate wave conditions, although significant overtopping may occur at lower water levels with higher wave heights.

The standard of defence for typical wave conditions has changed (from 2006) significantly for profile 8 from around a 1:10 year return period water level to more typically a 1:1 year return period water level with the managed profile of 2014. It is also noted that the profile becomes significantly more vulnerable to overtopping as water levels increase.
