Penally Training Camp

STAGE 1 ARCHAEOLOGICAL AND HERITAGE DESK BASED ASSESSMENT

SETA Stage 1 Heritage and Archaeology Desk-Based Assessment

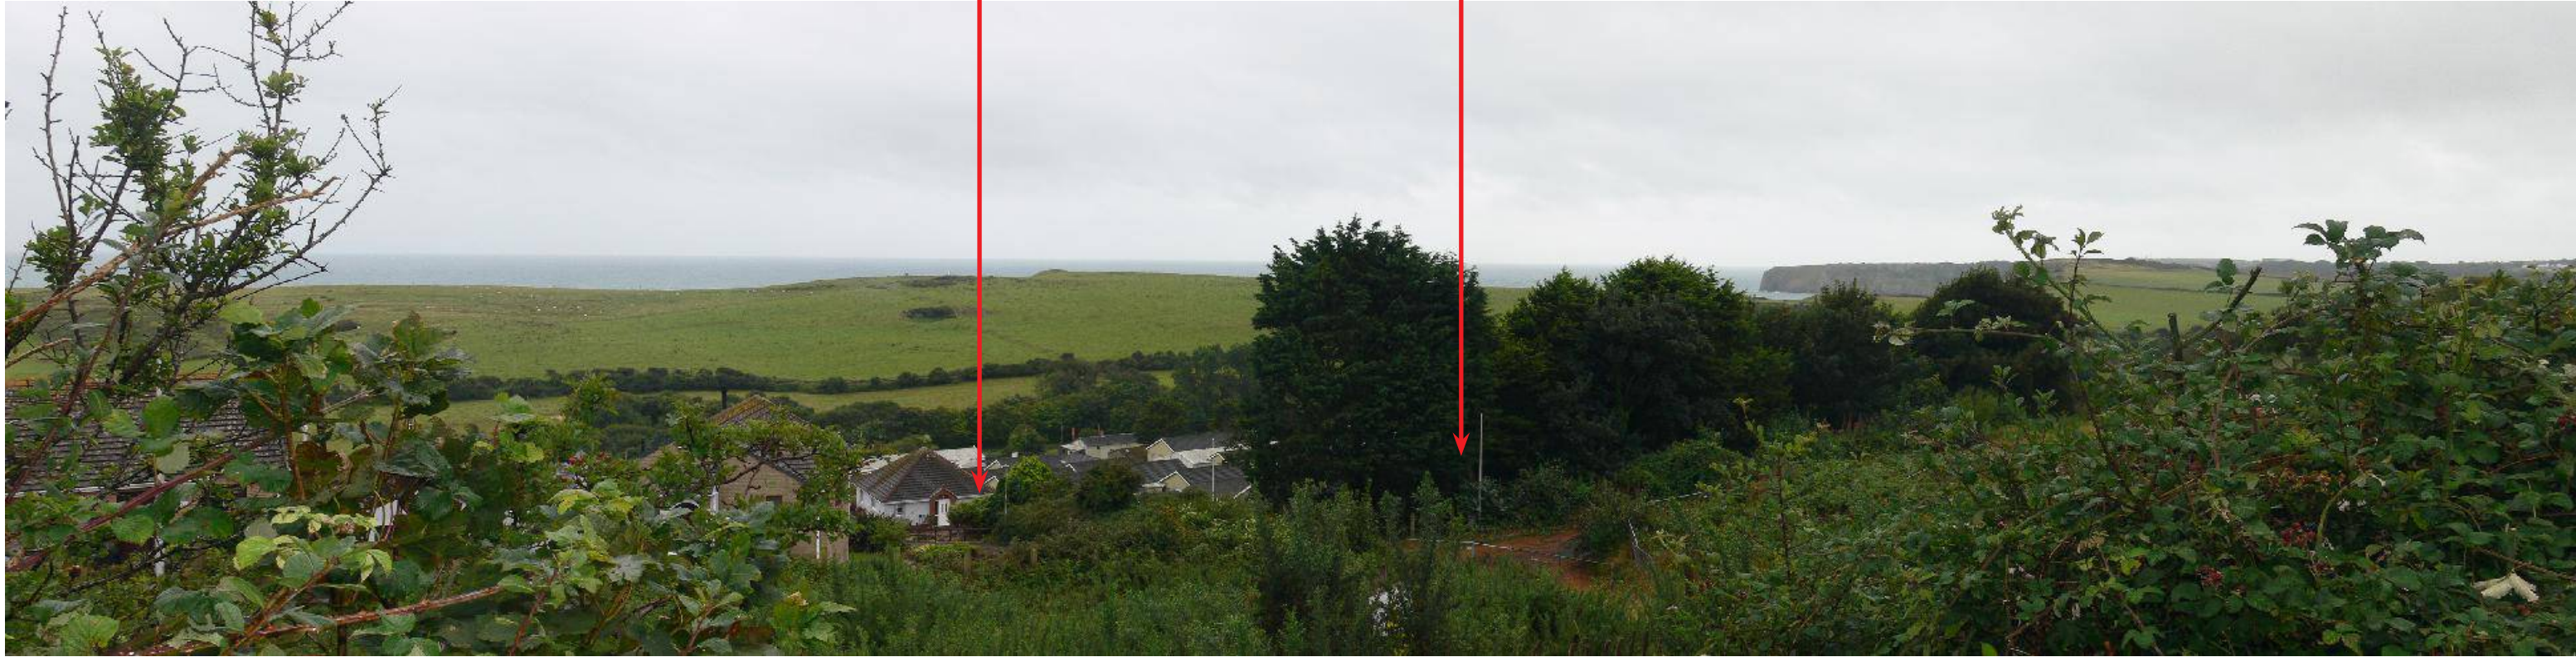
230 metres
Distance to Site Centre

Residential properties on Penally Heights

The site (screened)

Photo Viewpoint 1: Short-range view looking south west from a public footpath between Hill Farm and Crack Farm

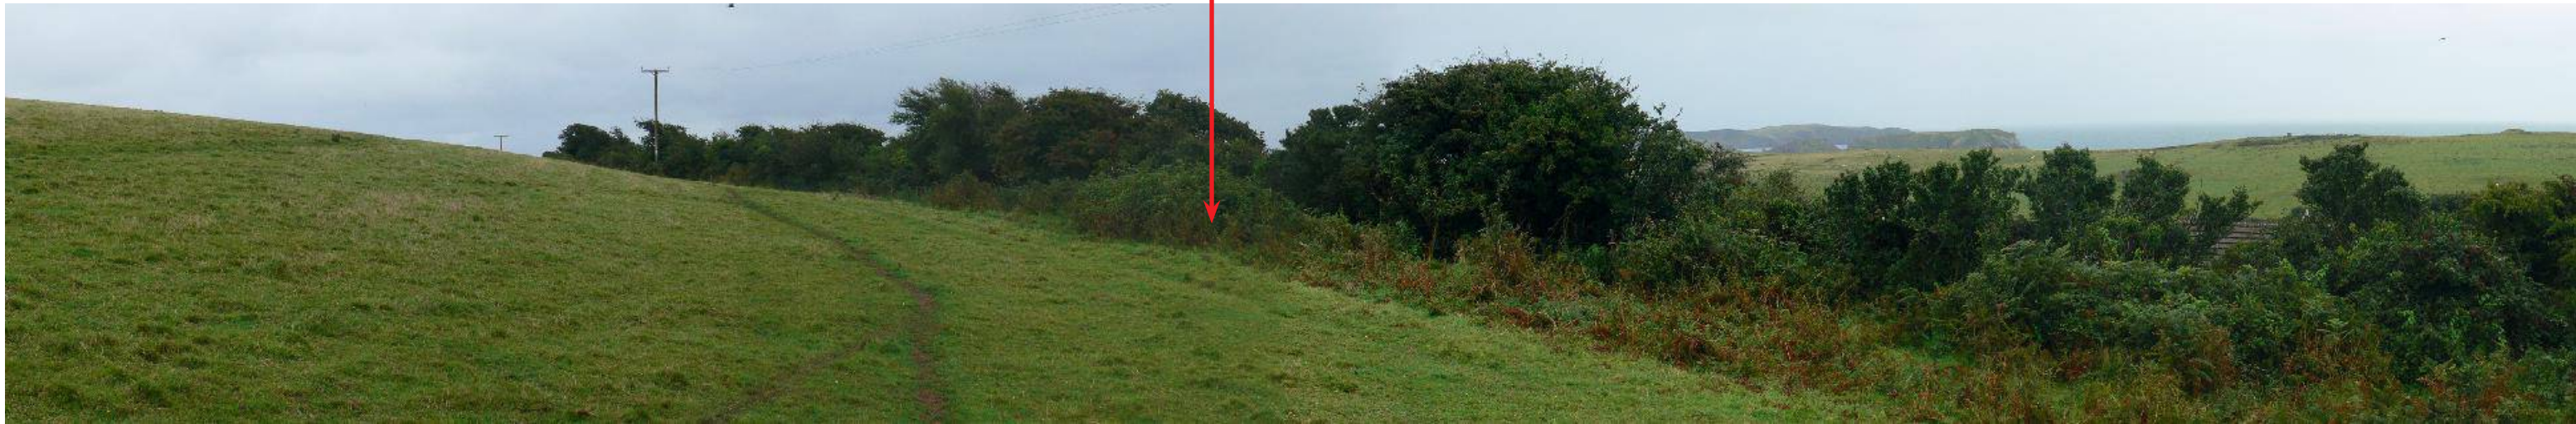
270 metres
Distance to Site Centre

Approximate location of site (screened)

Photo Viewpoint 2: Short-range view looking south east from a public footpath between Hill Farm and Crack Farm

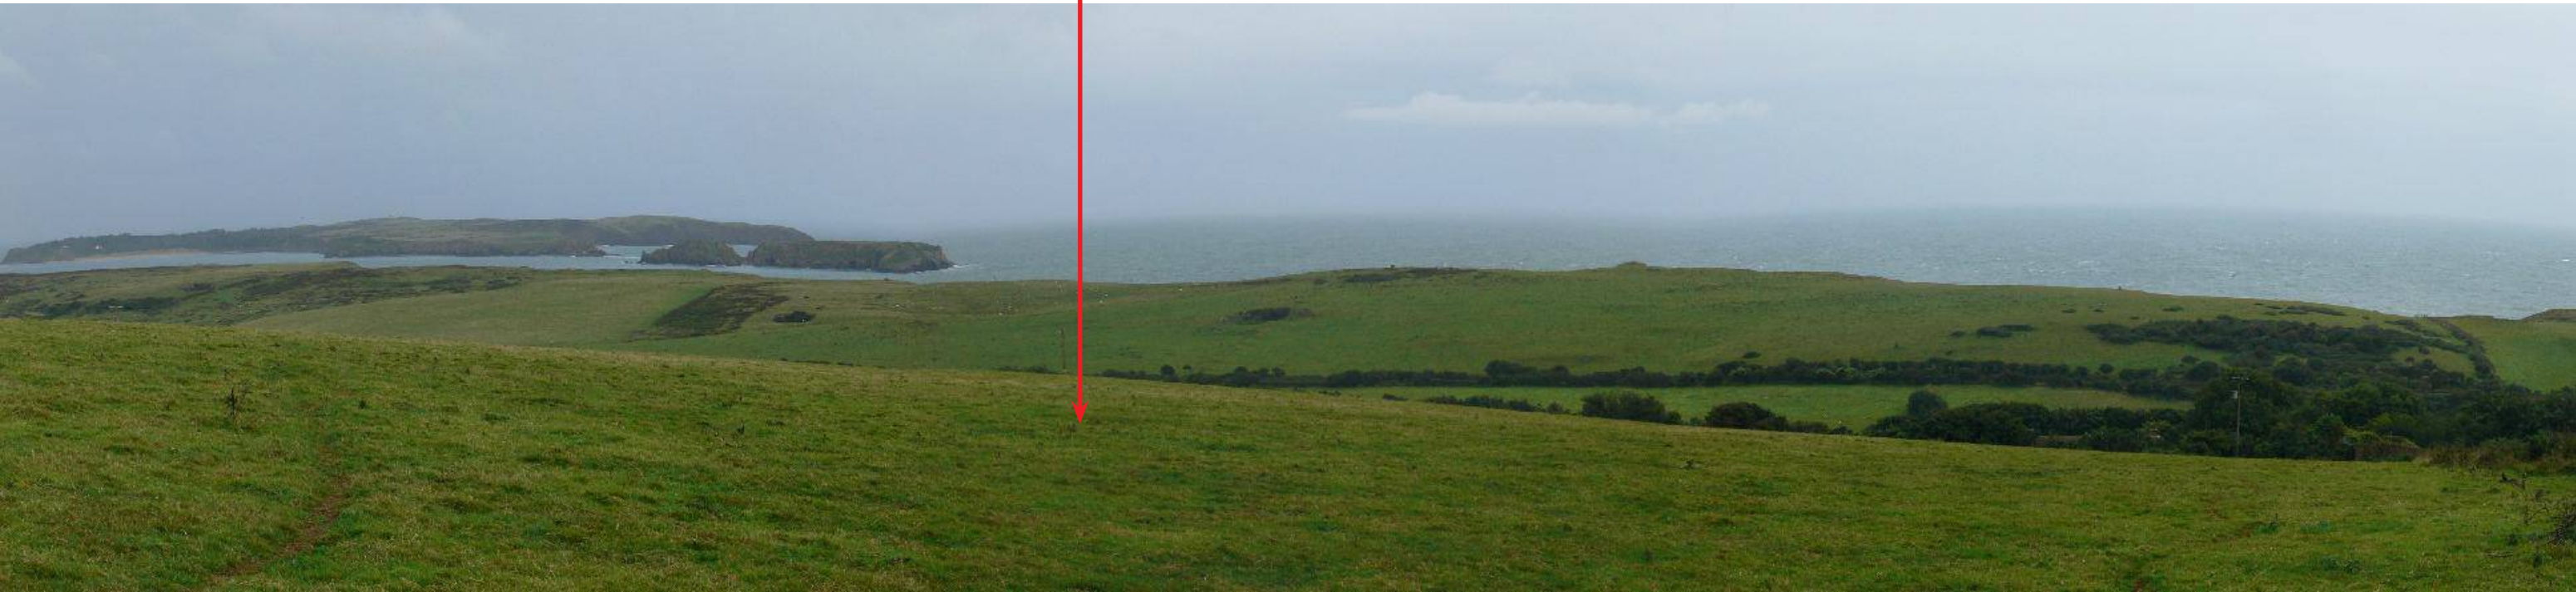
420 metres
Distance to Site Centre

Approximate location of site (screened)

Photo Viewpoint 3: Short-range view looking south from a public footpath to the south of the Ridgeway

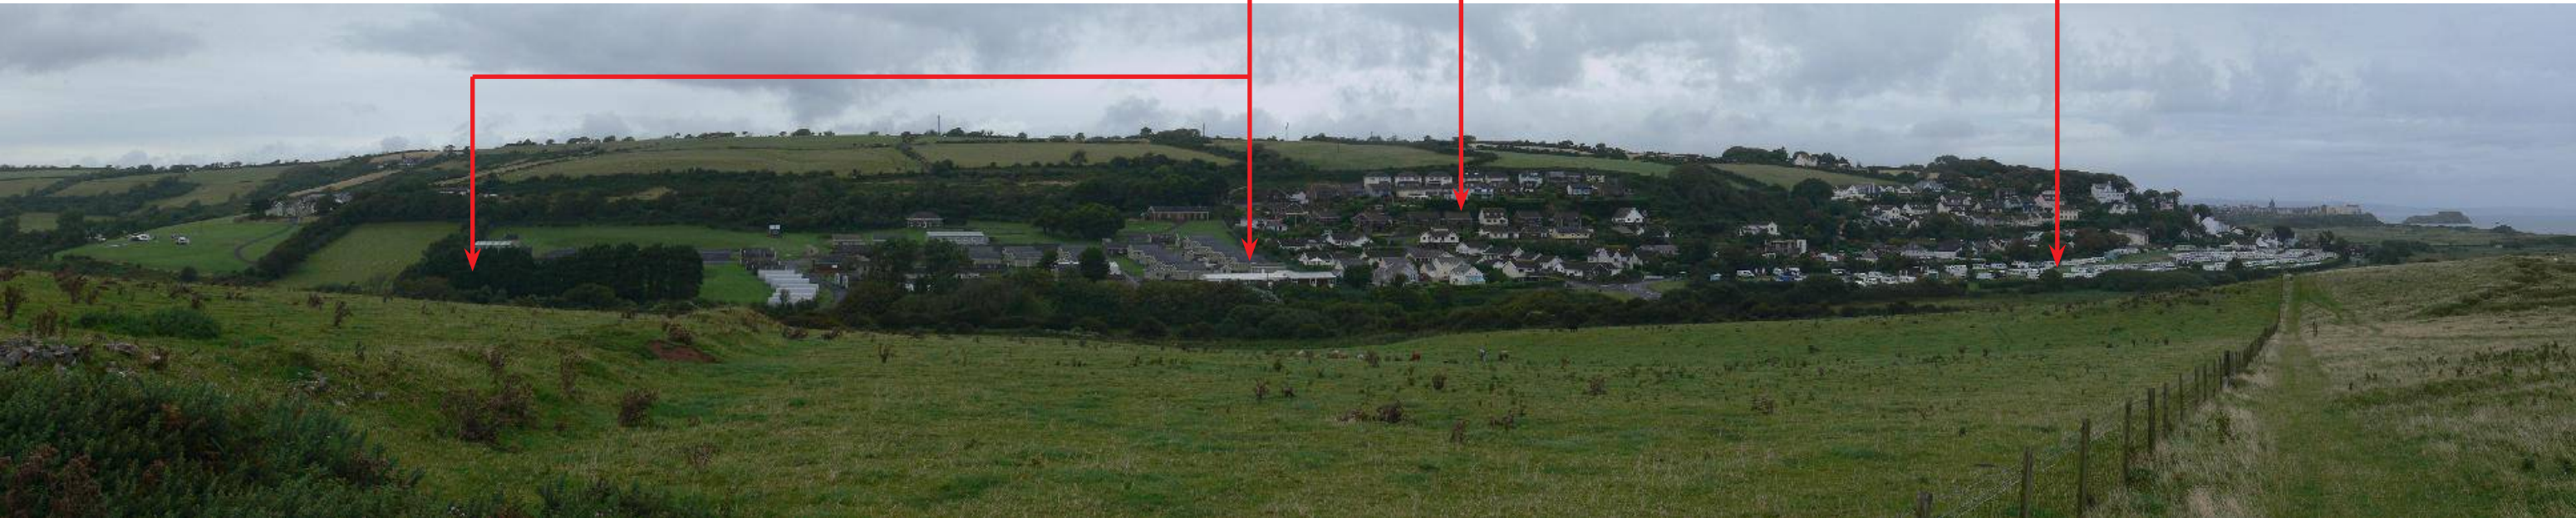
430 metres
Distance to Site Centre

The site Residential properties
on Penally Heights Penally Court
Farm Campsite

Photo Viewpoint 4: Short-range view looking north from the Wales Coast Path

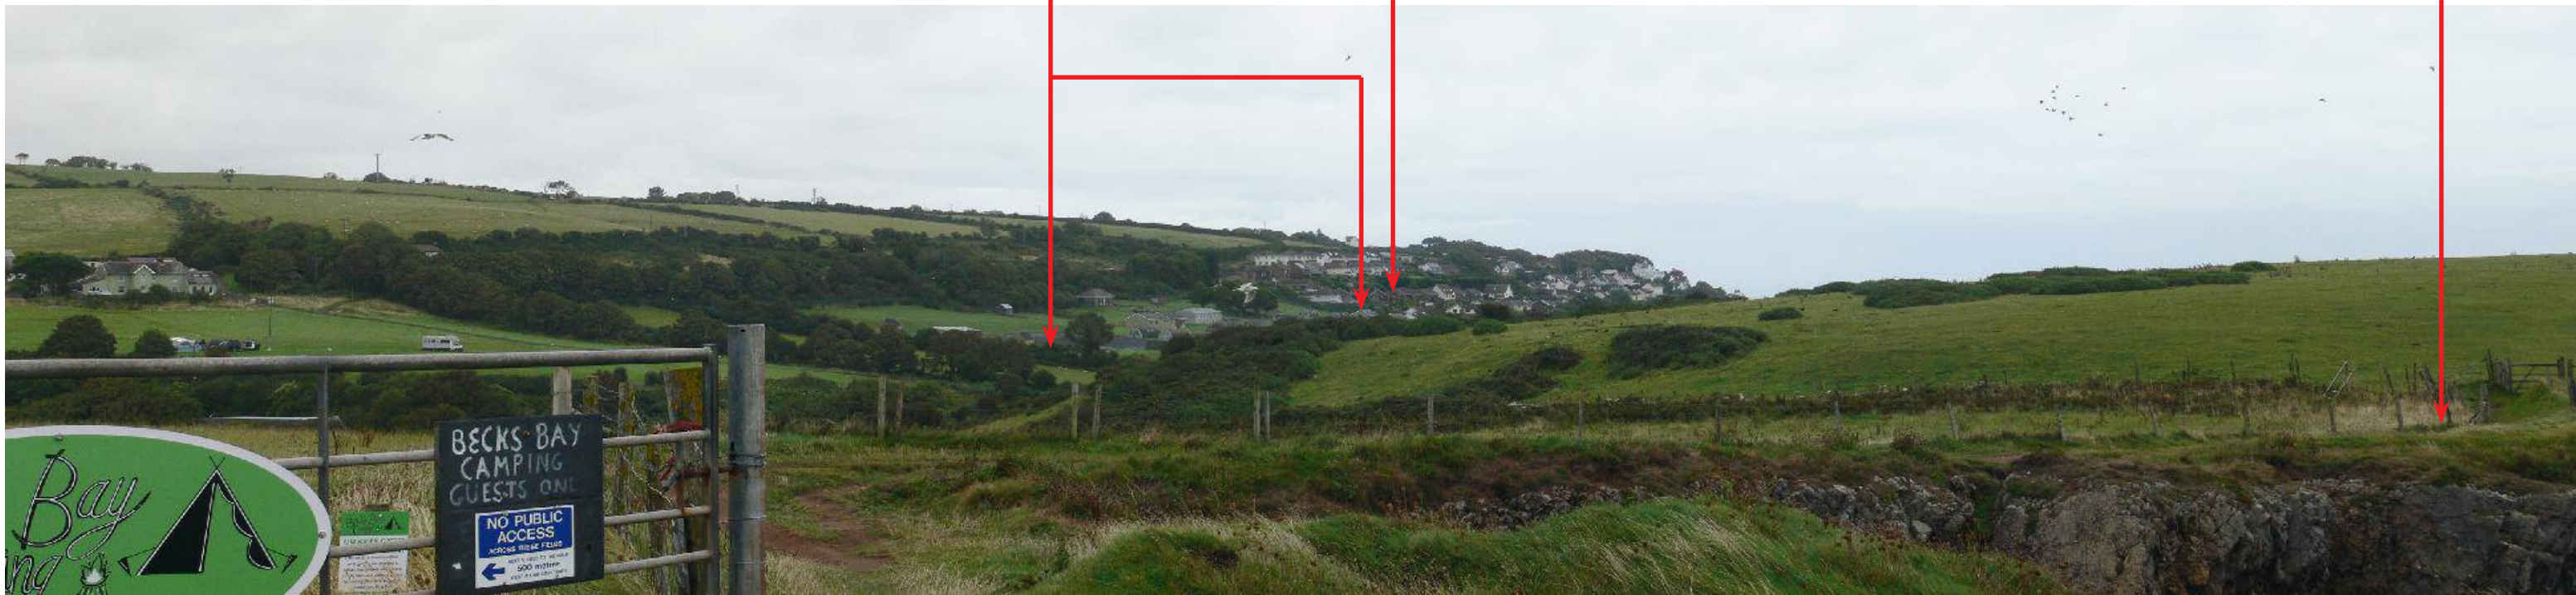
590 metres
Distance to Site Centre

The site

Residential properties
on Penally Heights

Wales Coast Path

Photo Viewpoint 5: Mid-range view looking north east from the Wales Coast Path

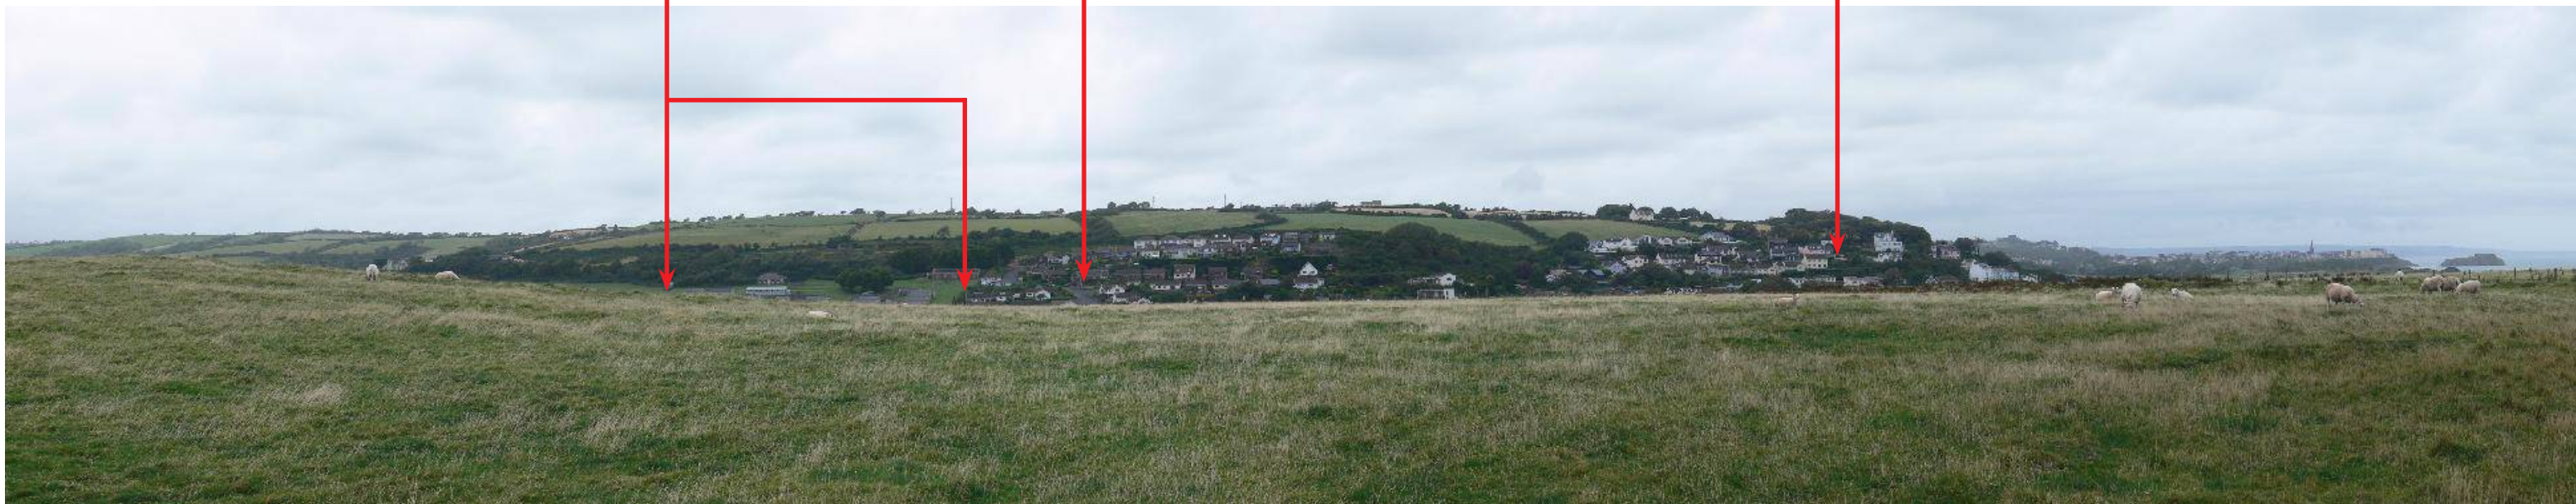
720 metres
Distance to Site Centre

The site

Residential properties
on Penally Heights

Penally

Photo Viewpoint 6: Mid-range view looking north from the Wales Coast Path

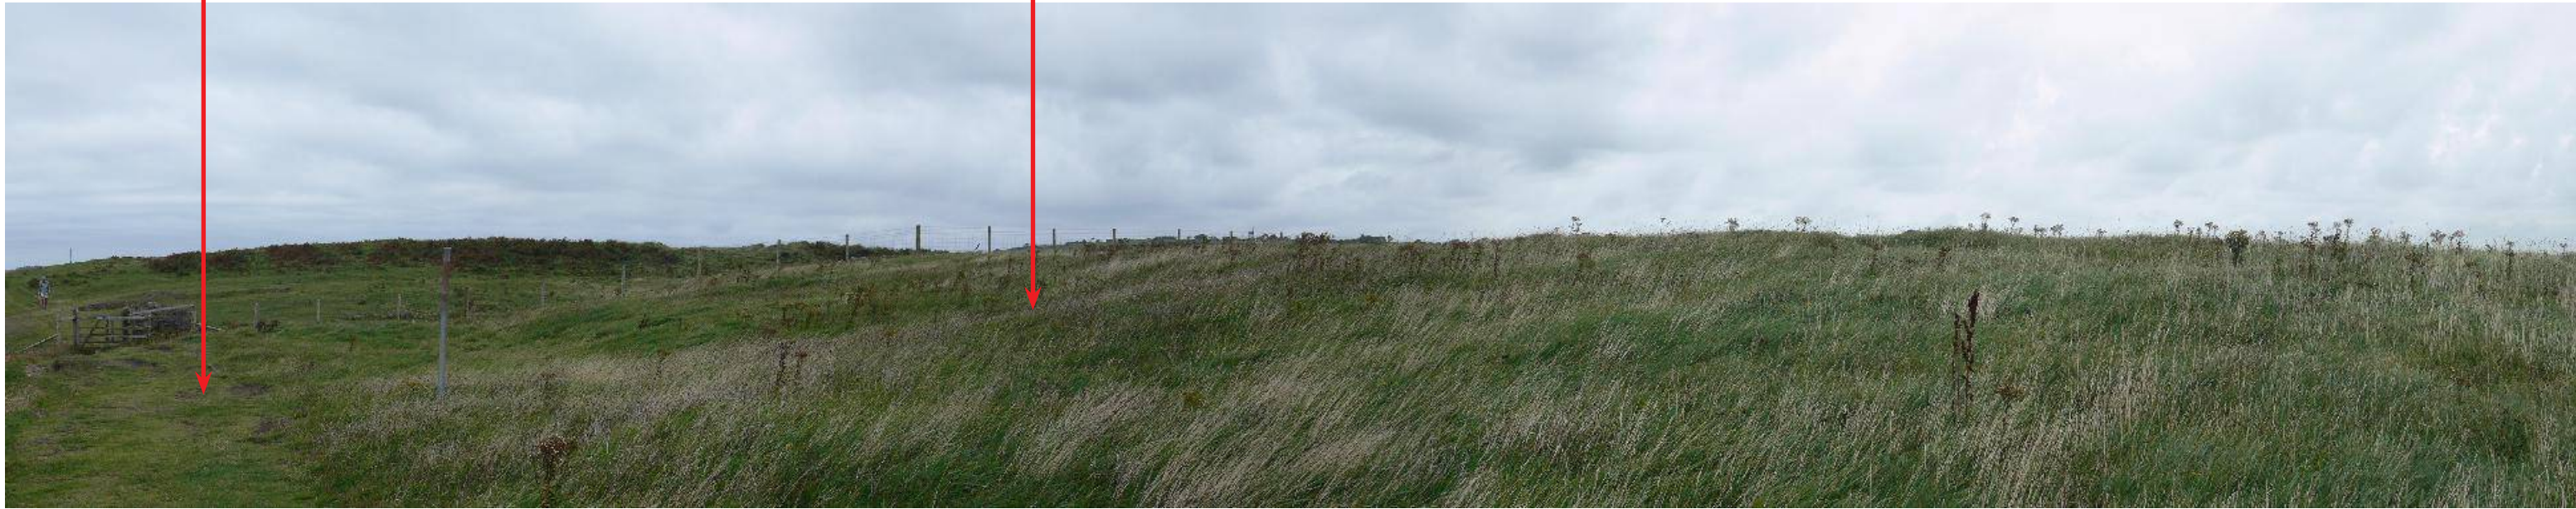
1200 metres
Distance to Site centre

Wales Coast Path

Approximate location of site (screened)

Photo Viewpoint 7: Long-range view looking north east from the Wales Coast Path

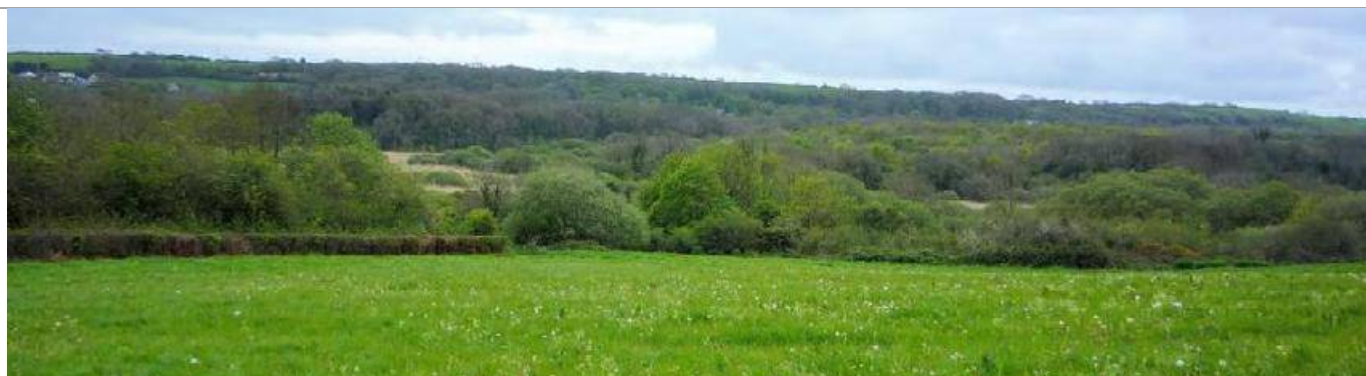
View of the edge of the ridge and skyline across valley floor from the north east

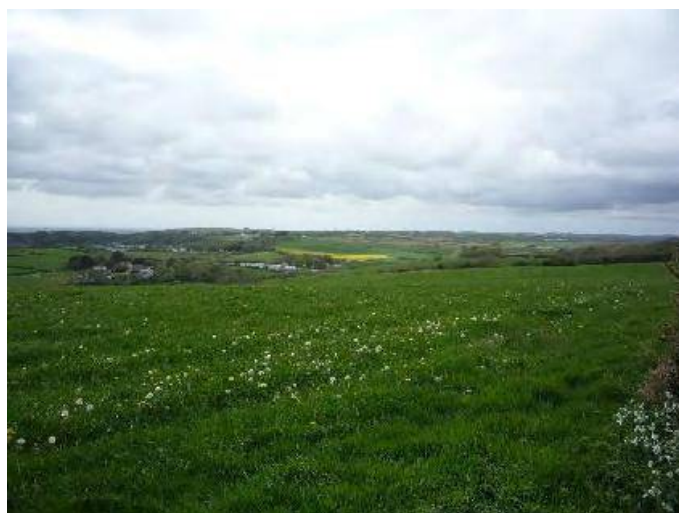
View out to the southwest from the Ridgeway towards the coast at Lydstep

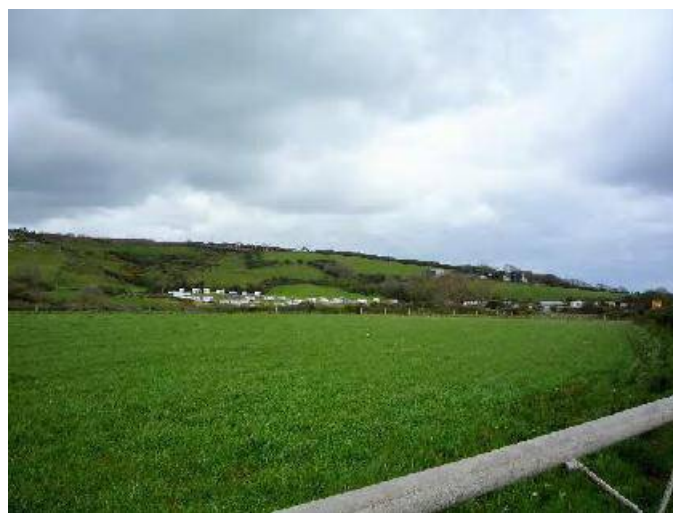
View of ridge skyline and backcloth from the south west within National Park

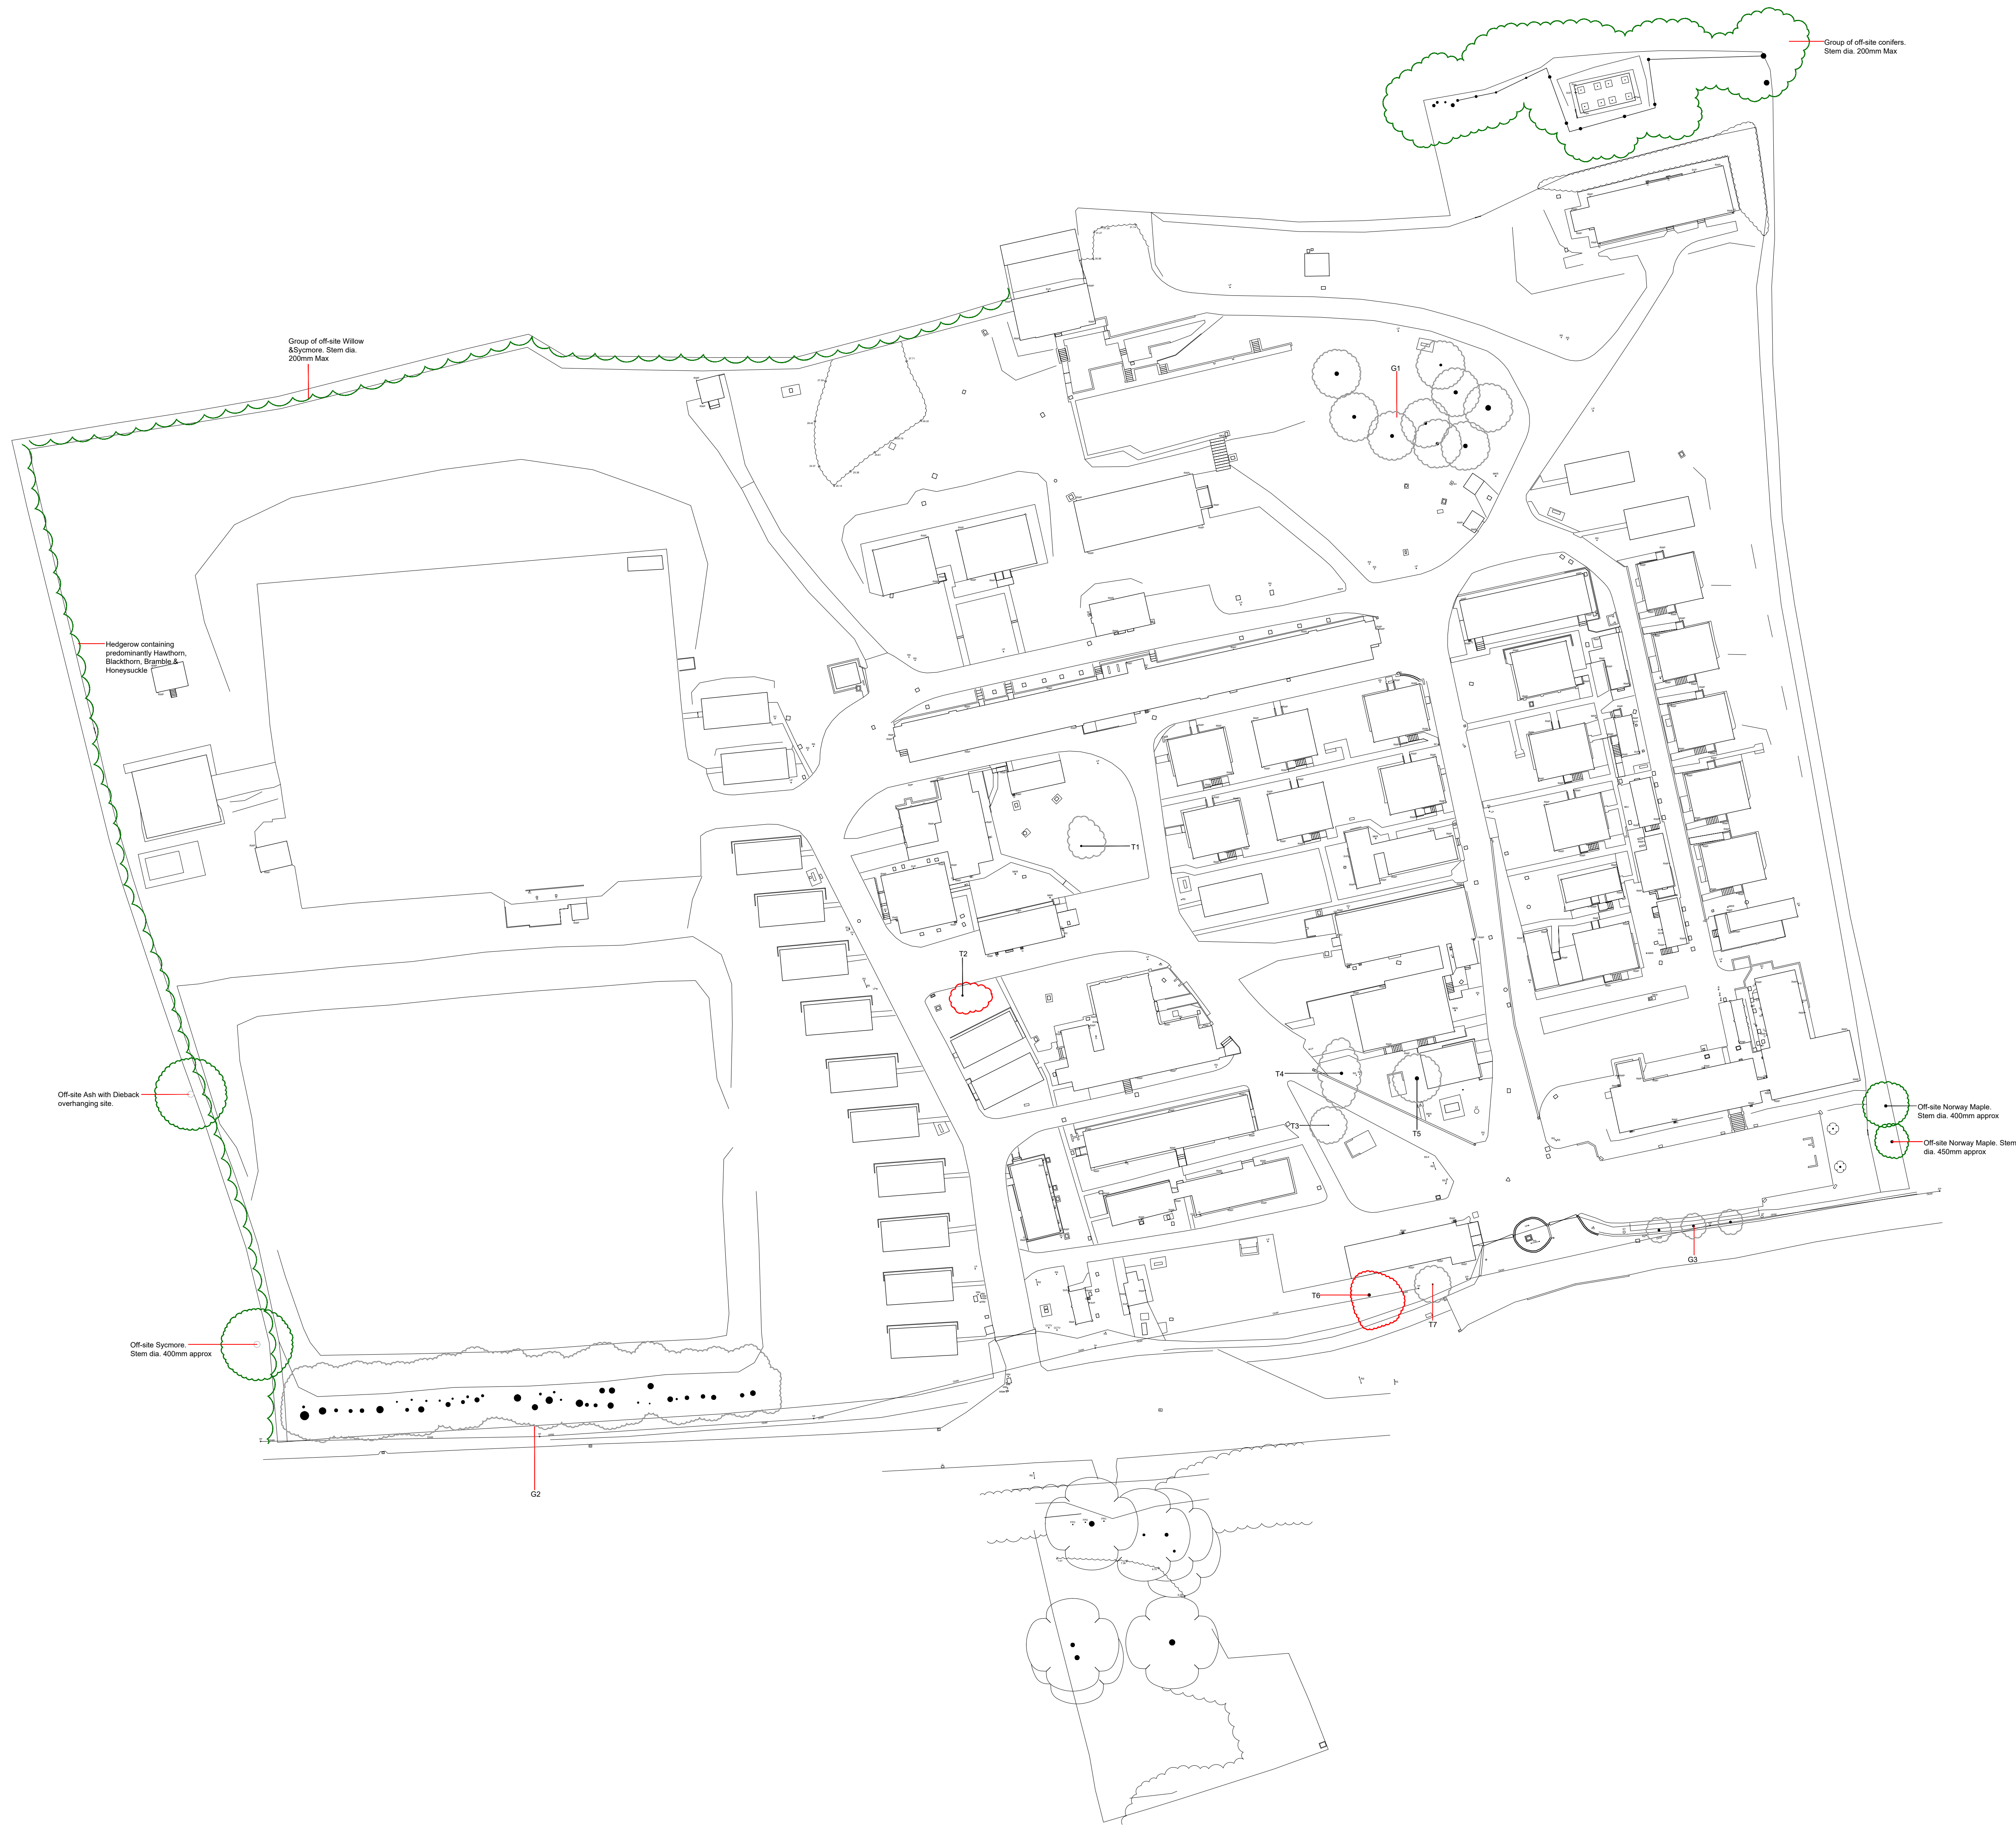
C. Low Quality and Value

U. Unsuitable / Remove

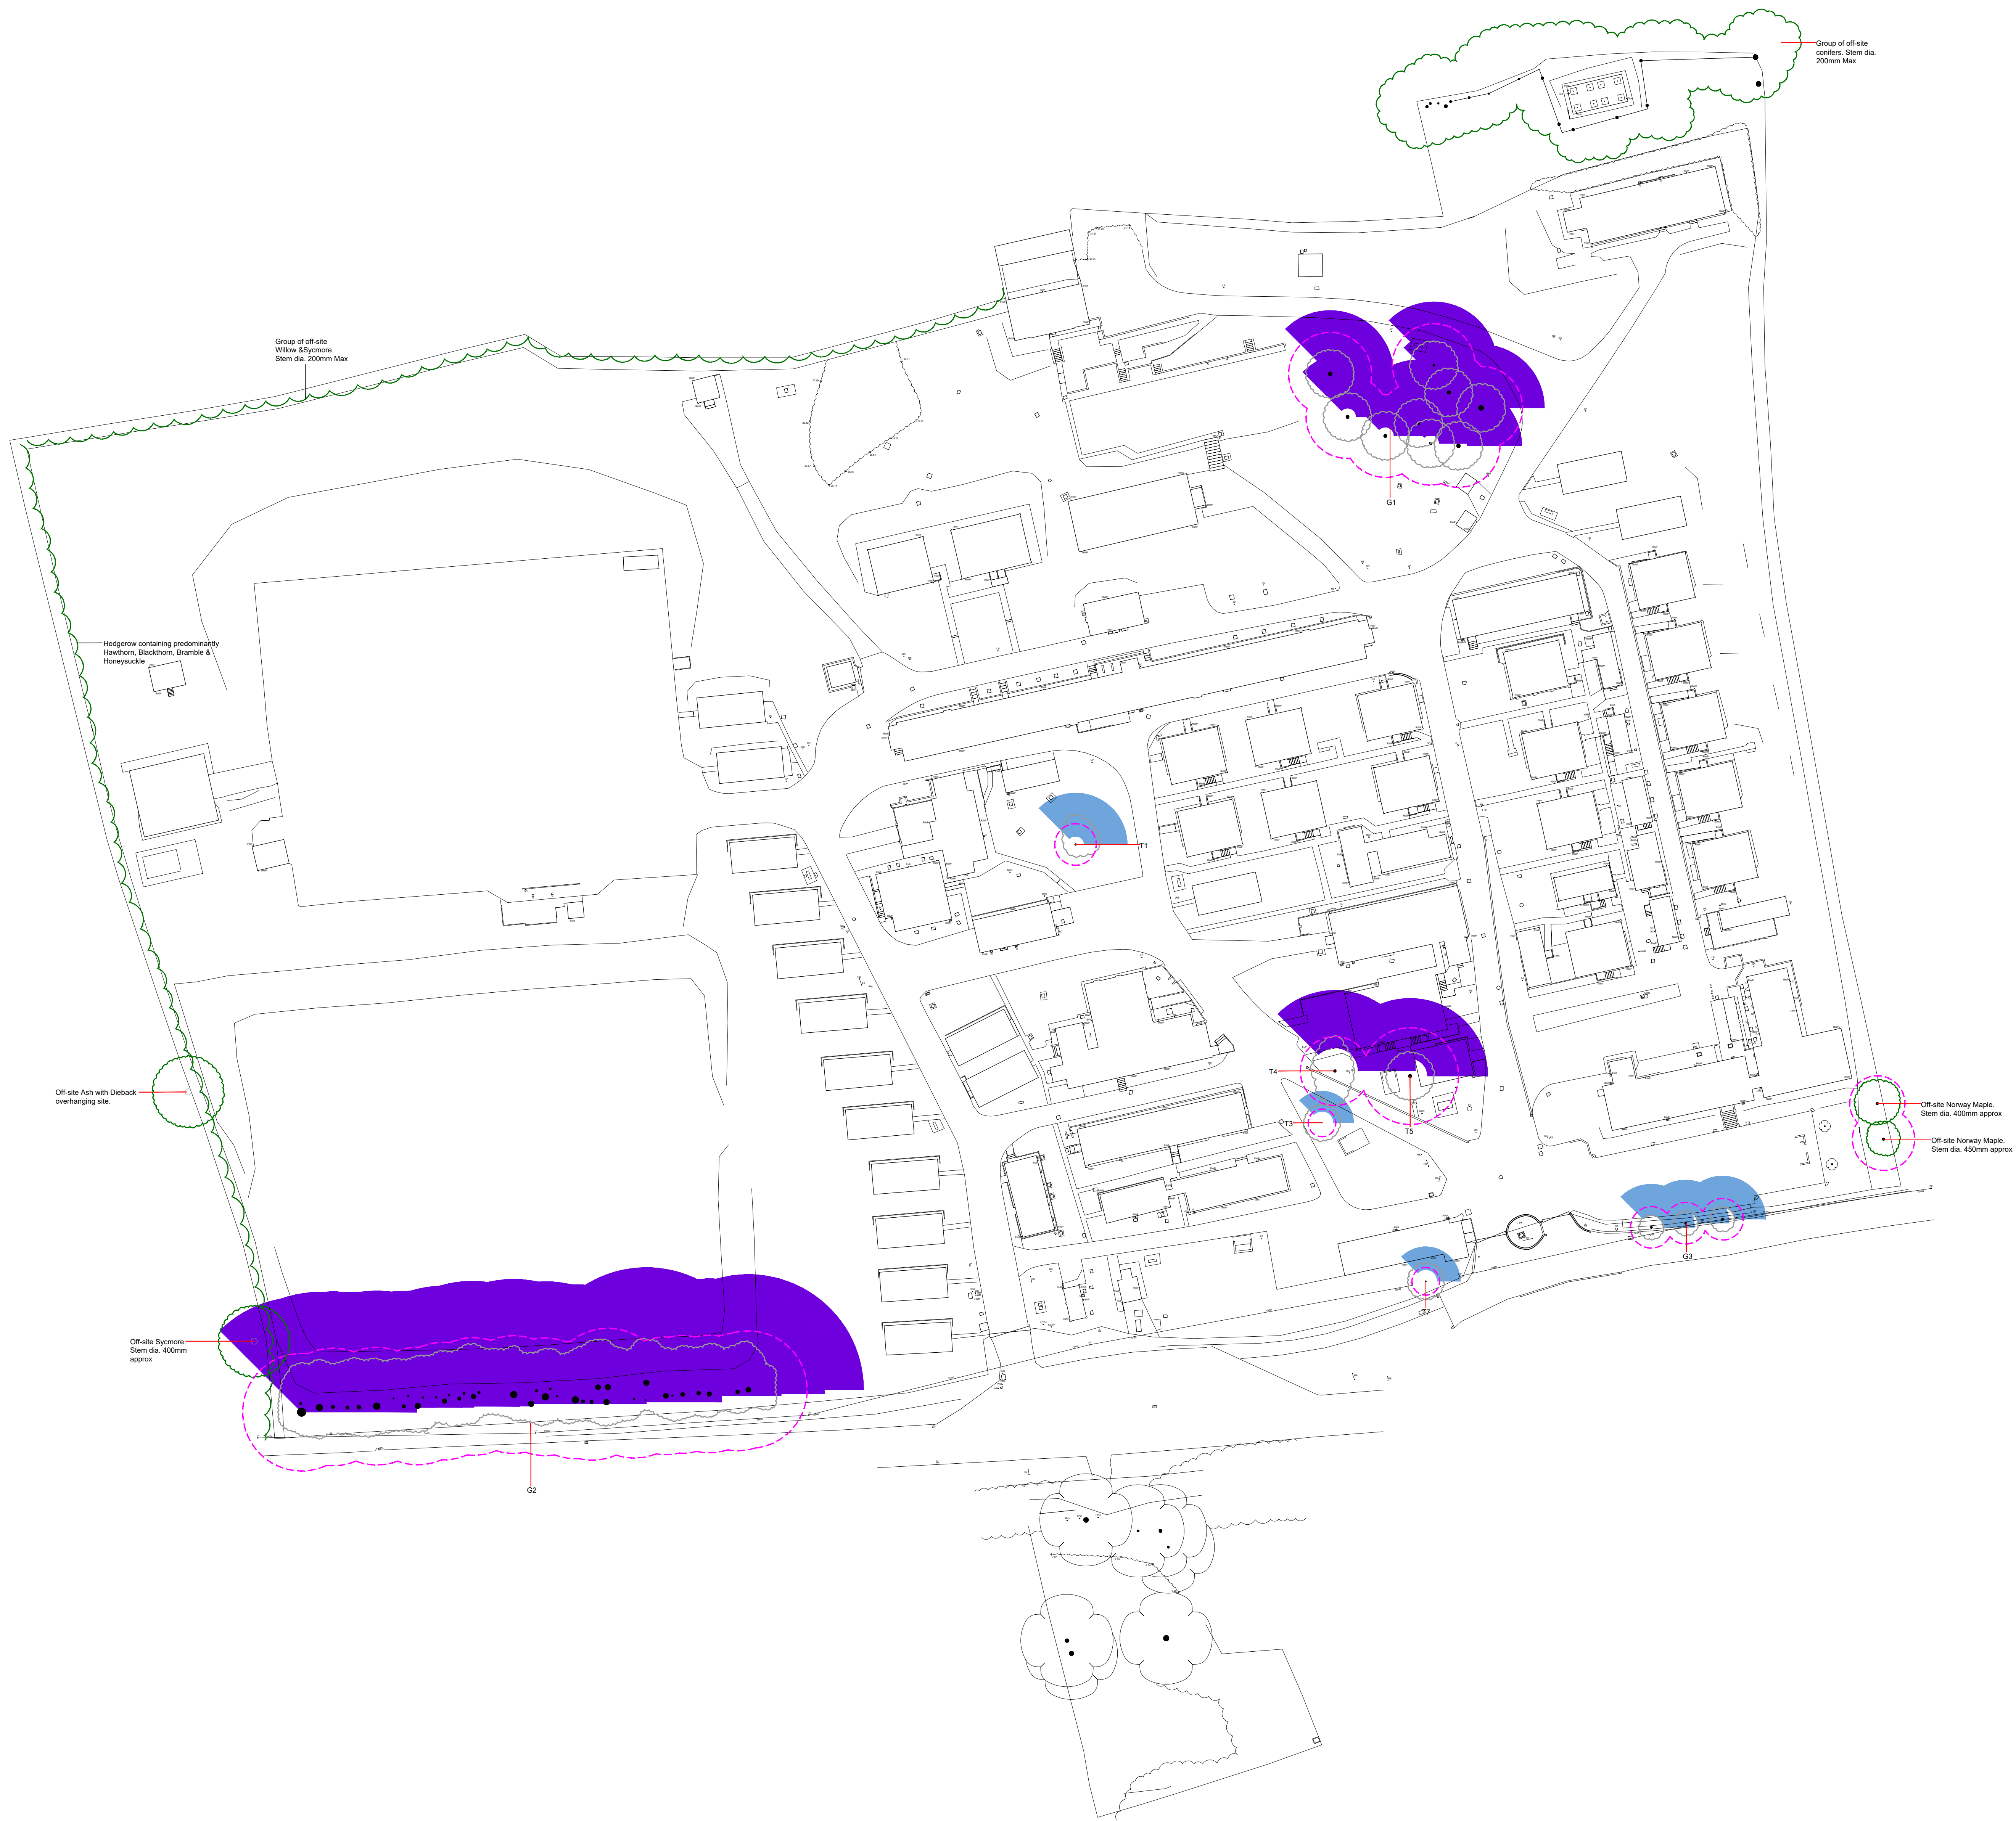
DRAWING TITLE TREE CONSTRAINTS DRAWING

KEY :
Assessment of trees in accordance with BS 5837: 2012

- A. High Quality and Value
- B. Moderate Quality and Value
- C. Low Quality and Value
- Root Protection Area Based on BS5837:2012
- Shadow Pattern of Existing Deciduous Trees with Light Crowns
- Shadow Pattern of Existing Deciduous Trees with Dense Crowns
- Shadow Pattern of Existing Coniferous Trees with Dense Crowns

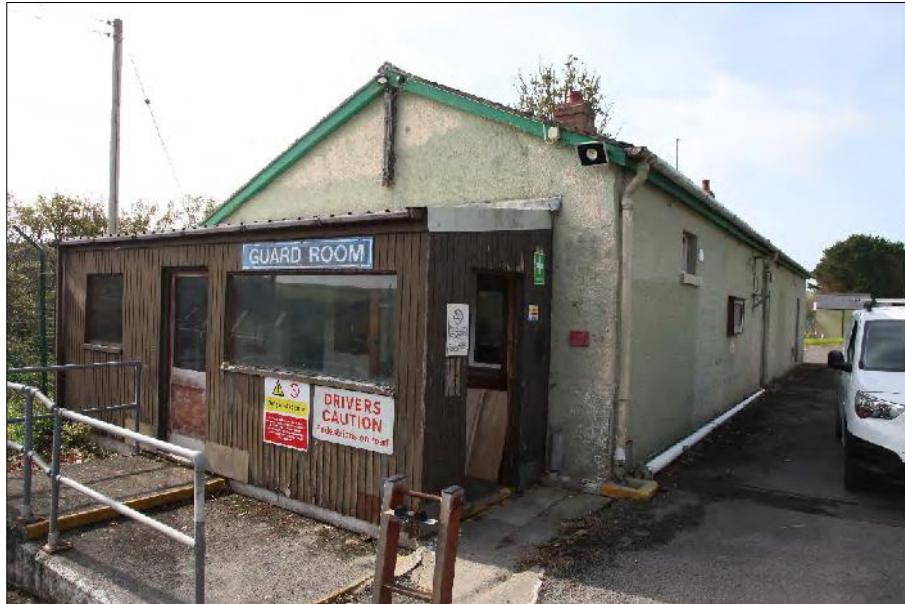
Plate 1) View of the 1860 Guardroom (PC_18)

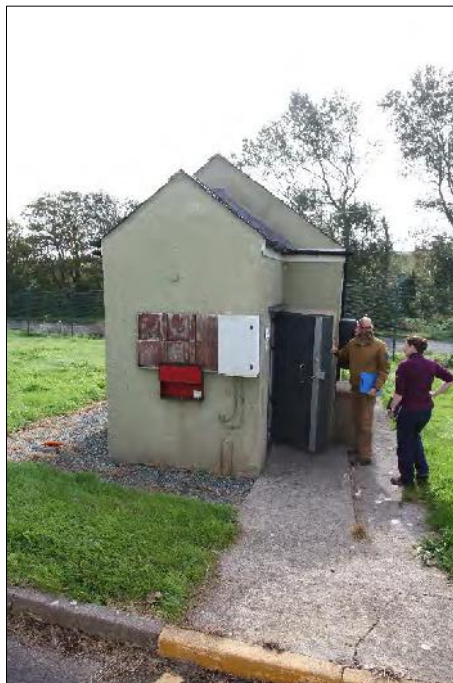
Plate 2) View of the 1860 Magazine (PC_19)

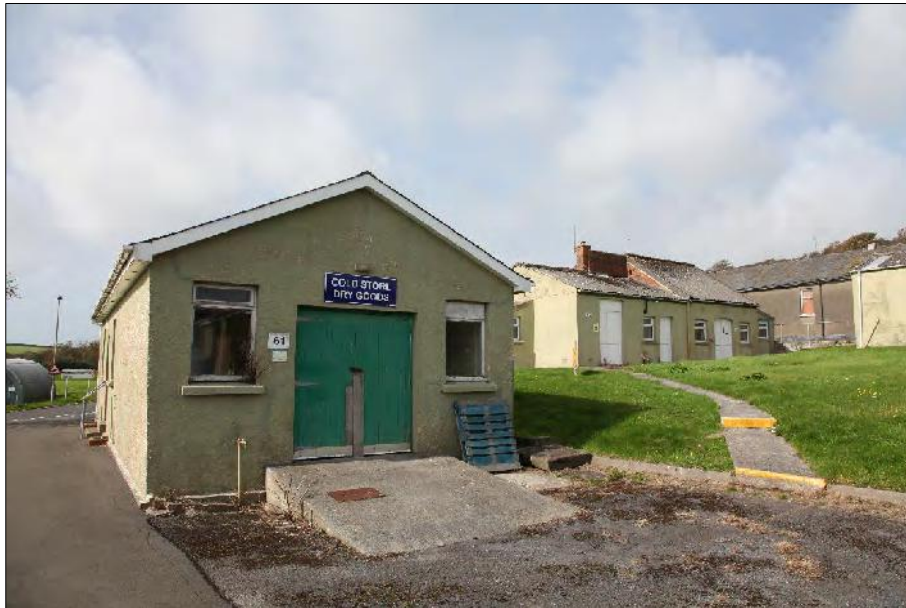
Plate 3) View of the 1860 southern kitchen

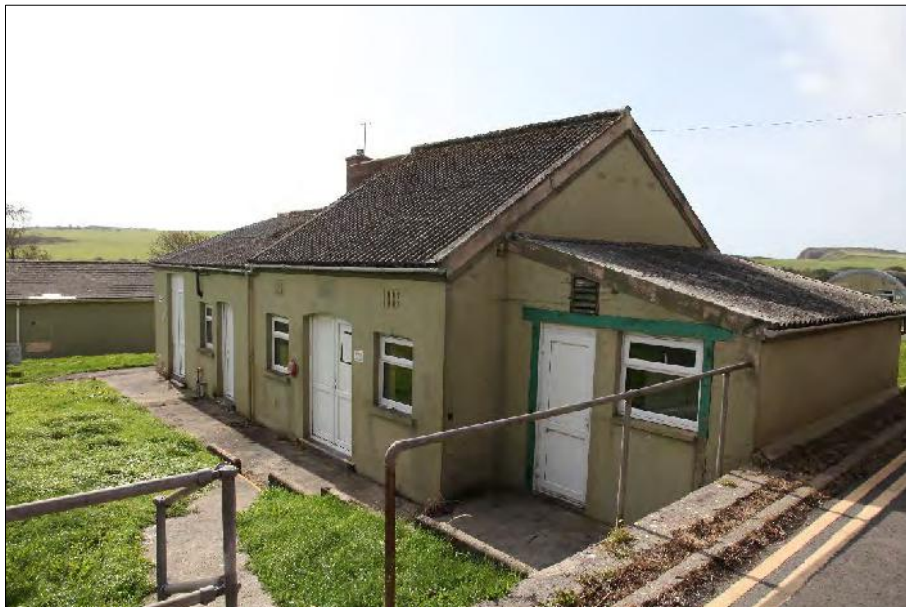
Plate 4) View of the 1860 Stores

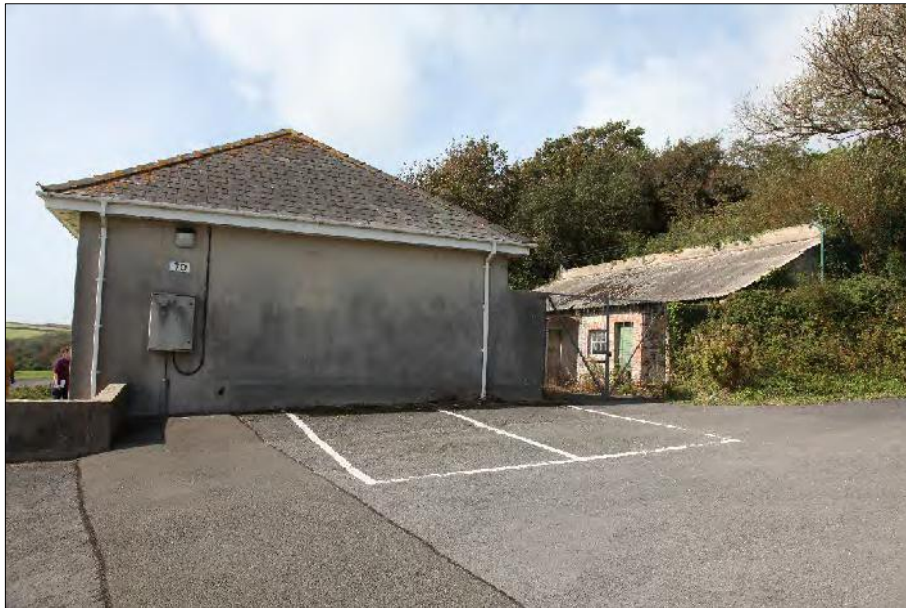
Plate 5) View of the 1860 Stables and Canteen

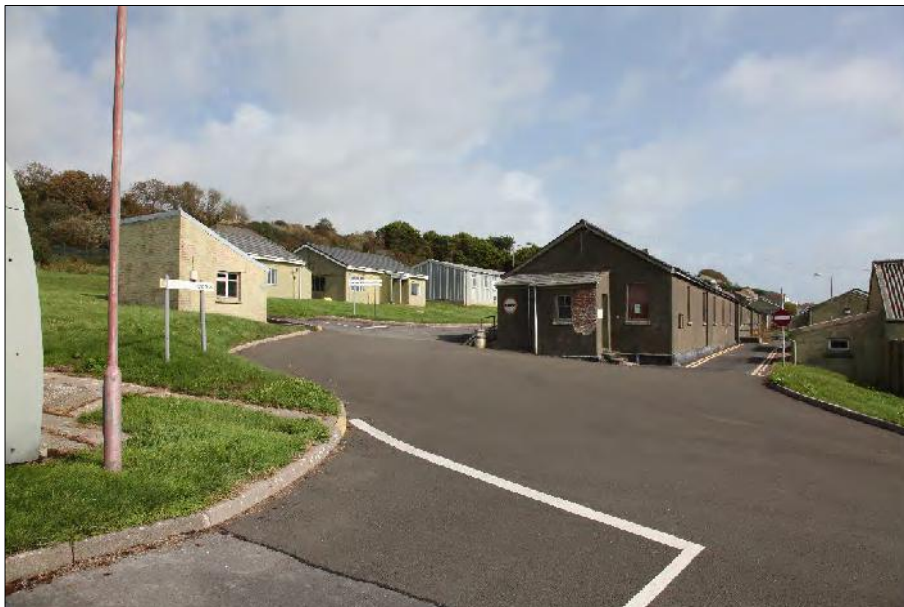
Plate 6) View of the 1860 Barracks

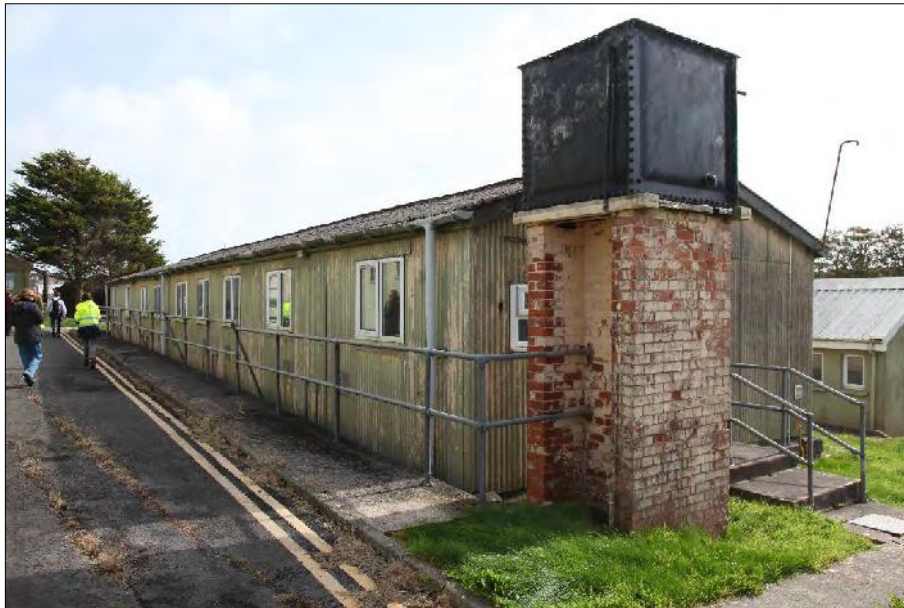
Plate 7) View of the First World War Hut PC_17

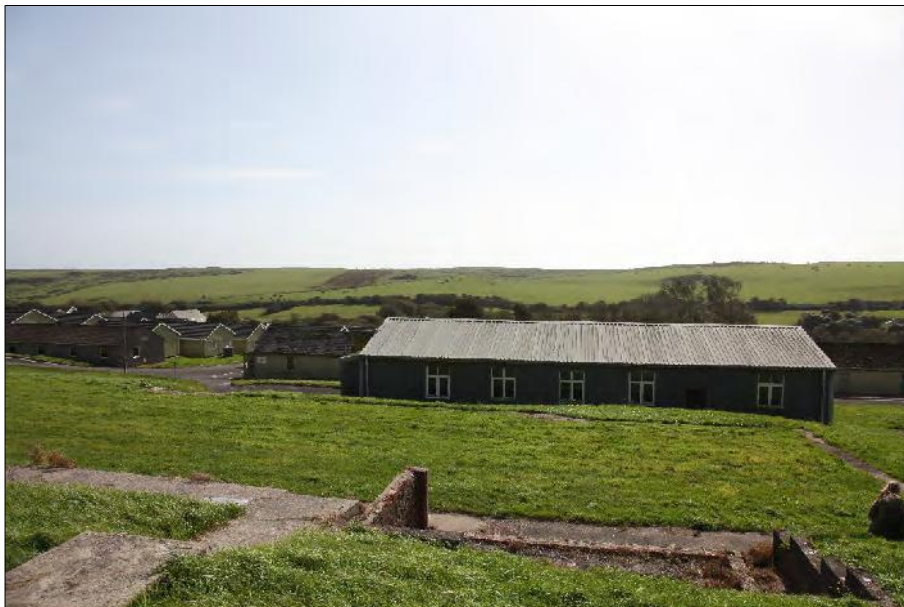
Plate 8) View of the First World War Hut PC_14
