Penally Training Camp

STAGE 1 ARCHAEOLOGICAL AND HERITAGE DESK BASED ASSESSMENT

SETA Stage 1 Heritage and Archaeology Desk-Based Assessment

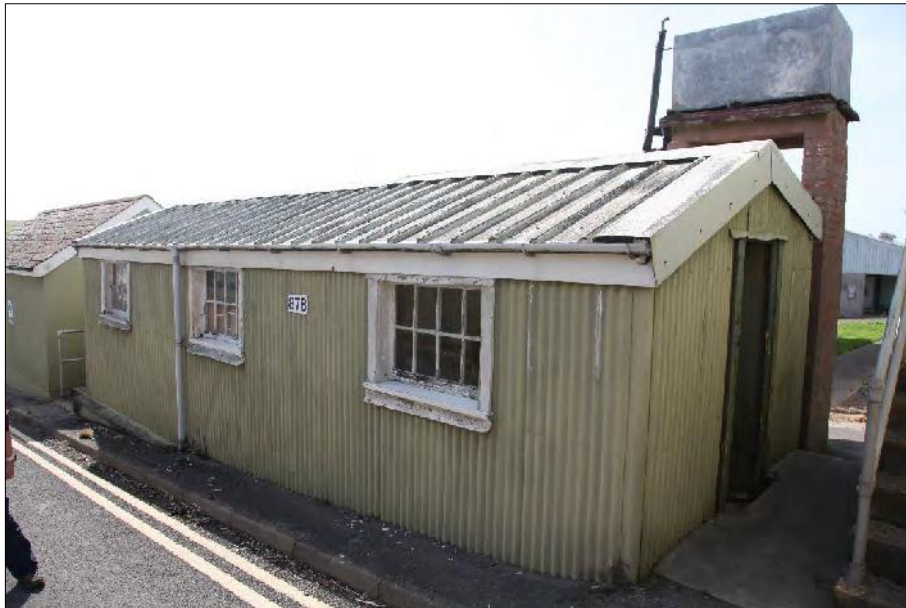
Plate 9) View of the First World War Ablution Block

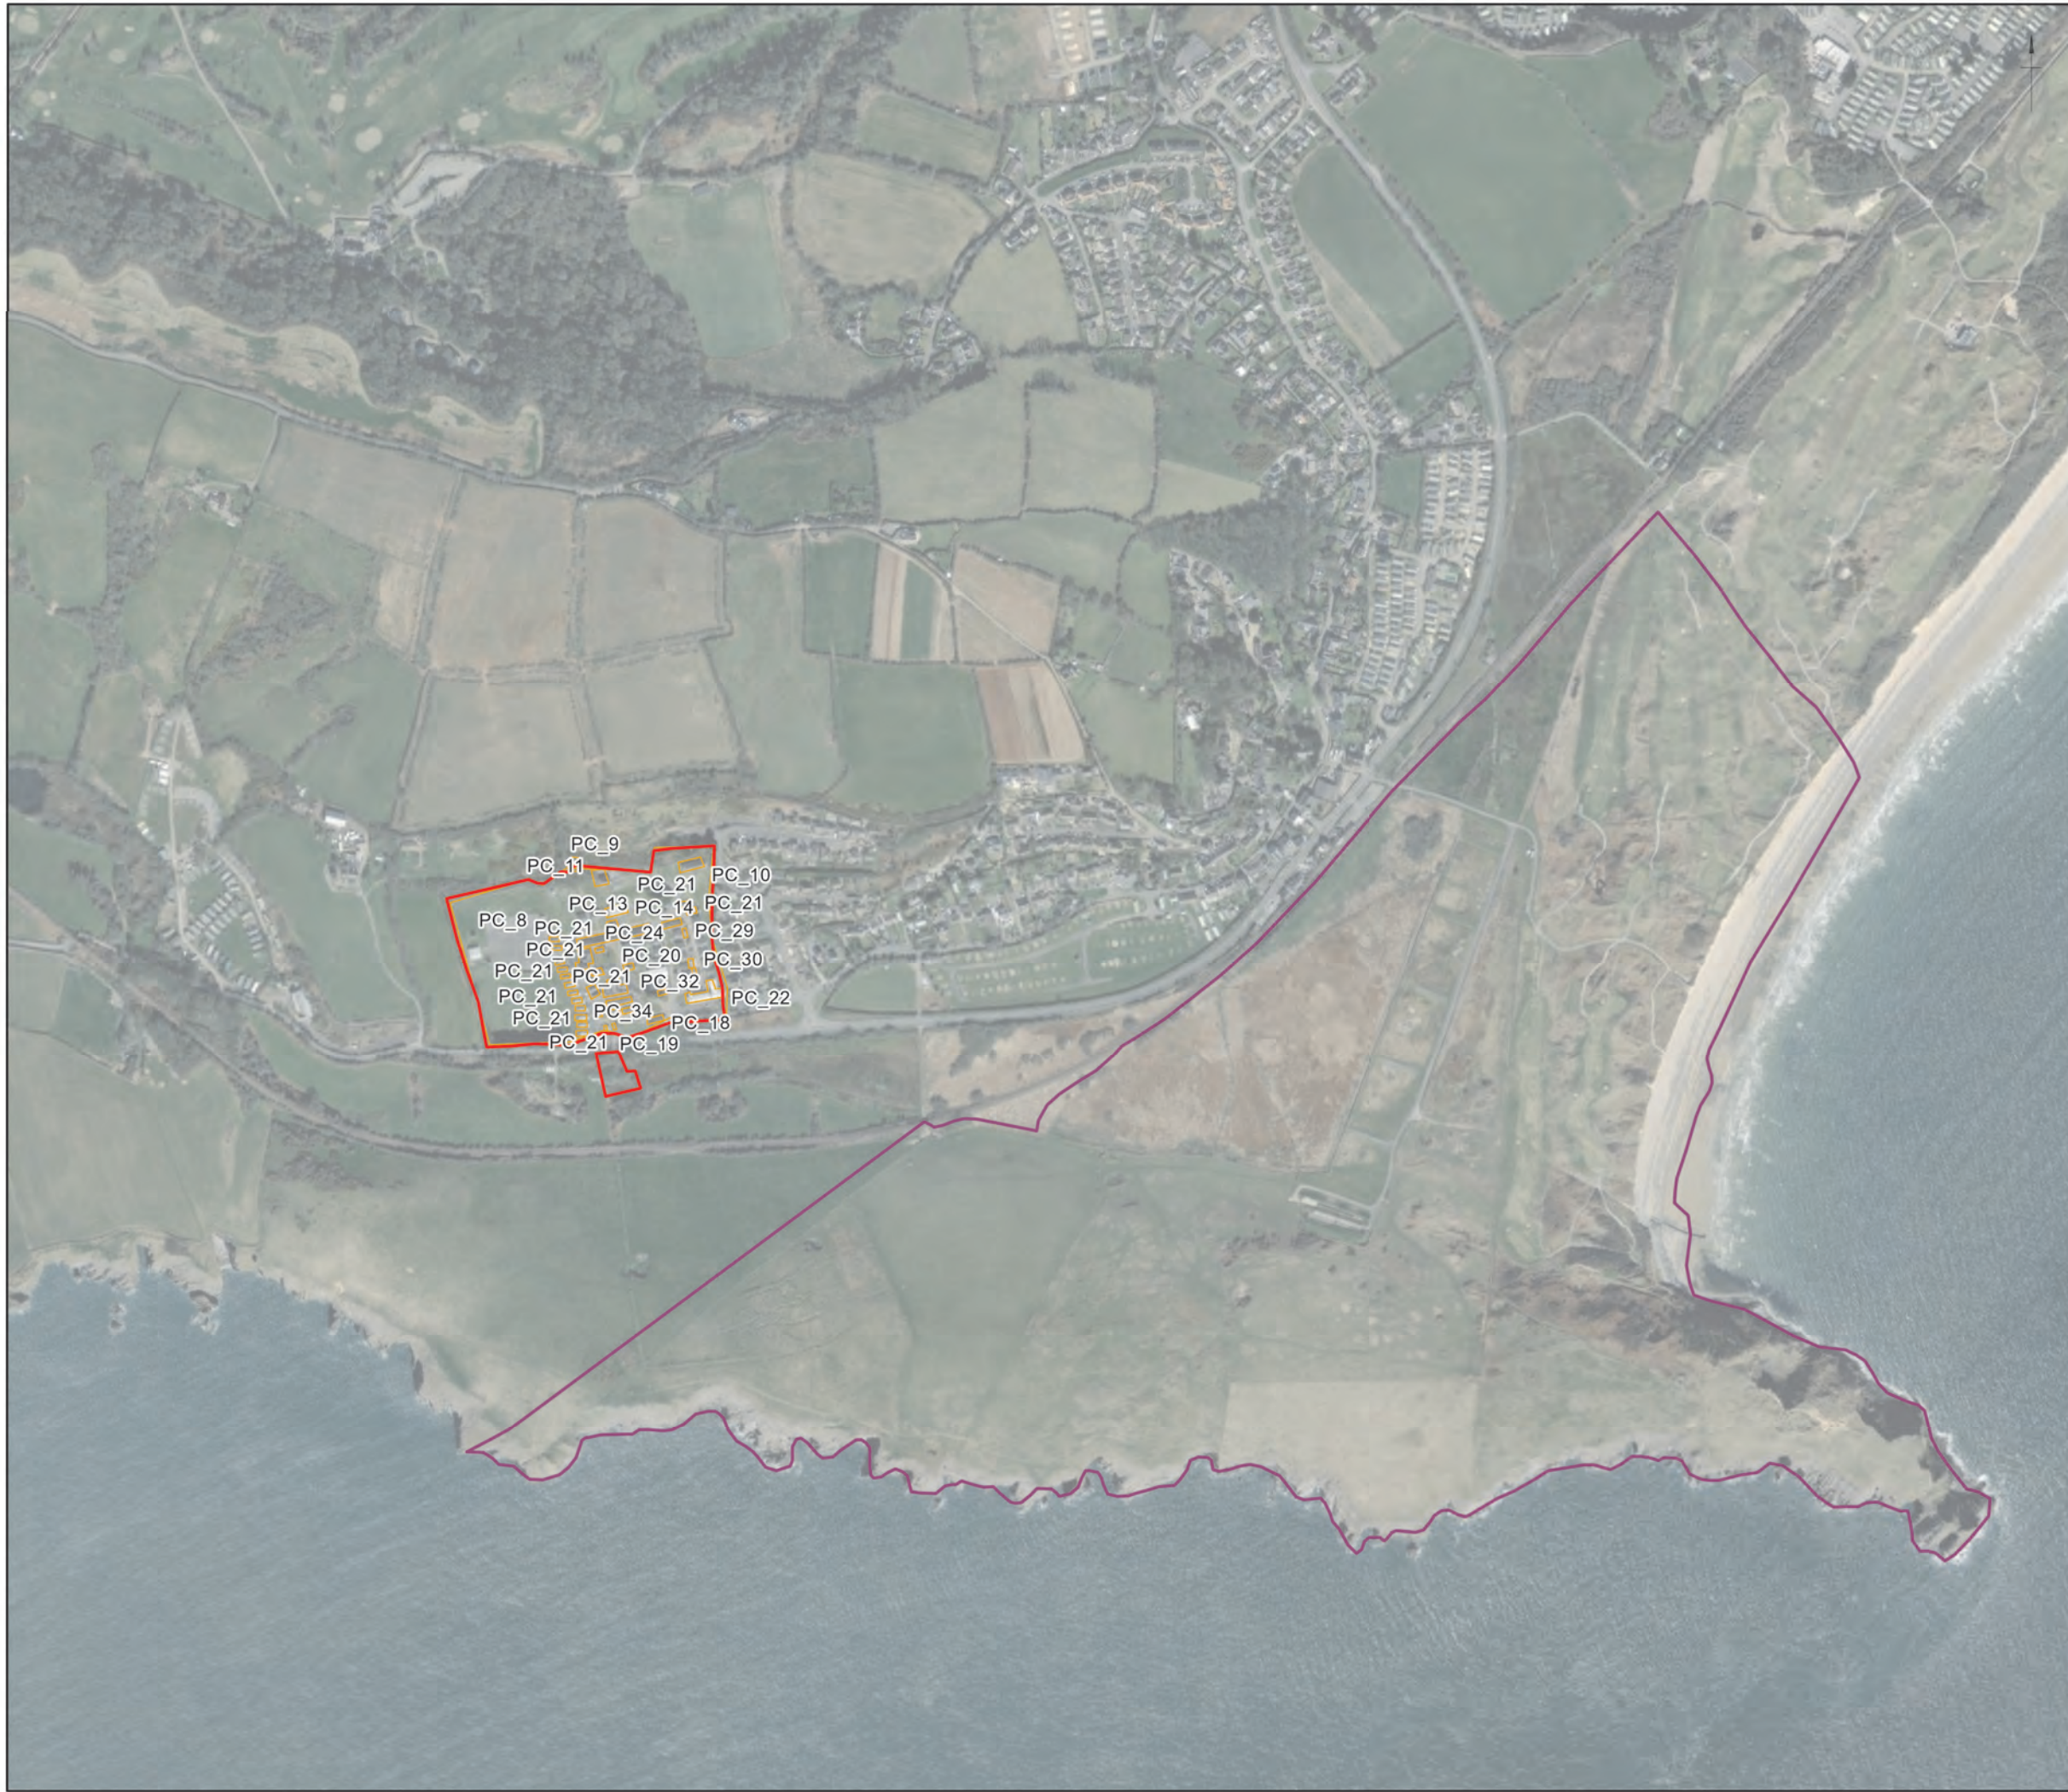
Figure 1: Site Location and Gazetteer Assets

- Site
- Penally Camp
 - Penally Range
- Gazetteer Assets
- Gazetteer Assets

- 1.2.1 Penally Camp (hereafter 'the Site') comprises two irregular parcels of land located to the west of the village of Penally (**Figure 1**). The northern Site parcel contains the main military site and covers some 5.6 hectares (ha). It is bound to the south by the A4139, to the east by modern residential housing, to the west by farmland and to the north by an area of woodland and areas of scrub. The southern Site parcel is the former site of a sewer treatment works and is approximately 0.16 ha. It is bound to the north by the A4139 and in all remaining directions by farmland and woods.

- 3.2.4 The creation of the PTRL acted as a catalyst for the development of a lime quarrying industry in the local area. Two large quarries, Black Rock Quarry and Trefloyne Quarry, were opened north of Penally that were supported by a series of small quarries dotted throughout the area and several limekilns. Although the HER has a record for a post-medieval limekiln within the northern parcel, based on the First Edition Ordnance Survey map, it is in fact further to the south (**Figure 4**). The extent of the quarry is still legible on satellite imagery (**Figure 1**).

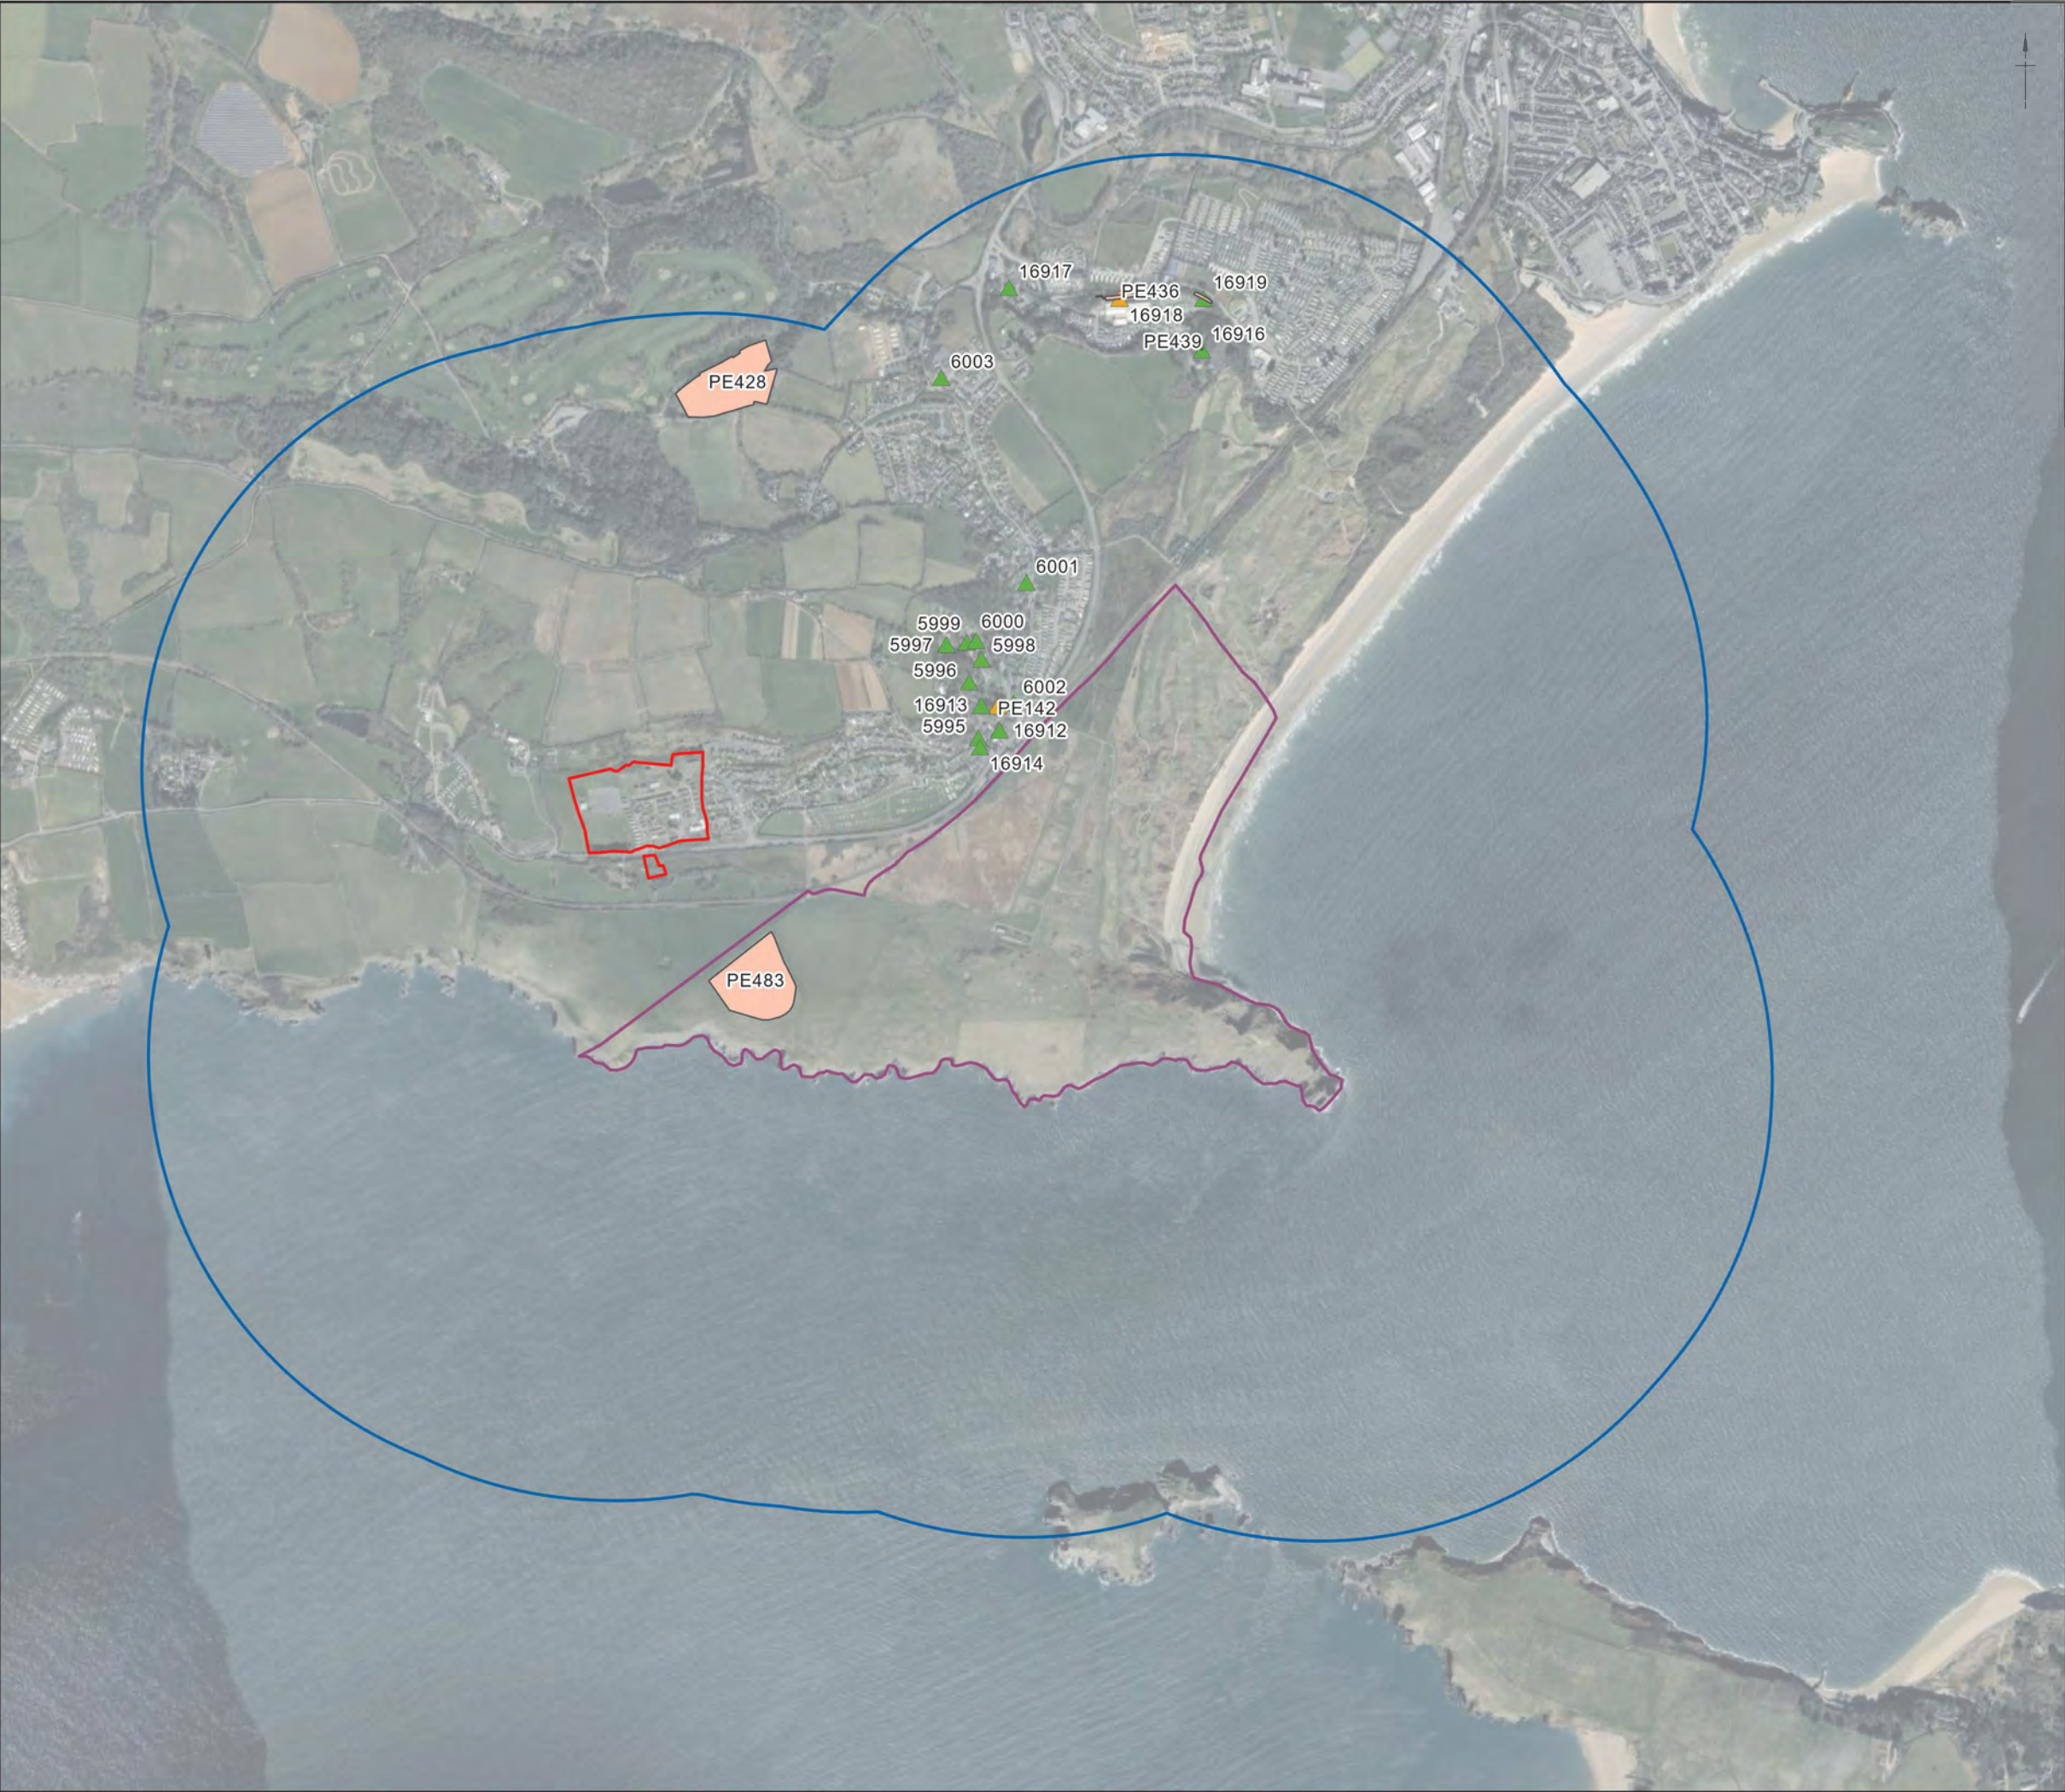
- Site
- Penally Camp
 - Penally Range
- Study Area
- Study Area
- Designated Historic Assets
- Grade II Listed Building
 - Grade II* Listed Building
 - Scheduled Monuments

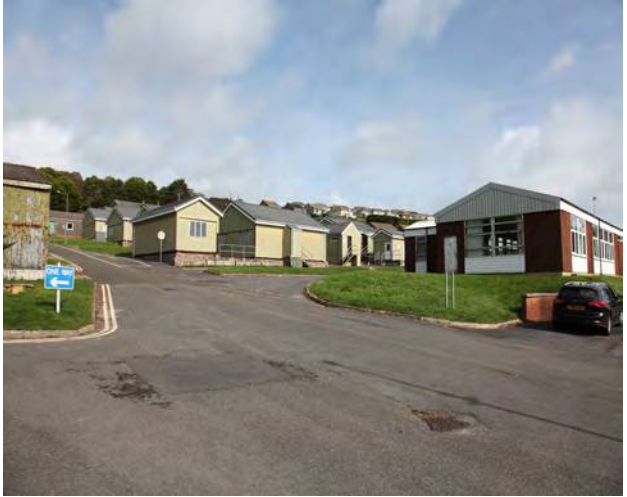
Penally Camp	Non-designated	
Significance	Designated/Non-designated ref	
Medium - High		
Heritage at Risk Asset?		
No		
Asset Description		
<p>Penally Camp was first established in 1860 as a musketry camp, part of a series of defences built to protect Milford Haven. The need for the defences had followed growing tensions between UK and France following the Crimean War. Early plans show that it consisted of guardhouse, officers' quarters and mess, sergeants' mess, soldiers' quarters and ablutions, a stable, stores, magazine, guardhouse, kitchen block, cookhouse, canteen and two underground water tanks. Most of these structures still remain.</p> <p>The camp was used extensively during the First World War for training with soldiers billeted under canvas. In addition to practice with weaponry, soldiers were instructed how to build trenches with Penally Range and land north of the village use for this purpose. Overtime a series of permanent accommodation blocks were built together with new service buildings, such as a magazine.</p> <p>The camp saw heightened activity during World War Two with 31 Nissen Huts built to accommodate additional recruits. After World War II it was used on an ad hoc basis by the MoD alongside the rifle range. The camp officially closed in 2022.</p>		<div>Potential for crashed aircraft?</div> <div>None</div>

Setting Description
		<p>The asset is located on the southwestern outskirts of the village of Penally with a small area of residential development to the east, a farm to the west and agricultural land to the north. To the south lies Penally Range which it has historical and functional associations with. Views southwards to watch and monitor activity in the Celtic Sea would have been an important reason for its position together with being able to react quickly in the event of a landing on the beach head to the east.</p>
Issues affecting asset - Present		
<p>The camp has not been used since 2022 and there are signs of deterioration in many of the buildings. Several are in poor condition.</p>		
Issues affecting asset - Future		
<p>Issues affected the future of the asset relate to its continued maintenance. Several of the structures are in poor condition already and without repair could be lost. Removal of the 19th century and surviving First World War and World War Two buildings would result in harm to the significance of the asset.</p>

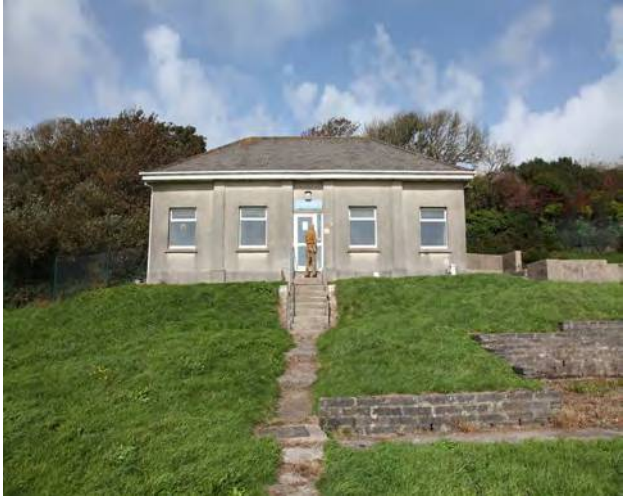
Canteen	Non-designated	
Significance	Designated/Non-designated ref	
High		
Heritage at Risk Asset?		
No		
Asset Description		
<p>Small rectangular brick built structure under a hipped slate roof with modern cement render. To the rear of the building is a brick built stables former coal store and outhouse. The building was constructed as part of the 1860 musketry camp and was re-used during the First World War.</p>		Potential for crashed aircraft?
		None
Setting Description		
		<p>The setting of the asset is defined by its position within Penally Camp. The building has group value with the surviving contemporary structures while the modern additions add to the visible longevity of the site as a military garrison in use for over 160 years.</p>
Issues affecting asset - Present		
<p>The primary issue affecting the asset is maintenance of the structure due to its age. Externally the building is in a fair condition.</p>

Issues affecting asset - Future		
<p>The primary issue is the potential for the asset to be demolished which would lead to a total loss of its significance. Should the asset remain, its maintenance will remain the primary issue in the future. Any development within the vicinity would almost certainly lead to a change in the setting of the asset, which may lead to a diminishment of its significance.</p>

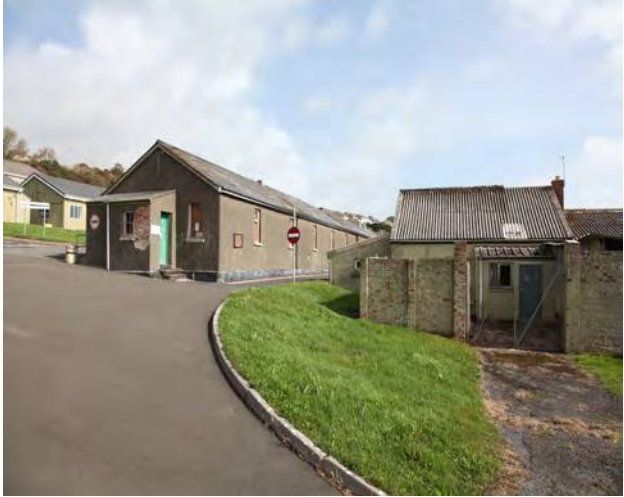
Barracks	Non-designated	
Significance	Designated/Non-designated ref	
High		
Heritage at Risk Asset?		
No		
Asset Description		
<p>Rectangular single storey building constructed from brick under a gabled roof clad in slate. Features a series of window openings on the south and north elevation, most of the historic windows have been replaced with uPVC windows. The building previously had a series of chimney but the have been removed to the ridge line level. It has also been rendered in cement and features two small extensions off each gable end that provide internal access.</p> <p>The building was built as part of the 1860 musketry camp and identified on the First World War plan of the camp as a barracks.</p>		
Potential for crashed aircraft?		
None		
Setting Description		
<p>The setting of the asset is defined by its position within Penally Camp. The building has group value with the surviving contemporary structures while the modern additions add to the visible longevity of the site as a military garrison in use for over 160 years.</p>

Issues affecting asset - Present		
<p>The primary issue affecting the asset is maintenance of the structure due to its age. Externally the building is in a fair condition.</p>		
Issues affecting asset - Future		
<p>The primary issue is the potential for the asset to be demolished which would lead to a total loss of its significance. Should the asset remain, its maintenance will remain the primary issue in the future. Any development within the vicinity would almost certainly lead to a change in the setting of the asset, which may lead to a diminishment of its significance.</p>

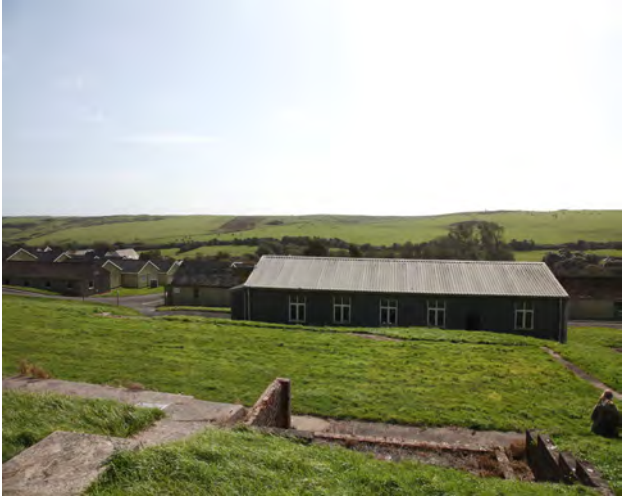
Military Training Site	Non-designated	
Significance	Designated/Non-designated ref	
Medium		
Heritage at Risk Asset?		
No		
Asset Description		
<p>Single storey building, timber framed with box-profile cladding on the external elevations. Features a gabled roof of corrugated sheeting and modern uPVC windows.</p> <p>The building is noted on the First World War plan as in use as a lecture room. It is one of two surviving structures that relate to the First World War expansion of Penally Camp.</p>		<div>Potential for crashed aircraft?</div> <div>None</div>
		Setting Description
		<p>The setting of the asset is defined by its position within Penally Camp. The building has group value with the surviving contemporary structure while the earlier and modern additions add to the visible longevity of the site as a military garrison in use for over 160 years.</p>
Issues affecting asset - Present

<p>The primary issue affecting the asset is maintenance of the structure due to its age. Externally the building is in a fair condition.</p>		
Issues affecting asset - Future		
<p>The primary issue is the potential for the asset to be demolished which would lead to a total loss of its significance. Should the asset remain, its maintenance will remain the primary issue in the future. Any development within the vicinity would almost certainly lead to a change in the setting of the asset, which may lead to a diminishment of its significance.</p>

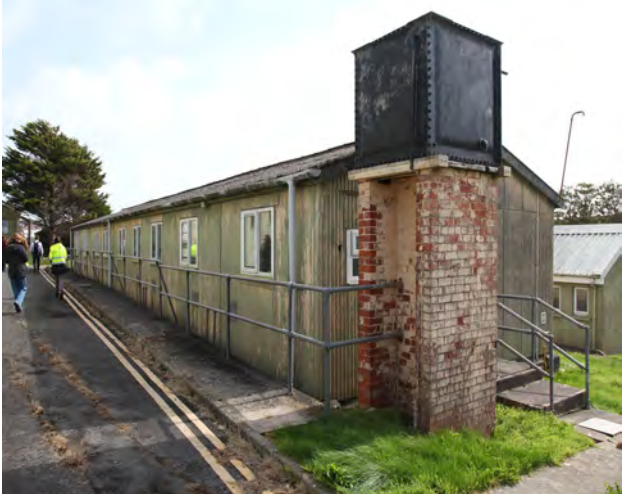
Asset Name	Designation
Military Residence	Non-designated
Significance	Designated/Non-designated ref
Medium	
Heritage at Risk Asset?	
No

Asset Description
<p>Single storey building set on a brick plinth with corrugated cladding and roof within a water tower at its western. Features a gabled roof with corrugated sheeting and uPVC windows.</p> <p>The building is first shown on the First World War plan of Penally Camp and a surviving element of the First World War expansion program.</p>

Issues affecting asset - Future
<p>The primary issue is the potential for the asset to be demolished which would lead to a total loss of its significance. Should the asset remain, its maintenance will remain the primary issue in the future. Any development within the vicinity would almost certainly lead to a change in the setting of the asset, which may lead to a diminishment of its significance.</p>

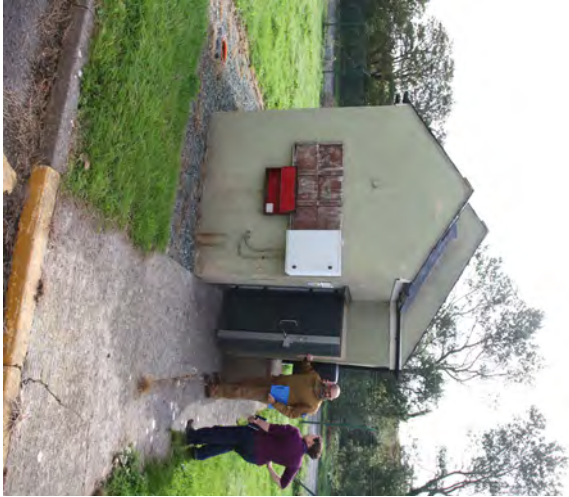
Magazine	Non-designated	
Significance	Designated/Non-designated ref	
High		
Heritage at Risk Asset?		
No		<div>Potential for crashed aircraft?</div> <div></div>
Asset Description		Setting Description
<p>Small rectangular building constructed from brick under a gabled roof clad in slate. The building has had cement render applied to the external walls.</p> <p>The building served as a former magazine and was constructed as part of the 1860 musketry camp.</p>		<p>The setting of the asset is defined by its position within Penally Camp. The building has group value with the surviving contemporary structures while the modern additions add to the visible longevity of the site as a military garrison in use for over 160 years.</p>
Issues affecting asset - Present		
<p>The primary issue affecting the asset is maintenance of the structure due to its age. Externally the building is in a fair condition.</p>

Issues affecting asset - Future		
<p>The primary issue is the potential for the asset to be demolished which would lead to a total loss of its significance. Should the asset remain, its maintenance will remain the primary issue in the future. Any development within the vicinity would almost certainly lead to a change in the setting of the asset, which may lead to a diminishment of its significance.</p>

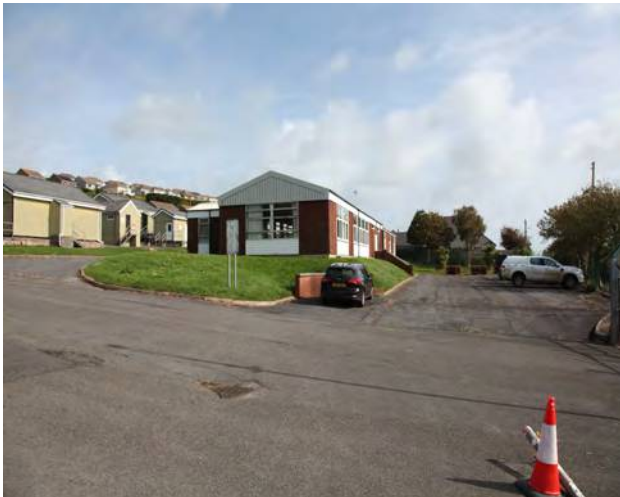
Former Sergeants Mess	Non-designated	
Significance	Designated/Non-designated ref	
Low		
Heritage at Risk Asset?		
No		
Asset Description		
<p>Three rectangular buildings that are connected to form a large T-shaped range. Constructed from brick with the north-south range rendered in concrete while the remaining range features corrugated sheeting on the external walls. The roof for the entire building is modern corrugated sheets while the windows are wooden and uPVC.</p> <p>The two sections that form the eastern range were built in WWII as the sergeants mess and workshop with the remainder of the structure building between 1943 and 1972.</p>		
Potential for crashed aircraft?		
None		
Setting Description		
<p>The setting of the asset is defined by its location within the camp and through its association with the other constituent buildings and earlier additions. Collectively they are a visible testament to the longevity of the site, which has been in active military service since 1860.</p>

Issues affecting asset - Present		
<p>The primary issue affecting the asset is maintenance of the structure due to its age. Several of the windows and corrugated sheeting on the external walls of the east-west aligned range are in poor condition. Internally, water ingress and damp have begun to cause issues to the ceiling and paintwork.</p>		
Issues affecting asset - Future		
<p>The primary issue is the potential for the asset to be demolished which would lead to a total loss of its significance. Should the asset remain, its maintenance will remain the primary issue in the future. Any development within the vicinity would almost certainly lead to a change in the setting of the asset, which may lead to a diminishment of its significance.</p>

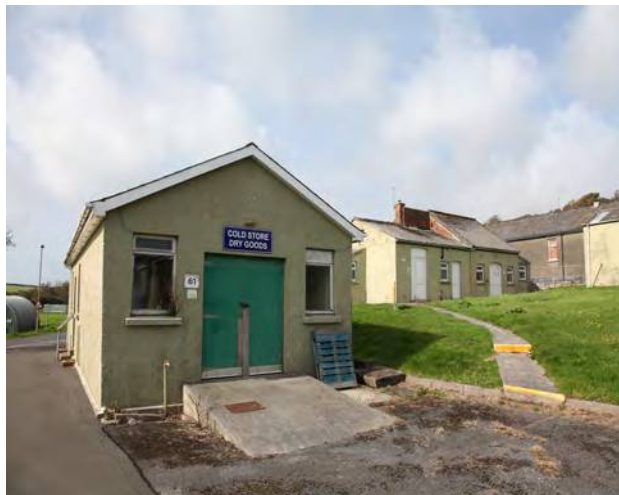
Small rectangular buildings constructed from brick under a gabled roof clad in slate. Access is via a set of double doors on the eastern gabled end or via an doorway in the south elevation. Features wooden windows with a top hinge on the gable ends and south and north elevations.

The building served as a former kitchen and was constructed as part of the 1860 musketry camp.

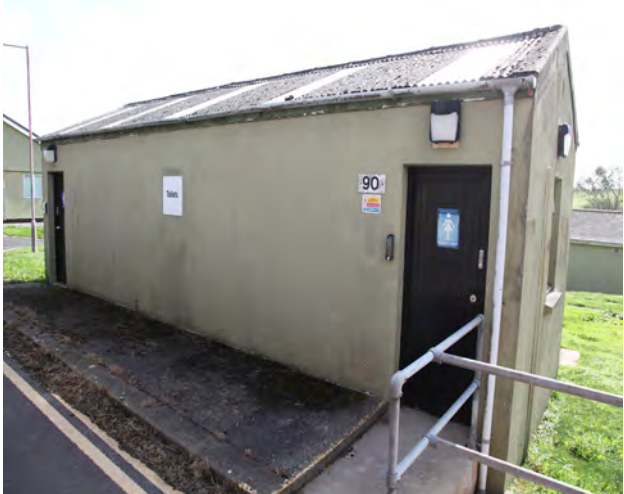
Building 61	Non-designated	
Significance	Designated/Non-designated ref	
Low		
Heritage at Risk Asset?		
No		
Asset Description		Potential for crashed aircraft?
<p>single storey rectangular buildings constructed from brick with cement render under a gabled roof with corrugated sheeting. Access is via a concrete platform on the north elevation with the building split into two toilet ranges. Wooden windows features on each gabled end and the south elevation.</p> <p>The building was constructed between 1943 and 1958, possible as part of the Cold War changes.</p>		None
		Setting Description
		<p>The setting of the asset is defined by its location within the camp and through its association with the other constituent buildings and earlier additions. Collectively they are a visible testament to the longevity of the site, which has been in active military service since 1860.</p>

Issues affecting asset - Present		
<p>The primary issue affecting the asset is maintenance of the structure due to its age. Externally the building is in a fair condition.</p>		
Issues affecting asset - Future		
<p>The primary issue is the potential for the asset to be demolished which would lead to a total loss of its significance. Should the asset remain, its maintenance will remain the primary issue in the future. Any development within the vicinity would almost certainly lead to a change in the setting of the asset, which may lead to a diminishment of its significance.</p>

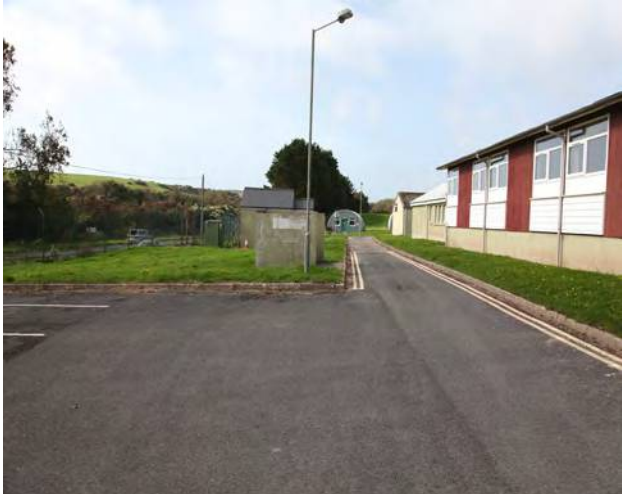
Asset Name	Designation
Building 81	Non-designated
Significance	Designated/Non-designated ref
Low	
Heritage at Risk Asset?	
No

Asset Description	Potential for crashed aircraft?
<p>Single storey rectangular buildings constructed from brick that has been cement rendered and painted green. Features a gabled roof clad in corrugated sheets. Windows appear to be a mixture of wooden and uPVC.</p> <p>The building was constructed as part of the World War Two expansion of Penally Camp.</p>	None
	Setting Description
	<p>The setting of the asset is defined by its location within the camp and through its association with the other constituent buildings and earlier additions. Collectively they are a visible testament to the longevity of the site, which has been in active military service since 1860.</p>

Issues affecting asset - Present
<p>The primary issue affecting the asset is maintenance of the structure due to its age. Externally the building is in a fair condition.</p>
Issues affecting asset - Future
<p>The primary issue is the potential for the asset to be demolished which would lead to a total loss of its significance. Should the asset remain, its maintenance will remain the primary issue in the future. Any development within the vicinity would almost certainly lead to a change in the setting of the asset, which may lead to a diminishment of its significance.</p>

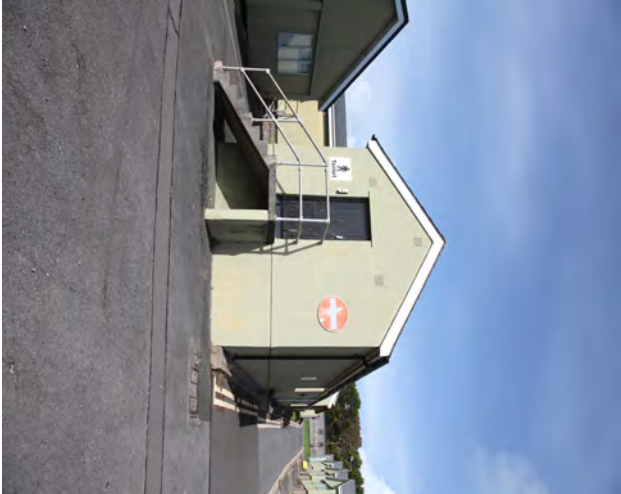
Asset Name	Designation
Building 87A	Non-designated
Significance	Designated/Non-designated ref
Low	
Heritage at Risk Asset?	
No

Asset Description	Potential for crashed aircraft?
<p>Single storey rectangular building constructed from brick that has been rendered in cement. Features a gabled roof that is clad in corrugated sheeting. Access into the building is via a doorway in the south elevation that is accessed by a set of concrete steps.</p> <p>The building was constructed as part of the World War Two expansion of Penally Camp.</p>	None
	Setting Description
	<p>The setting of the asset is defined by its location within the camp and through its association with the other constituent buildings and earlier additions. Collectively they are a visible testament to the longevity of the site, which has been in active military service since 1860.</p>

Issues affecting asset - Present
<p>The primary issue affecting the asset is maintenance of the structure due to its age. Externally the building is in a fair condition.</p>

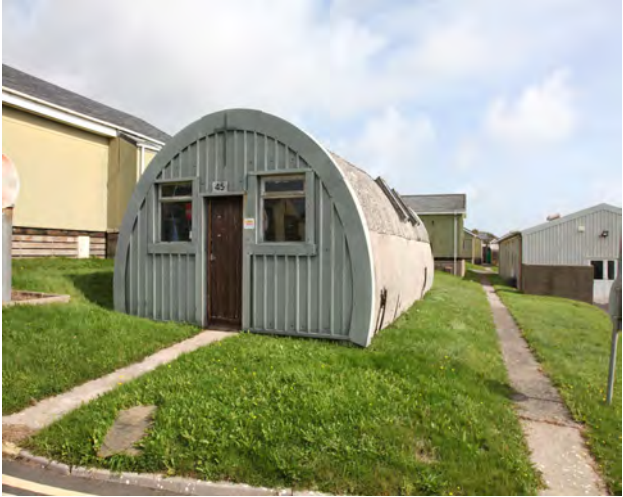
Building 45	Non-designated	
Significance	Designated/Non-designated ref	
Low		
Heritage at Risk Asset?		
No		
Asset Description		Potential for crashed aircraft?
<p>Nissen Hut. Constructed to standard Nissen Hut design with corrugated sheeting and brick infill at each end. Both ends have been clad in corrugated sheeting. Windows are wooden and historic features of the building.</p> <p>The building was constructed as part of the World War Two expansion of Penally Camp.</p>		None
		Setting Description
		<p>The setting of the asset is defined by its location within the camp and through its association with the other constituent buildings and earlier additions. Collectively they are a visible testament to the longevity of the site, which has been in active military service since 1860.</p>
Issues affecting asset - Present		
<p>The primary issue affecting the asset is maintenance of the structure due to its age. Externally the building is in a fair condition.</p>

Issues affecting asset - Future		
<p>The primary issue is the potential for the asset to be demolished which would lead to a total loss of its significance. Should the asset remain, its maintenance will remain the primary issue in the future. Any development within the vicinity would almost certainly lead to a change in the setting of the asset, which may lead to a diminishment of its significance.</p>

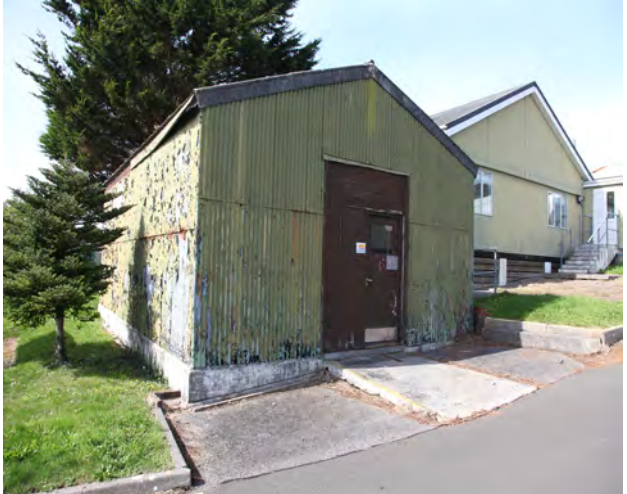
Building 56	Non-designated	
Significance	Designated/Non-designated ref	
Low		
Heritage at Risk Asset?		
No		
Asset Description		Potential for crashed aircraft?
<p>Single storey buildings likely steel framed and finished with corrugated sheeting. Access is provided by a doorway on the east elevation. This may have replaced a historic double door.</p> <p>The building was constructed as part of the World War Two expansion of Penally Camp.</p>		None
		Setting Description
		<p>The setting of the asset is defined by its location within the camp and through its association with the other constituent buildings and earlier additions. Collectively they are a visible testament to the longevity of the site, which has been in active military service since 1860.</p>
Issues affecting asset - Present		
<p>The primary issue affecting the asset is maintenance of the structure due to its age. Externally the building is in a poor condition.</p>

Issues affecting asset - Future		
<p>The primary issue is the potential for the asset to be demolished which would lead to a total loss of its significance. Should the asset remain, its maintenance will remain the primary issue in the future. Any development within the vicinity would almost certainly lead to a change in the setting of the asset, which may lead to a diminishment of its significance.</p>
