Penally Training Camp Phase 1 Land Quality Assessment

PROJECT NO. 62302982

OUR REF. NO. 62302982-20-1005-WSP-REP-001

DATE: FEBRUARY 2024

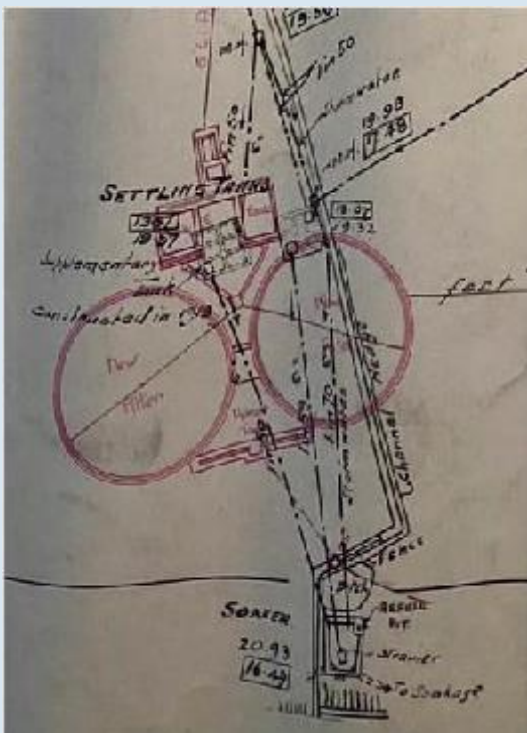
Photo 23 Extract of 1913 plan [15]		Photo 24 Historical sewage treatment works area

<p><i>Photo 22 Drainage outflow point</i></p>
R02 Sewage treatment works	R02-1	<p>Historical sewage treatment works located to the south of the main camp, across the A4139 road. A site plan dated to 1913 [15] shows the layout of the sewage treatment works, featuring two filter beds, a bank of settling tanks and what appears to be a soakaway system. Two foul water drainage routes were shown to connect the camp to the system, one of which was labelled 'stormwater'. The outlet pipe discharged to an off-site drainage channel [16]. It was labelled as a 'sewage farm' in 1978 [11] and was disused by 1991 [17].</p> <p>The area is now heavily overgrown and there is little evidence of prior use. The current utility plan [6] does not show any historical services connecting to this area.</p>

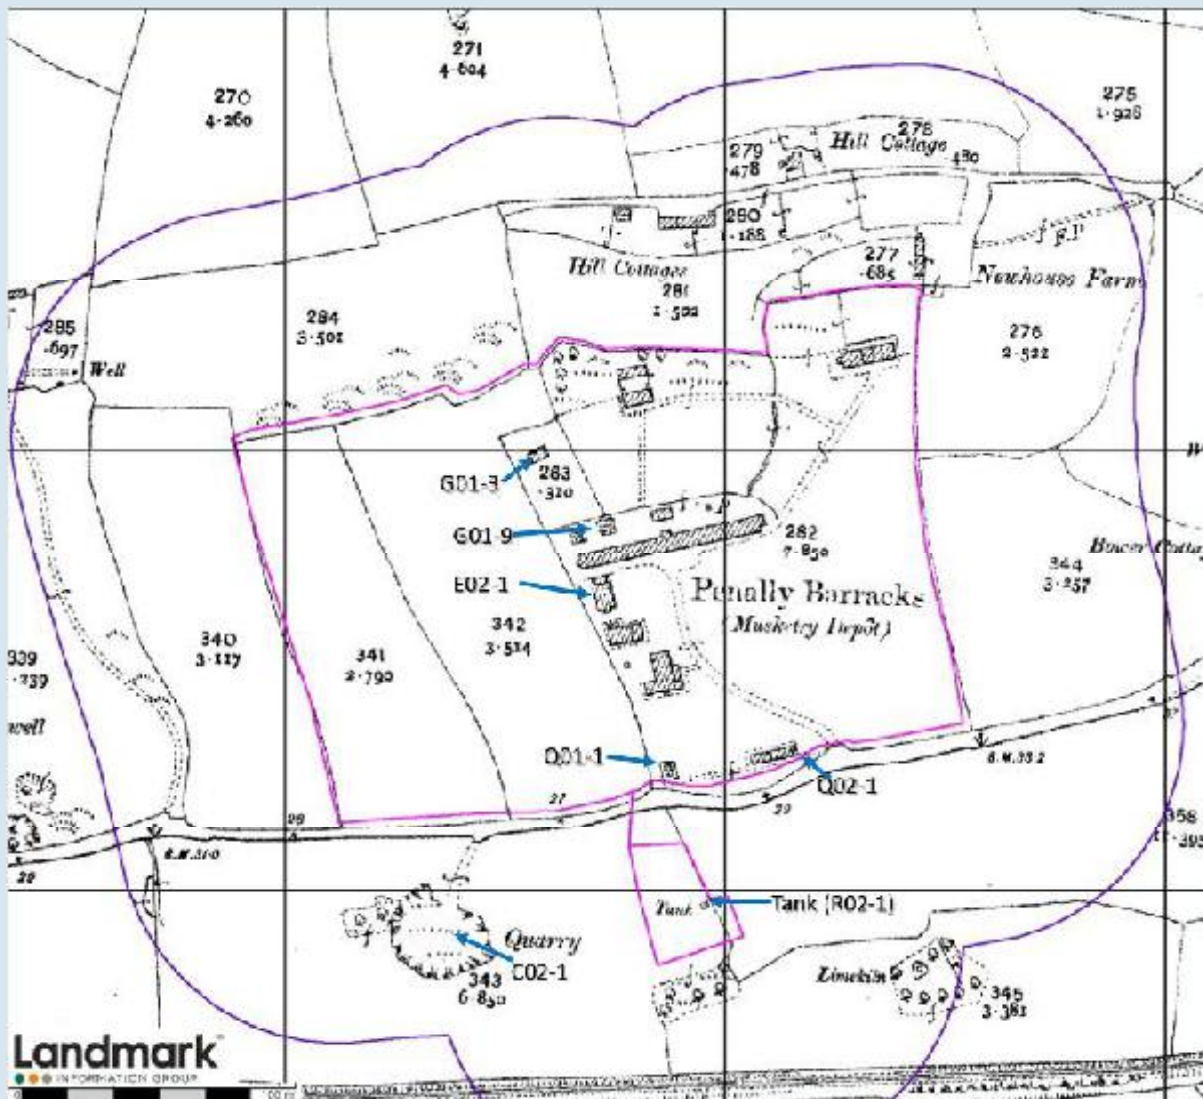
Figure 4-1 - Extract of 1907 OS map (1:2,500 scale)

The site was surrounded by agricultural land with several cottages and farms in the area. OS Mapping from 1889 [7], a quarry (C01-2) was located 30m from the site boundary. A limekiln was located 50m to the south of the site, adjacent to a railway line trending west to east. Penally Ranges were shown 850m to the east of the site, and the village of Penally was 500m east of the site.

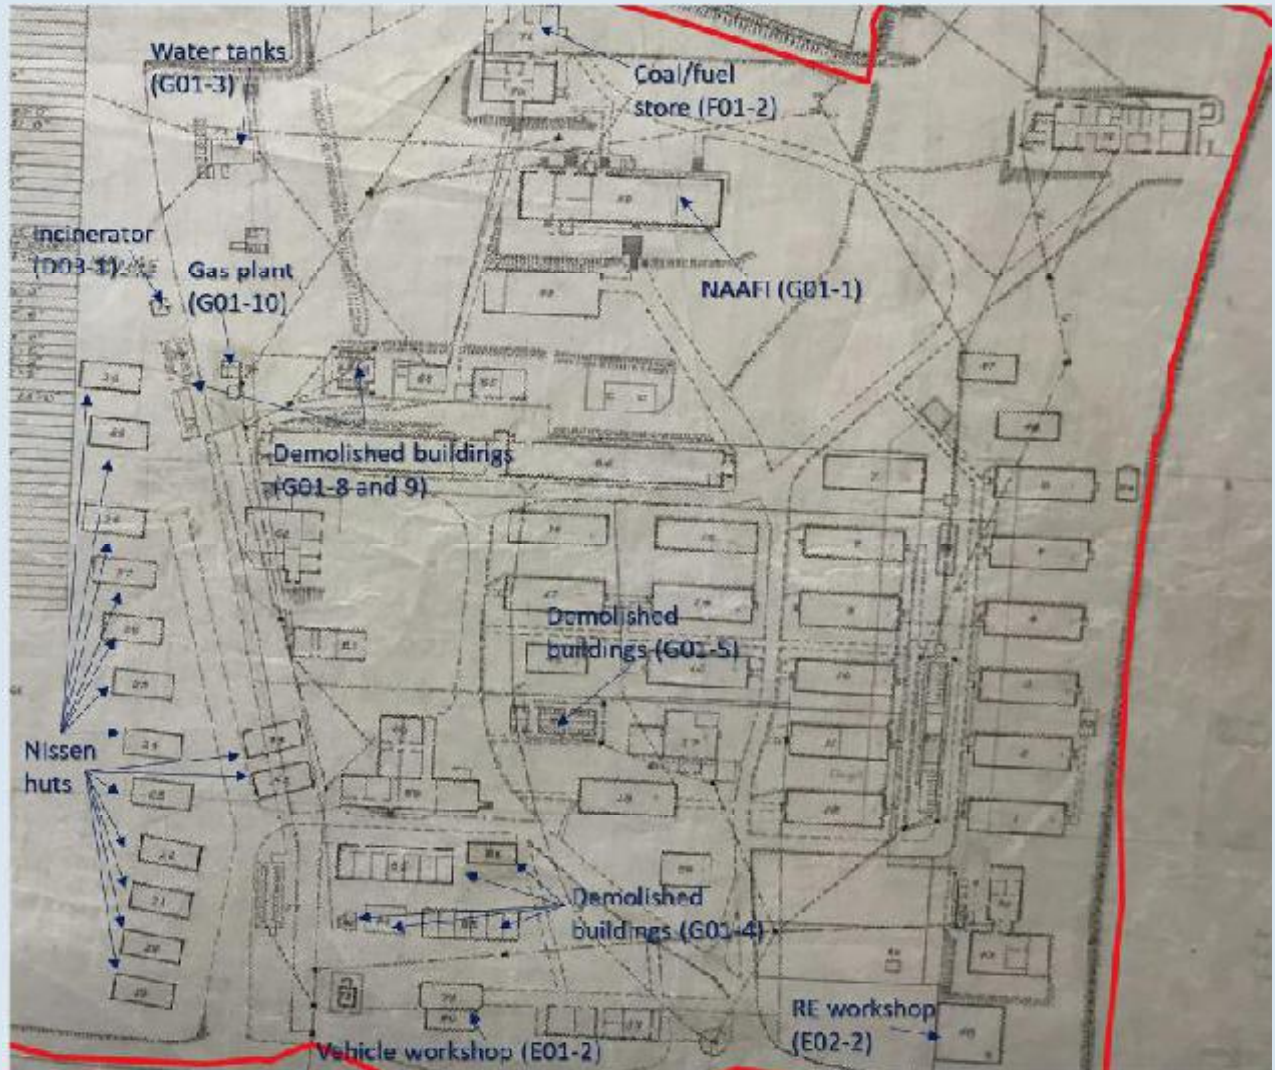
Figure 4-2 - Extract of 1943 site plan [10]

1946 aerial photograph. A 1943 site plan [10] shows a site layout similar to the current day, with noted buildings including workshops (E01-2, E02-2), a gas hut (J01-2), gas plant (G01-10) and an incinerator (D03-1). It also provides a list of building uses and construction materials, including a bank of demolished Nissen huts (G01-6) to the west of the current huts.

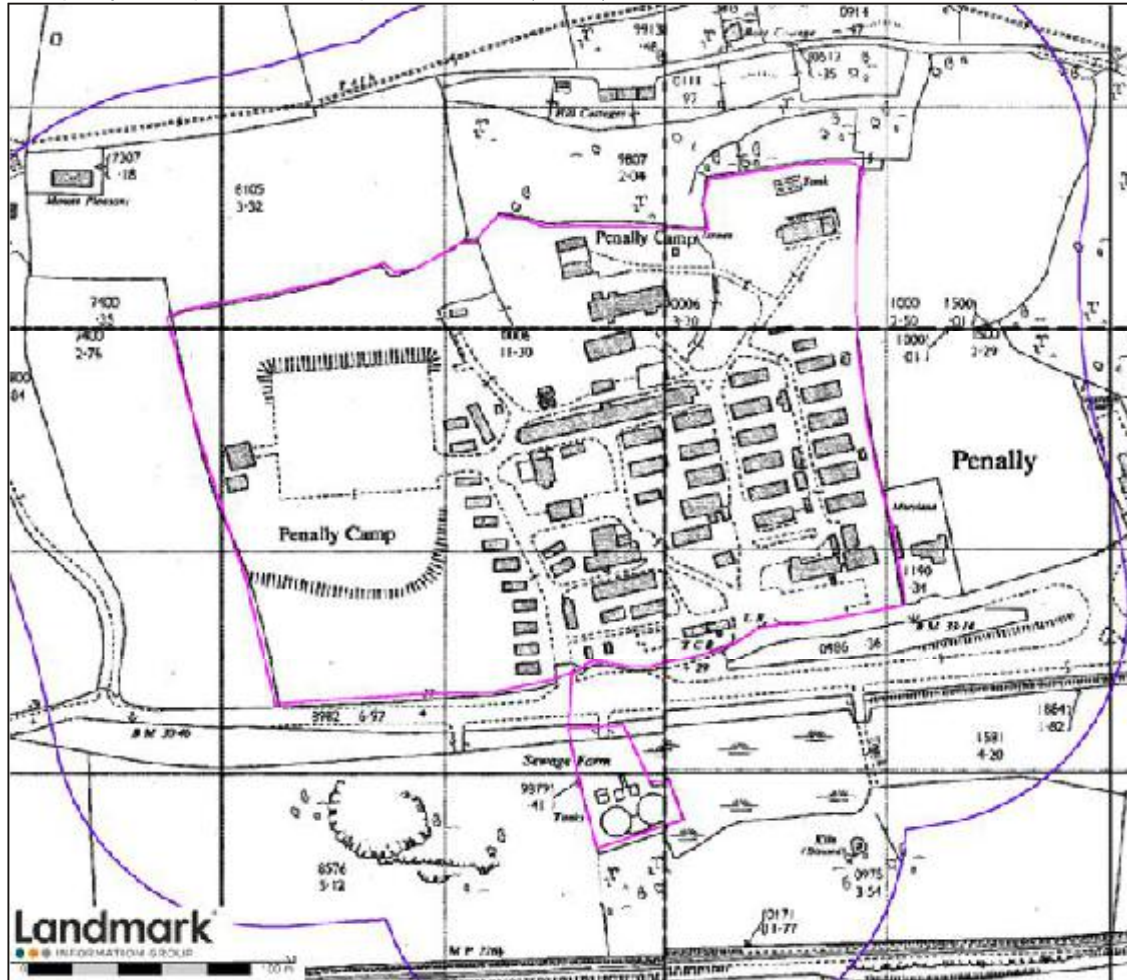
Figure 4-3 - Extract of 1967/68 OS map (1:2,500 scale)

OS mapping up to 1966 shows minimal changes from previous editions. Maps from 1970 show the nearby village of Penally to have expanded towards the camp, following the main road and encompassing several pre-existing cottages, ending 100m east of the site. The limekiln was labelled as 'Kiln (disused)'. Crackwell Farm to the northwest was expanded to include several structures. By 1986 the village of Penally had expanded up to the eastern boundary of the site and by 1994 grew to match the current layout of the village, along the full length of the eastern boundary of the site. The quarry is still present as an open excavation (C02-1).

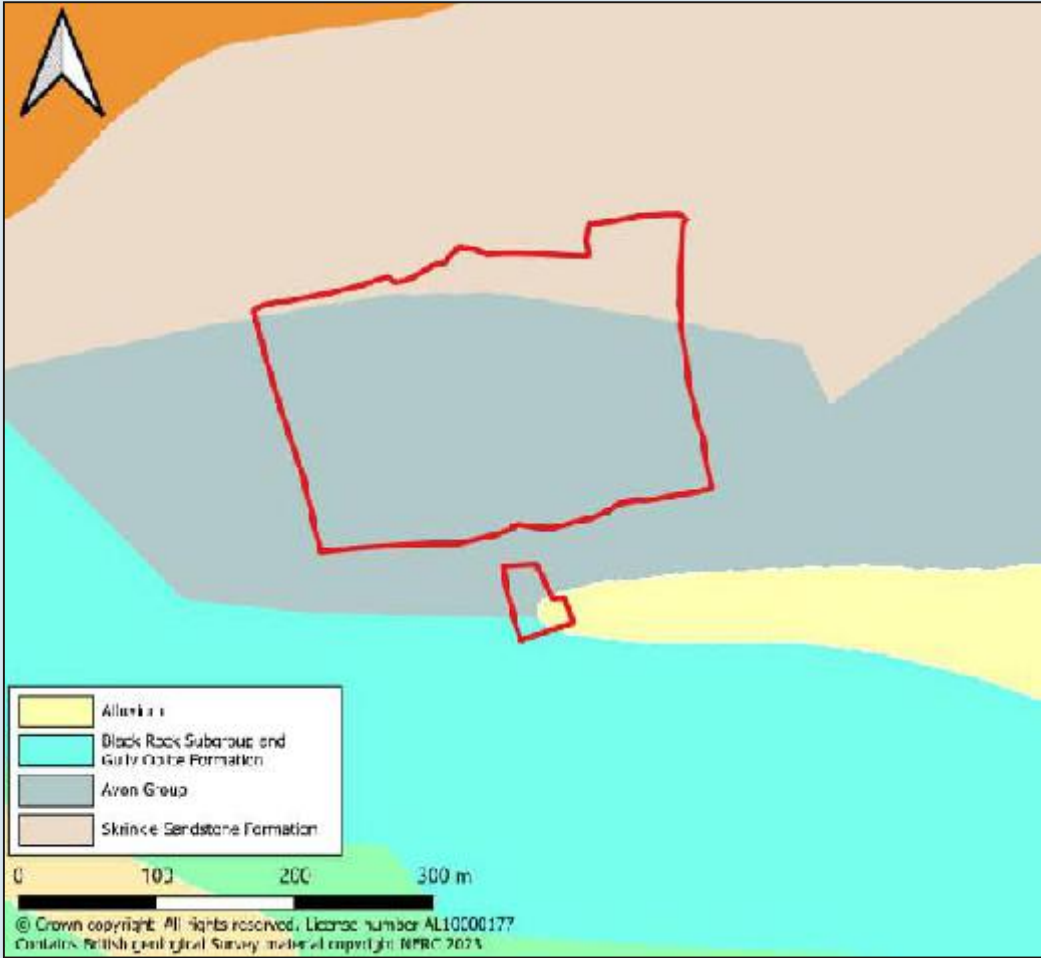
<p>Figure 6.1 Summary of geology</p>

Strata	Location	Description	Aquifer Type, average thickness (m), and approximate water level
Made Ground	Majority of site likely, specifically in built up areas	Made ground comprising building rubble (including asbestos) is anticipated across much of the site, although has not been proven and is not noted on BGS mapping.	Unknown. No ground investigation data is available for the site.
Alluvium	Southeastern boundary of PTCR02	Intermixed clay, silt, sand and gravel	Secondary A Aquifer. Thickness unknown, although anticipated to be limited.
Bedrock			
Black Rock Subgroup and Gully Oolite Formation (Undifferentiated)	Southern tip of PTCR02 A limestone quarry was located to the south of the main site	Limestone with subsidiary dolomitic limestone and dolostone.	Principal Aquifer, thickness unknown. Groundwater details unknown
Avon Group (Lower Limestone Shale [30])	Across most of the site	Interbedded limestone and dark grey to black shale.	Secondary A Aquifer 30m thick in a borehole located 560m east of the site [37]. Rest water level in 1890 was 11.7mbgl (550m east of site) [37]

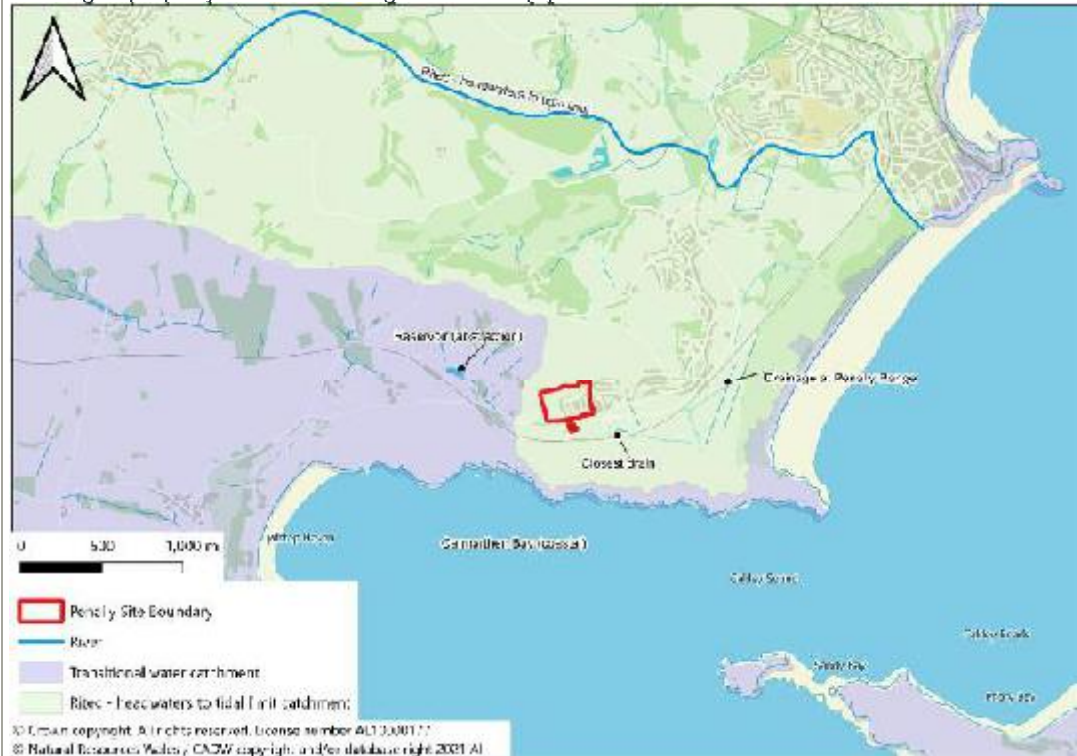
Figure 6.3 Summary of Hydrology

The majority of the site is not located within an area susceptible to fluvial or tidal flooding. Part of the sewage works (R02-1) is within an area allocated a high risk of flooding from rivers [7]. This unoccupied part of the site has a chance of flooding of 3.3% a year. The site is not at risk of flooding from seawater. It has a limited potential for groundwater flooding across the part of the site correlating with the Avon Group, and the south of the site is considered to have 'potential for groundwater flooding of property situated below ground level' [7].

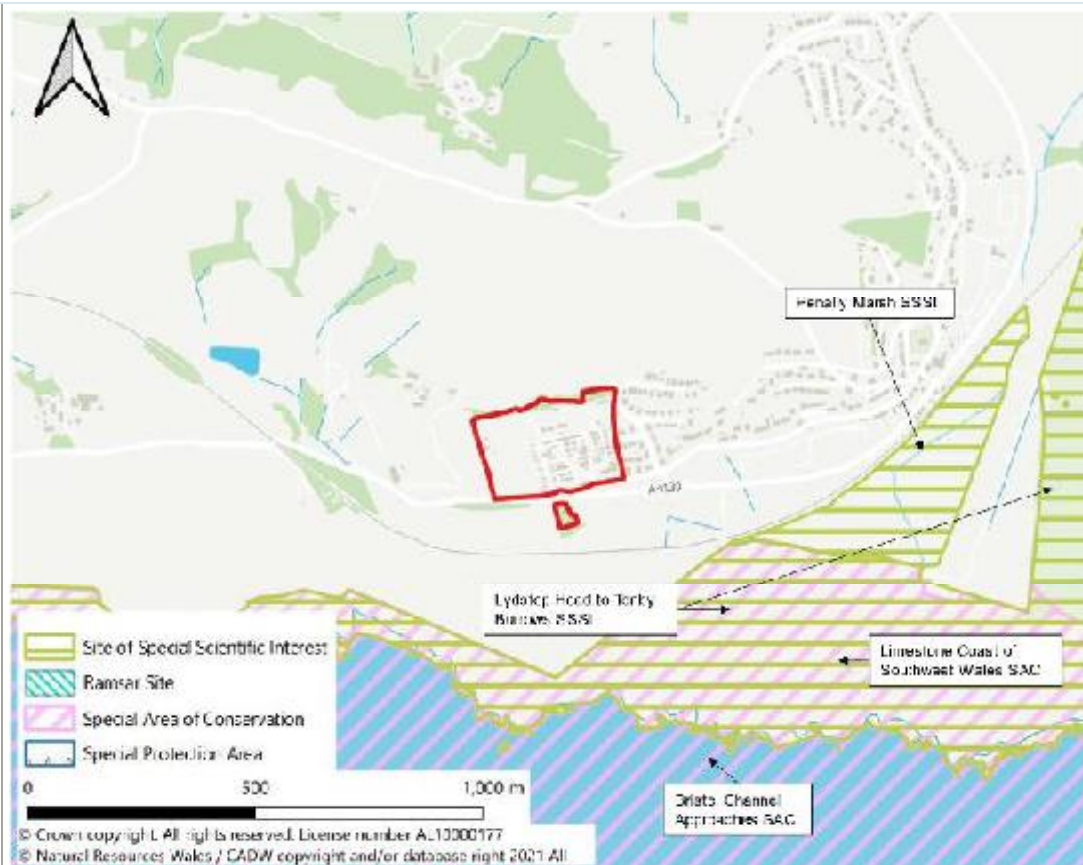
Figure 6-4 - Summary of ecologically designated areas

The site is approximately 250m to the north of the Lydstep Head To Tenby Burrows SSSI and Lydstep Head To Tenby Burrows SAC, 275m to the west of Penally Marsh SSSI, and 400m north of the Bristol Channel Approaches SAC.
