Newgale Shingle Bank

Vulnerability Assessment

Pembrokeshire County Council

Final Report

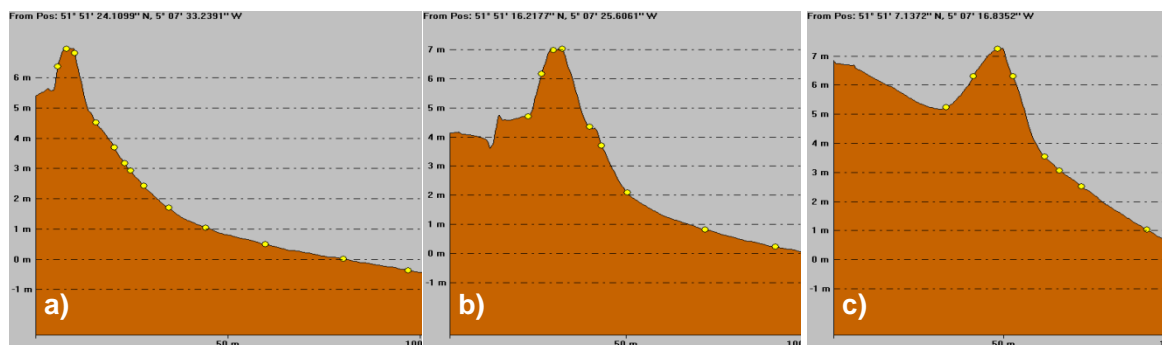
Figure 2.5. Variation in beach and ridge profiles - a) Profile 8, b) Profile 5, c) Profile 2

Three representative profiles shapes are presented in Figure 2.5 showing the general shape of the beach following the storms in 2014 at:

- a) Profile 8, the northern section where the road turns to cross the bridge before climbing through the main village of Newgale,
- b) Profile 5, to the southern end of the managed beach section where the road runs up hill and inland; and,
- c) Profile 2, further south, to the southern end of the car park along the coastal road towards Nolton Haven.

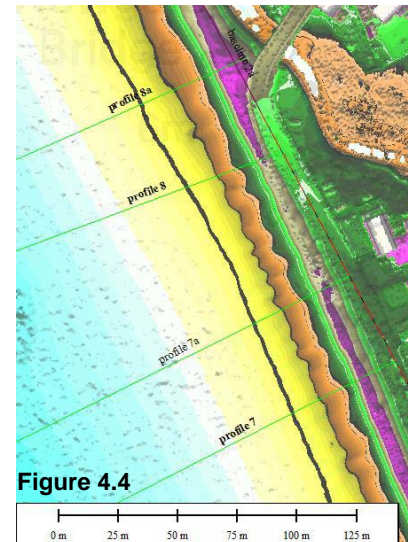
At profile 8a (Figure 4.4), it can be seen that there is a wide berm at the crest running back to the stream behind. Here, and as seen during the 2014 storms, the Breakwat model predicts that starting from the 2006 profile, with a water level of 3.8m ODN shingle is likely to be moved away from the front face and moved onto the crest. Analysis of the 2014 profile suggests that while the ridge, under similar storm conditions is slightly more vulnerable, sediment is still likely to remain within the existing ridge. While the profile, therefore becomes more vulnerable, even with increased water levels (i.e. more severe events or with sea level rise) there is still sufficient width (bulk) within the bank to resist full collapse.

Profiles 7a and 8 (Figure 4.4) cover part of the most vulnerable section of the frontage. While the trigger water level at either section remains the same (comparing 2006 profile and that of 2014) at around a 3.5m ODN level, both sections have become more vulnerable, even with efforts to re-establish the crest. In the case of profile 8, the 2006 cross section could potentially withstand waves up to 2m on a water level of 3.8m ODN but starts to fail on higher water levels. With the narrower ridge, the resilience of the bank remains relatively similar but becomes significantly more vulnerable to even minor increase in water level above 3.8m ODN. Significant failure might be expected with waves of 2m on a 4m ODN water level and, indeed, greater damage may now occur with higher waves on water levels as low as 3.5m ODN.

The increase in vulnerability (comparing 2006 and 2014) is even clearer for profile 7a. With the present profile full failure might now be expected with wave heights greater than 2m on water levels above 3.8m ODN.

Typically these profiles might be considered to have a standard of failure at around a 1:1 year water level (Figure 4.1 – 3.5m ODN) with major failure occurring at around a 1:10 to 1:20 year water level. With sea level rise, the standard of failure might be expected to be exceeded more frequently than once a year, with total failure occurring possibly every year with a sea level rise of 0.25m.

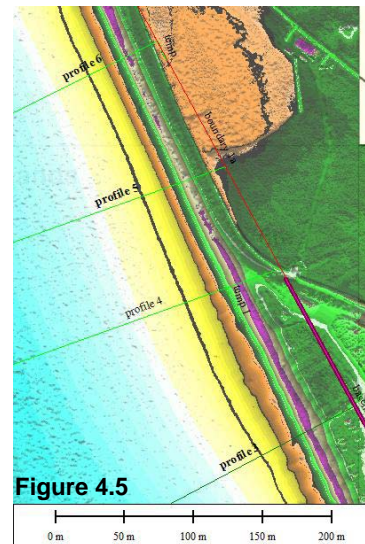
Profile 3, shown on Figure 4.5, represents a more naturally developing section of the frontage. For this profile it may be seen from Figure 4.3 that significant overwash occurs at a water level of 3.5m ODN (with higher wave height) but that complete failure is not indicated to occur even under the most severe conditions tested.

From the analysis, there is a suggestion that as the bank has changed and has rolled back, it has increased its resilience. It is suggested that the ability for the bank to adapt under storm conditions is apparent as it has moved into a new position where it is better able to resist overwash.

This frontage, from the profile shape, is not that obviously different from the managed profiles discussed above. However, in part because the profile is allowed to develop naturally and in part because the land levels behind the bank are higher, the profile is more resilient.
