# **Pembrokeshire County Council Cyngor Sir Penfro**

## **Goodwick Conservation Area Character Appraisal and Management Plan**

**Adopted November 2016**

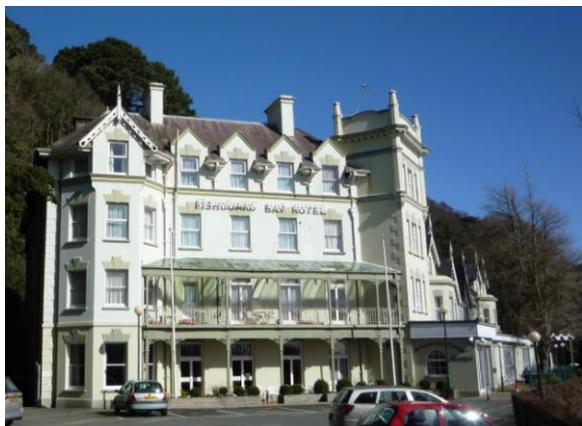
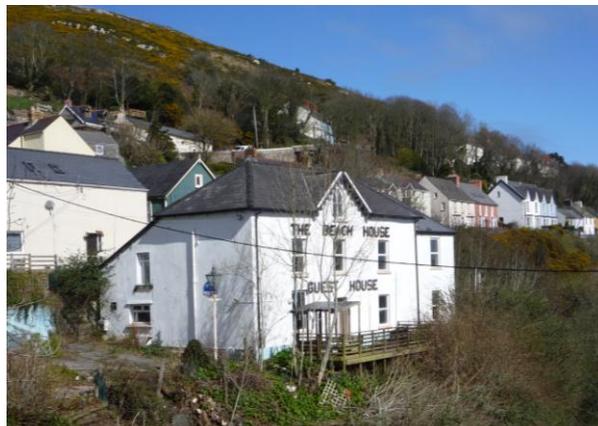
Fishguard Bay Hotel, and The Beach House, formally a hotel but now in need of some attention, in particular are both large and imposing buildings that stand proudly against the backdrop of the cliff face and Goodwick town respectively, both prominent landmarks highly visible to the surrounding area.

The Fishguard Bay Hotel, overlooking Fishguard Bay (26.3.15), The Beach House, overlooking Goodwick Parrog and Harbour (26.3.15)

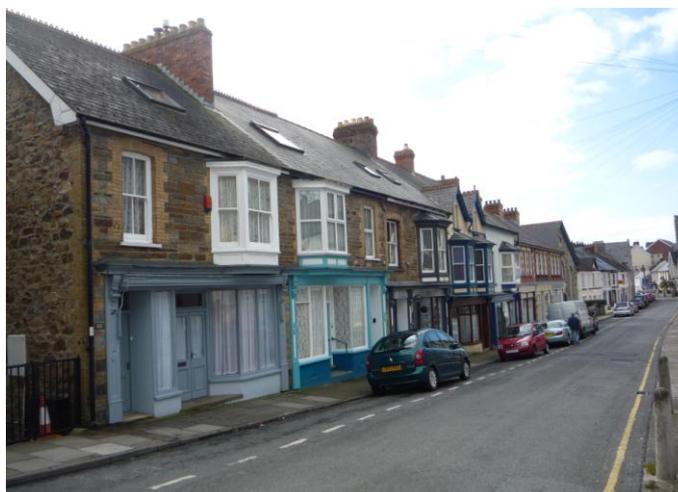
4.3.11 Groups of buildings such as the Victorian and Edwardian town houses further provide strong visual reference points within the Conservation Area. Goodwick Main Street in particular exhibits buildings with differing heights, a variety of pitched dormer roofs, first floor Oriel windows, ground floor bays with slated roofs, and in places an uneven building line, all of which adds to the interest and character of the streetscape.

Views southwest along Main Street Goodwick (26.3.15)

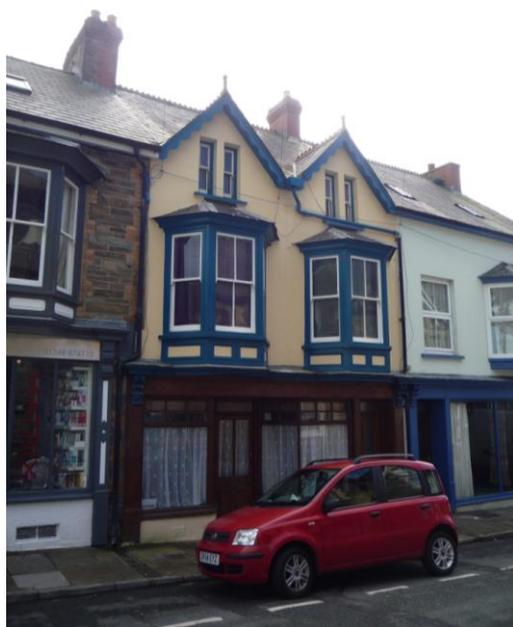
4.4.4 The original detailing and unity along Main Street make it a fine example of a Victorian commercial townscape, which would have been the focal point for the community and developed in response to the prosperity brought by the railway. Most of the shop fronts retain original features, including window and door styles, although many of the properties are now purely residential in use and have lost their signage. Many of the shops would originally have had hand painted lettering on the timber fascia's and probably had fold out awnings with advertising incorporated. The properties are capable of reinstatement as shops with living accommodation above should the opportunity arise.

View Traditional Shop Front on Main Street Goodwick, View of Gwalia House & north along Main Street (26.3.15)

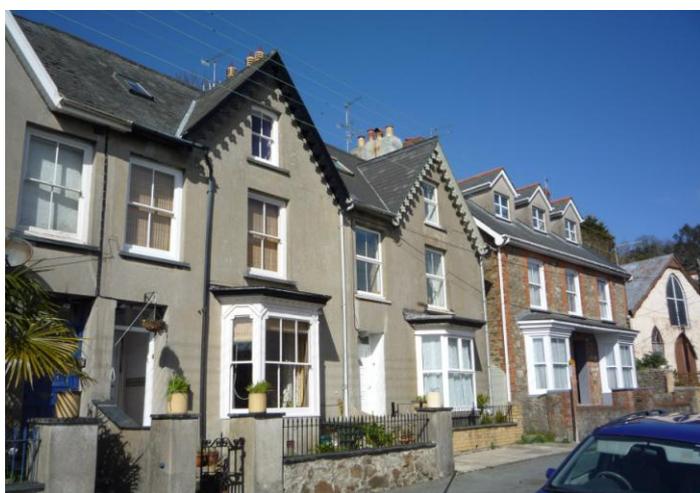
4.4.6 In terms of the character of materials and roofing, roofs are mainly 35 - 45 degree pitch, finished with locally quarried slate, and many have decorated clay ridge tiles, with a large number of decorative clay finials and well detailed brick chimneys. Many roof spaces have been adapted internally to provide additional rooms with 'Velux' style windows set into the pitches, even in buildings with more superior facades. Wall surfaces however are varied; some have a lime/cement render finish with raised plaster quoin details and around openings, some are painted, some have pointed stonework facades, with red brick detailing around the apertures, and some are of two tone brick.

View of Goedwig Villas, Main Street Goodwick  
(26.3.15)

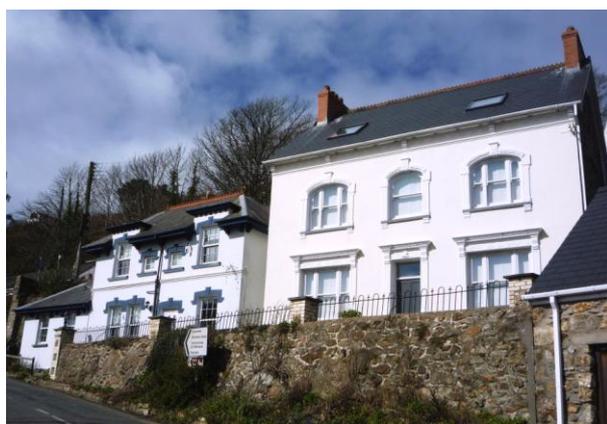
with a variety of pane configurations from 2 to 12 panes. The variety of roof dormers and timber bay windows, some at ground floor with wood core rolled lead covered roofs, some at first floor, and some forming full height bays which form part of the structural façade, with timber windows set into the projections, some having almost flat lead covered roofs, and some have pitched slate roofs over separate to the main roof, and with decorative fascia boarding, adds greatly to the character and special interest of the street scene. Often forming an extension of the façade, many properties have steep pitches of 40 – 45 degrees, and decorative details such as ornate fascia boards, finials and ridge tiles, with windows set above, mid way or below the eaves line, and proportioned so that they are smaller than the ground and first floor windows, but match in style. Close set eaves with 150mm deep fascia boards and half round cast iron rainwater goods affixed, red brick chimneys, pointed stone or cement / lime painted rendered finishes, raised plaster bands around openings and raised plaster quoin details also add interest to the street scene. Many properties sited along the steep inclines of the roads have front retaining walls, mostly constructed in stone, and some with a rendered finish.

View of Stone Hall, Goodwick Hill (26.3.15)  
View of Ty Glandwr & Gwylfa, Goodwick Hill (26.3.15)

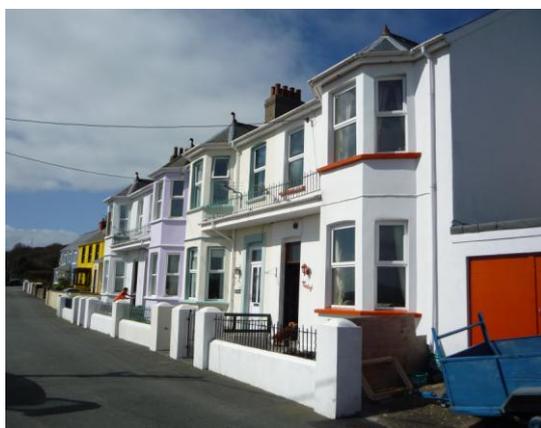
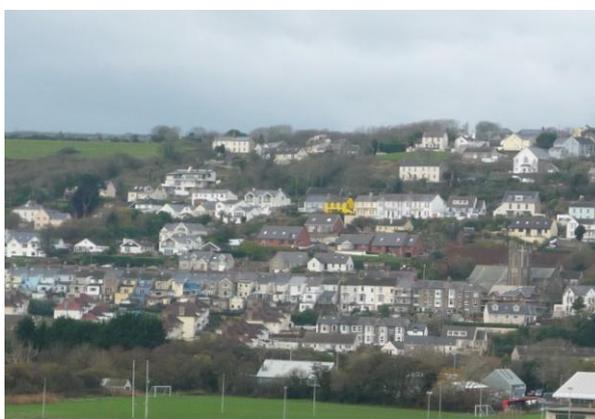
View of Rewey Terrace, Glanymor Road (26.3.15) and (Photo 18a) from French walk Fishguard

4.4.13 Rewey Terrace (above) to the western end of Glanymor Road consists of two pairs of mirror image Edwardian villas, each having full height projecting bays. Adjacent entrances with a single narrow canopy / balcony running between the bays and fine wrought iron decorative railings, smooth plaster finishes with horizontal plaster bands and raised quoin details, characterise the villas which sit as a horizontal terrace on the hillside.

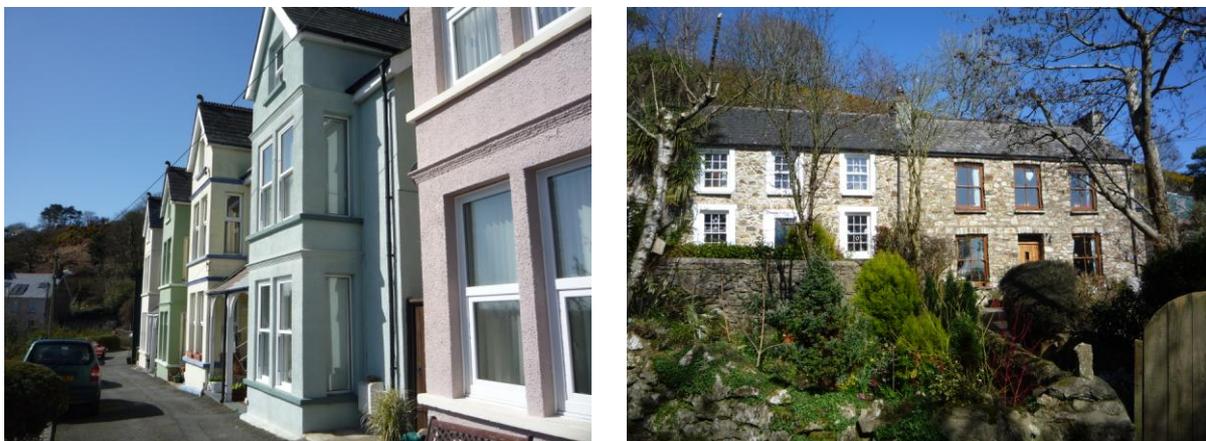
4.4.16 Clement Terrace at the northern end of Clement Road is a terrace of larger scale mid to late 19<sup>th</sup> Century properties with a grand end terrace of three pairs of two mirror image villas. Each villa has been built with bays rising to form large roof dormers above the eaves line of the property and with timber canopies over close coupled entrances. These tall properties are a striking feature of the town when viewed from the south.

Clement Terrace, north of Clement Road, Spring Gardens & Bronwydd, Pant-yr-ychain (26.3.15)

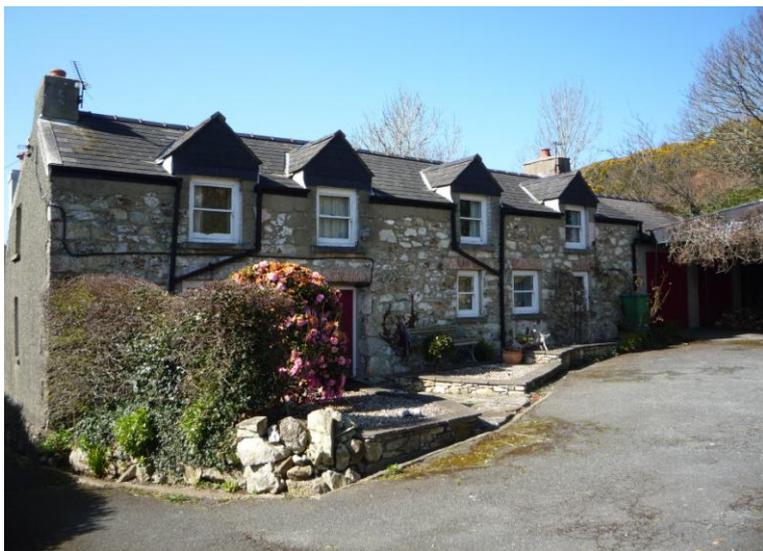
4.4.19 Furthermore at the top of this very steep lane is Penseran which presents as two 19<sup>th</sup> cottages. These cottages have a low pitched slate roofs and outbuildings to the north end, and unusually, face north east. The dormer windows of the cottages are larger than the ground floor windows and look out of scale, with random rubble

pointed limestone walls.

Penseren, Pant-yr-ychain (26.3.15)

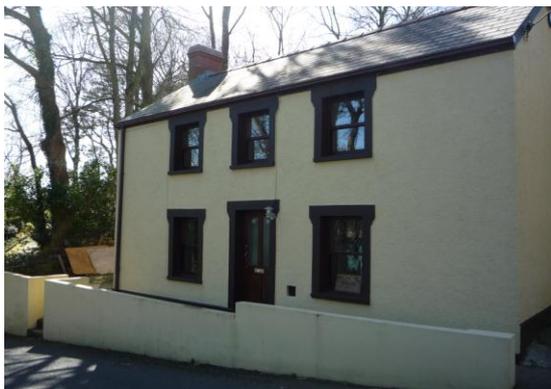
Above, Laurels Cottages, north of Berachah Presbyterian Church, New Hill. Left: Sunnyside, New Hill (26.3.15)

4.4.25 Significant properties within this character zone include Heather Cop, Coach House and Sunnyside. Heather Cop is a large traditional two story Victorian villa (built 1891-1912) set high up from the road level and up a steep drive way, with a 40 degree

pitched slate roof, rendered brick chimneys, two ground floor bay windows with slated pitched roofs and sliding sash windows above, and a central first floor window. Adjacent to Heathercop is Coach House (1891-1912), a property substantially modernised with most of its original late 19<sup>th</sup> Century features now removed. Sunnyside is the earliest of the grouping, and is shown on the historic map of 1843– 93 ([Appendix 1](#)) as New Hill Cottage. Sunnyside is a traditional 2 storey stone built house, with a 30 - 35 degree pitched roof, brick chimneys at each end, 'set in' sash windows, with contrasting decorative bands around openings and a modern blockwork front wall which provides separation from the road.

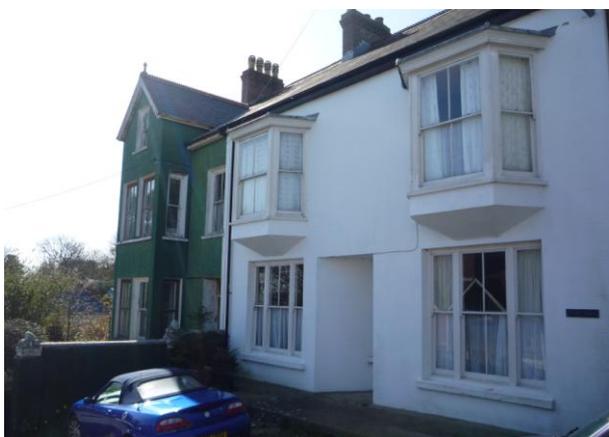
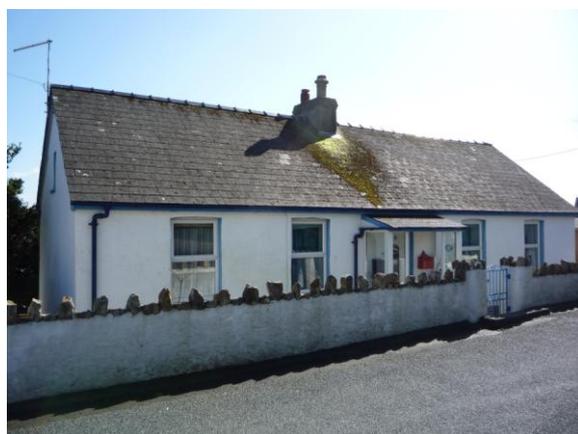
4.4.26 Two further notable semi detached residential properties at the very northern limit of the Conservation Area are Heatherland and Tenby House. These properties are typical large post Edwardian villas built between 1919 -1943 with continuous roof and eave lines, but differing facade and fenestration details. The two buildings have a striking presence on the hill side not least because of the imposing south facing gable end of Heatherland. There are a number of outbuildings to the rear of the properties, and one of these buildings was used as a small cinema during the 1950's.

Heatherland & Tenby House, New Hill and Photo 25: Landscape Cottage, New Hill (26.3.15)

**Recommendation 1: that the Conservation Area boundary be amended to include New Villas 9-14 and Landscape Cottage and their curtilages within the boundary.**

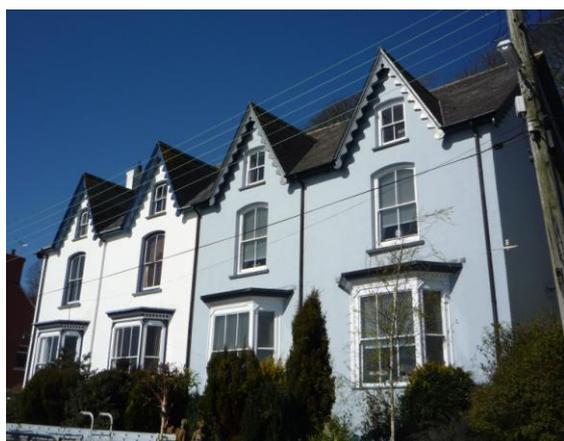
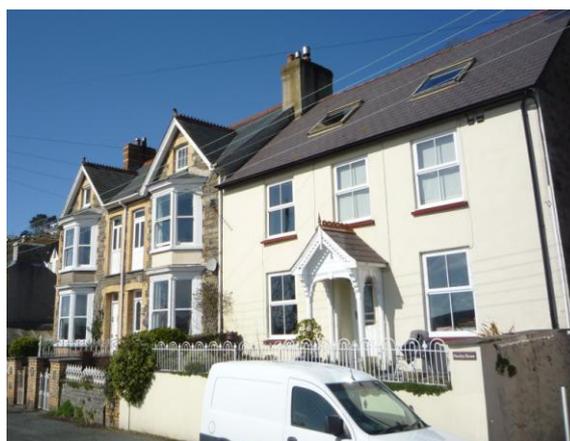
4.4.28 Quay Road runs below New Hill and is made up of a number of individual early to late 19<sup>th</sup> Century buildings in a mix of styles and sizes. Buildings range from small scale simple 2 storey stone built workers cottages, to pairs of grand 3 storey villa style brick houses. Building finishes vary too from smooth painted render, ornate plaster mouldings, to those of stone with ornate brick detailing, some with plain slated roofs and some with large pitched dormer roofs. The earlier 19<sup>th</sup> Century buildings reflect the activities of the time which were predominantly linked to agriculture, fishing, and quarrying activities. Such properties were later joined by grander houses associated with the settling of wealthier residents attributed to improved accessibility by road and rail, and the increased popularity of Goodwick as a sheltered coastal town.

Siriole 1-2, Quay Road and Photo 27: Stanley House, Quay Road (26.3.15)

4.4.29 In terms of character and style, detailing mainly varies between two and two and a half storey Victorian and Edwardian buildings which have developed incrementally within this character zone. Most Buildings have retained their original details, and in particular, the multi paned traditional sliding sash bay windows with finely detailed mouldings for the mullions and transoms. Unifying details of the later Victorian and Edwardian buildings include ground floor bay windows with flat leaded

roofs, bays with vertical sliding sash windows set into the front and sides, mostly 40 degree pitched natural slate roofs, and double bay projections with tall pitched roof dormers forming an extension of the facades, and terminating above eaves level with separate roofs. The majority of properties have small, walled front gardens set above the road, and there is a variety of style in the wrought iron work as well as the wall construction, some are in pointed stonework, some rendered and painted stone or brickwork, and all with squared gate piers and copings, and a variety of original painted wrought iron railings and gates, which add texture and variety on the street scene. Furthermore many of the houses along Quay Road have steep, tiered gardens to the rear, which adds interest along the road, as they can be clearly seen in the gaps between the properties.

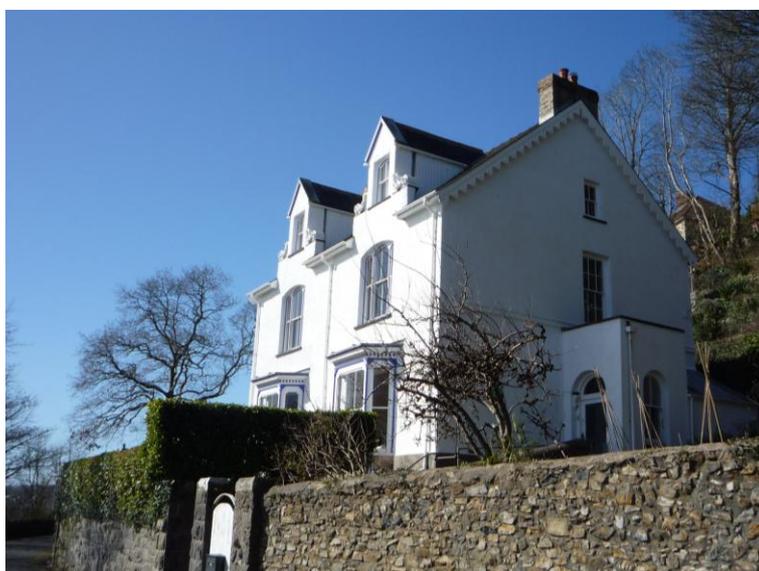
4.4.30 In terms of specific property detail, the end property along Quay Road, Rocket Cottage, has recently been substantially altered from its original form, extended with traditional and gothic style openings, modern roof dormers, and a modern conservatory and terrace built over 2 garages. It sits apart from the rest of the terrace but does not seriously detract from the mostly unspoilt, traditional housing along this road. Furthermore, just before the entrance to Fishguard Bay Hotel is Penrhyn, a large late 19<sup>th</sup> Century villa set well above the road level. It has all original details intact with distinctive Rococo plaster scroll details built above the eaves decorating the upstands at each side of the two dormer windows; it has elegant first floor windows with low sprung arched lintels, and finely detailed mullions and transoms to the ground floor bay windows.

Penrhyn, Quay Road (26.3.15)

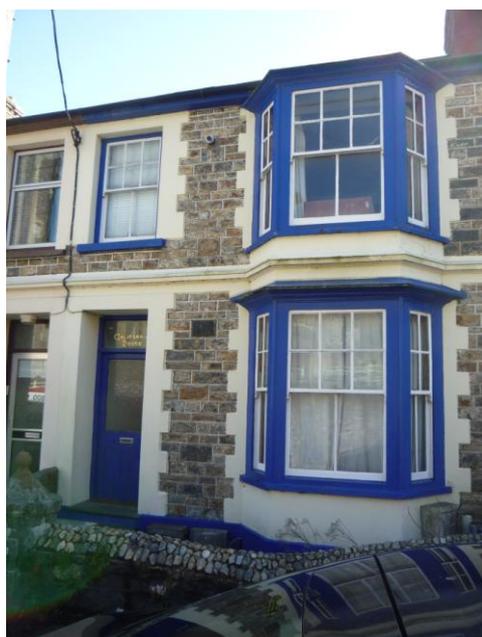
4.4.38 Church Terrace consists of a terrace of 8 properties located opposite the Grade II Listed Church of St. Peter's, a gothic style church built in 1910-1911 (see Appendix 1). Much detail of the original Church Terrace has been lost through modernisation, with the exception of number 5 which has retained all original detail and should be preserved as such – see below.

No.5 Church Terrace (26.3.15)

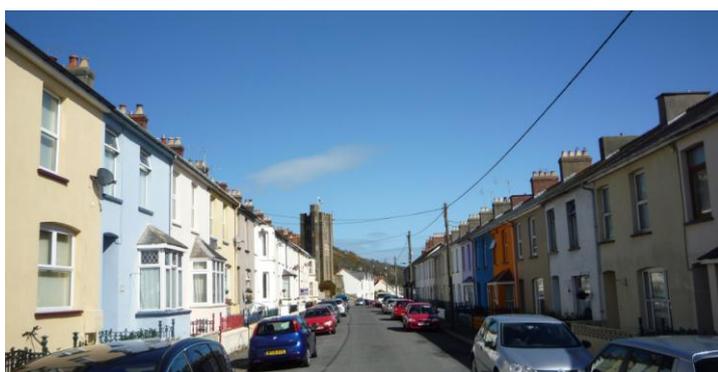
4.4.39 Church terrace links into the long terraces of Plasygamil Road, a traditional Victorian residential street of 40 properties. The continuous rendered frontage along the street is only broken by a small number of ground floor bays, and all have small front gardens enclosed by painted render stone walls topped with a variety of wrought iron railings and gates. The door and window apertures of the majority of dwellings have low arches, and many openings have raised plaster band surrounds, and continuous horizontal plaster architrave detailing between ground and first floor. The continuity of the ridge and eaves line, matching property widths with equidistant red brick chimney stacks, and similarity of detail to the frontages creates a striking and notable rhythm along the street, and like Main Street is a fine example of a Victorian townscape, although most properties now have poor quality upvc replacement windows.

Plasygamil Road, view towards the Church of St. Peters (26.3.15)

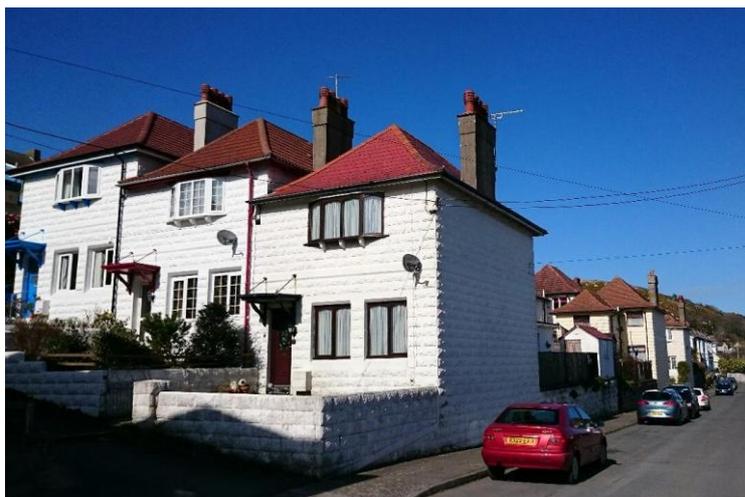
4.4.40 At the southernmost edge of Goodwick Conservation Area is St Davids Place, a residential street which displays a very different style to those elsewhere in the Conservation Area. Properties here were built to accommodate a rapidly expanding workforce for the port's construction in the 1960's, and have little architectural connection to the rest of the town's historic development and separate detailing and material finishes. The properties are constructed with concrete, have high pitched red clay pyramid style roofs, and almost all have upvc replacement windows and doors and each has a first floor cantilevered bow window on a corbelled cill. The garden enclosure walls have been constructed from dressed concrete blockwork. The properties are built along short cul-de-sac spurs and dwellings at either end of the street are larger, suggesting that these were probably built for workers in managerial/supervisory positions.

St. Davids Place (26.3.15)

- Unsympathetic design of early 20<sup>th</sup> century semi detached dwellings at New Hill which sit below the road level but are visible in views across from the south.
- St Davids Place where more modern properties are lacking in original design (This area is recommended for exclusion from the Conservation Area).

**Recommendation 4: That the Conservation Area boundary be revised to omit properties along St Davids' Place, with the revised boundary terminating at the road junction between Main Street and Church Terrace.**
